Engineering Reconnaissance of the 24 August 2016 Central Italy Earthquake. Version 2

*Original*

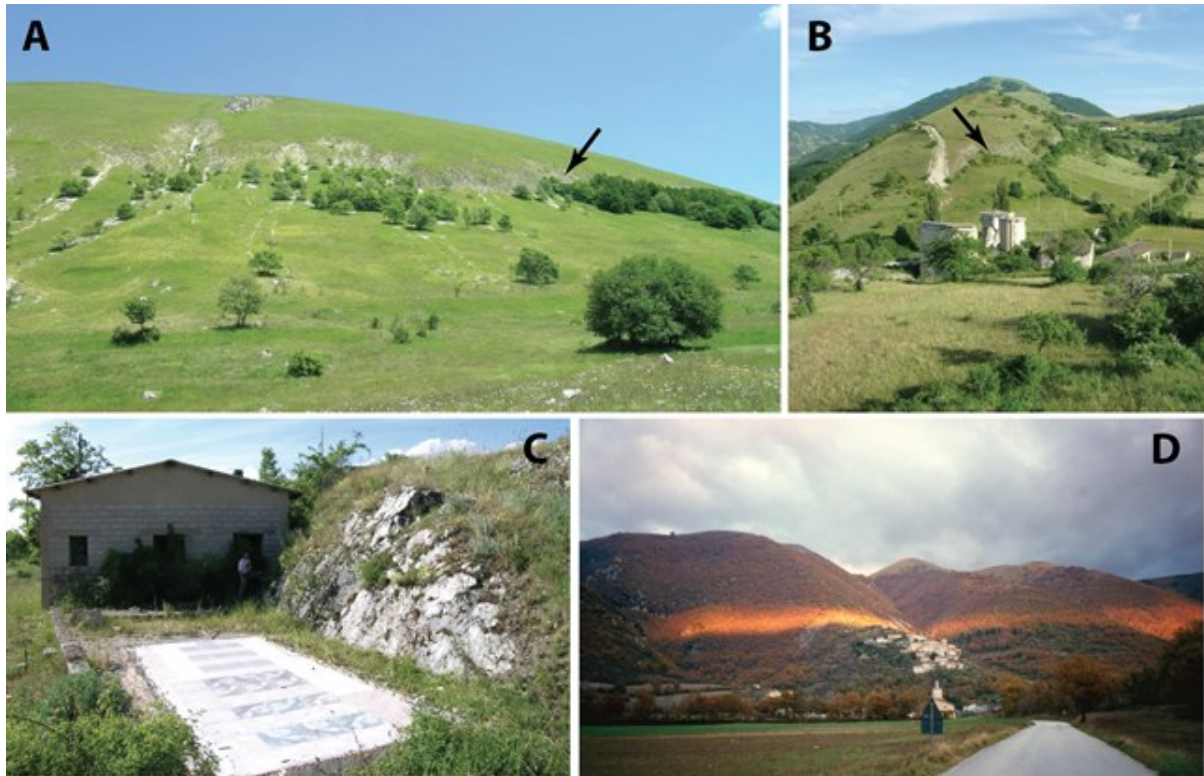
**Figure 2.4.** Norcia fault: a) southernmost fault section in the area of Cittareale (Le Piatenette); the arrow indicates the bedrock fault scarp; b) bedrock fault scarp close to Castel Santa Maria; the remains of the Madonna della Neve church, destroyed by the 1979 earthquake, are visible; c) building and the remains of a building close to the emergence of the fault at Castel Santa Maria; d) panoramic view of the NE slope of the Campi basin, north of Norcia, about 15 years ago; sunlight is shining on the slope sector where the fault is emerging, above the village of Campi.

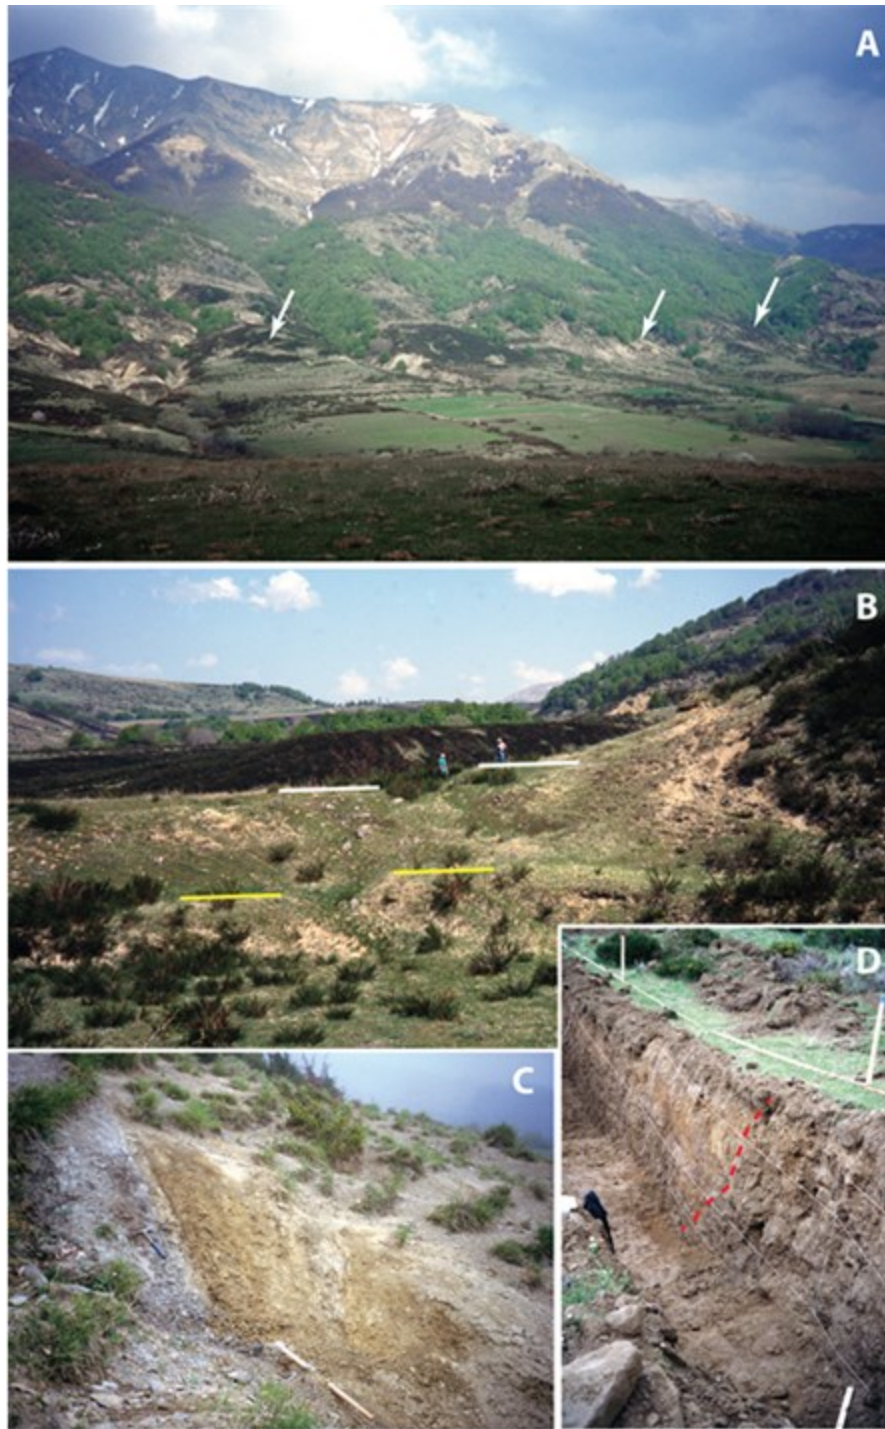
**Figure 2.7.** a) Panoramic view of the Laga fault in the Campotosto plateau; the arrows indicate places where fault scarps in the arenaceous bedrock have been detected; b) Holocene terraces displaced by the Laga fault in the Campotosto plateau; c) fault plane placing the clayey-arenaceous Laga flysch in contact with colluvium probably deposited during the Upper Pleistocene; d) panoramic view of the trench excavated in 1998 across the Laga fault in the Campotosto plateau by Galadini and Galli (2003); the fault places the arenaceous bedrock of the Laga flysch in contact with colluvial units of Holocene age.

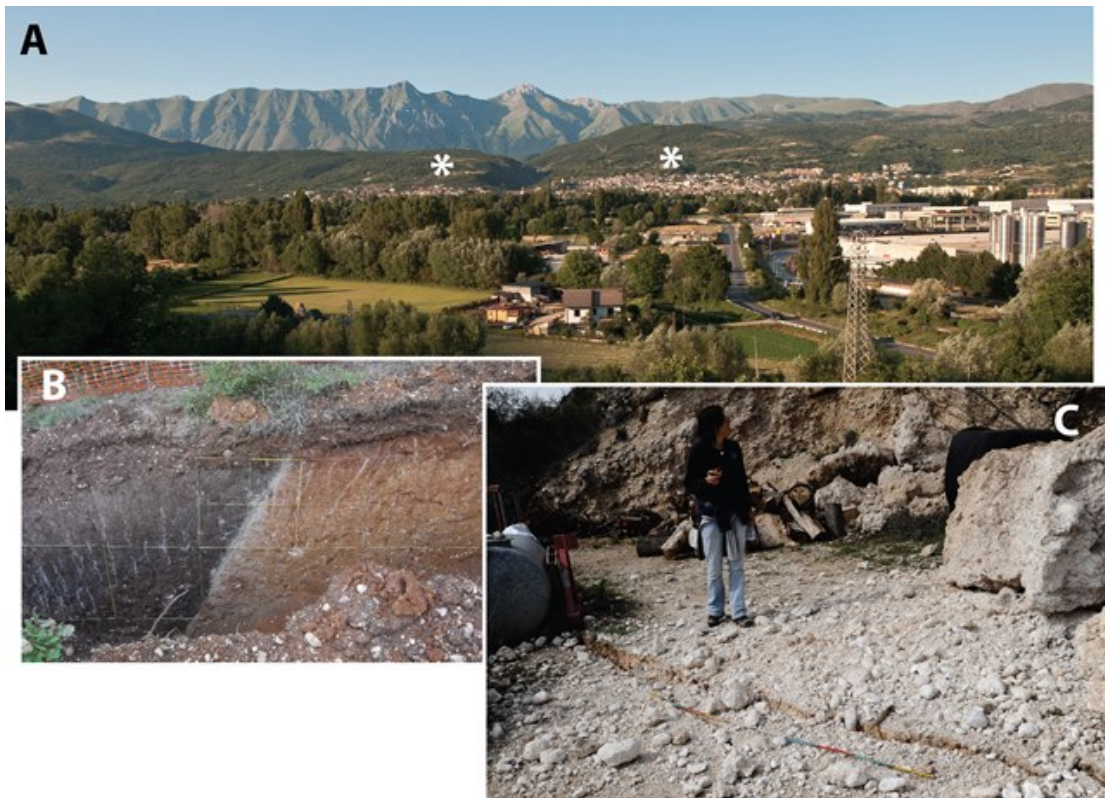
**Figure 2.10.** a) Panoramic view of the Paganica-Bazzano plain; the white asterisks indicate the gentle slope where the Paganica fault has been detected; b) wall of one the trenches excavated by Moro et al. (2013) across the Paganica fault: the fault places a Pleistocene colluvium (red unit in the footwall) in contact with Upper Pleistocene and Holocene colluvial units in the hanging wall; c) surface faulting observed along the Paganica fault after 6 April 2009 earthquake.

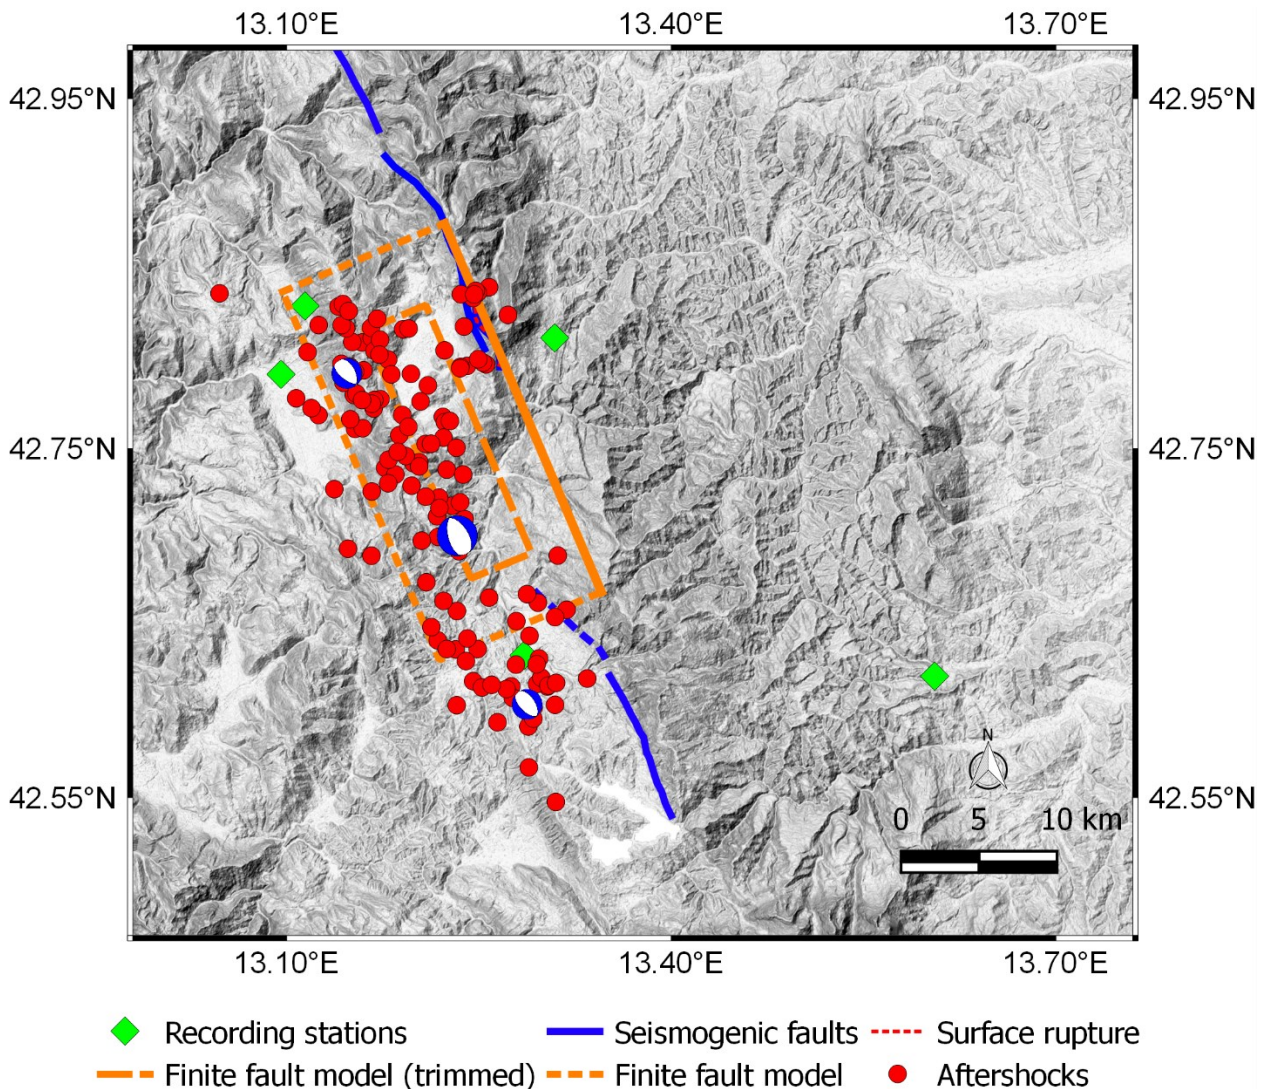
**Figure 2.12.** Map showing the 24 August 2016 mainshock and aftershocks within a five-day time window. Finite fault model adopted in section 2.3.3 shown for reference purposes.

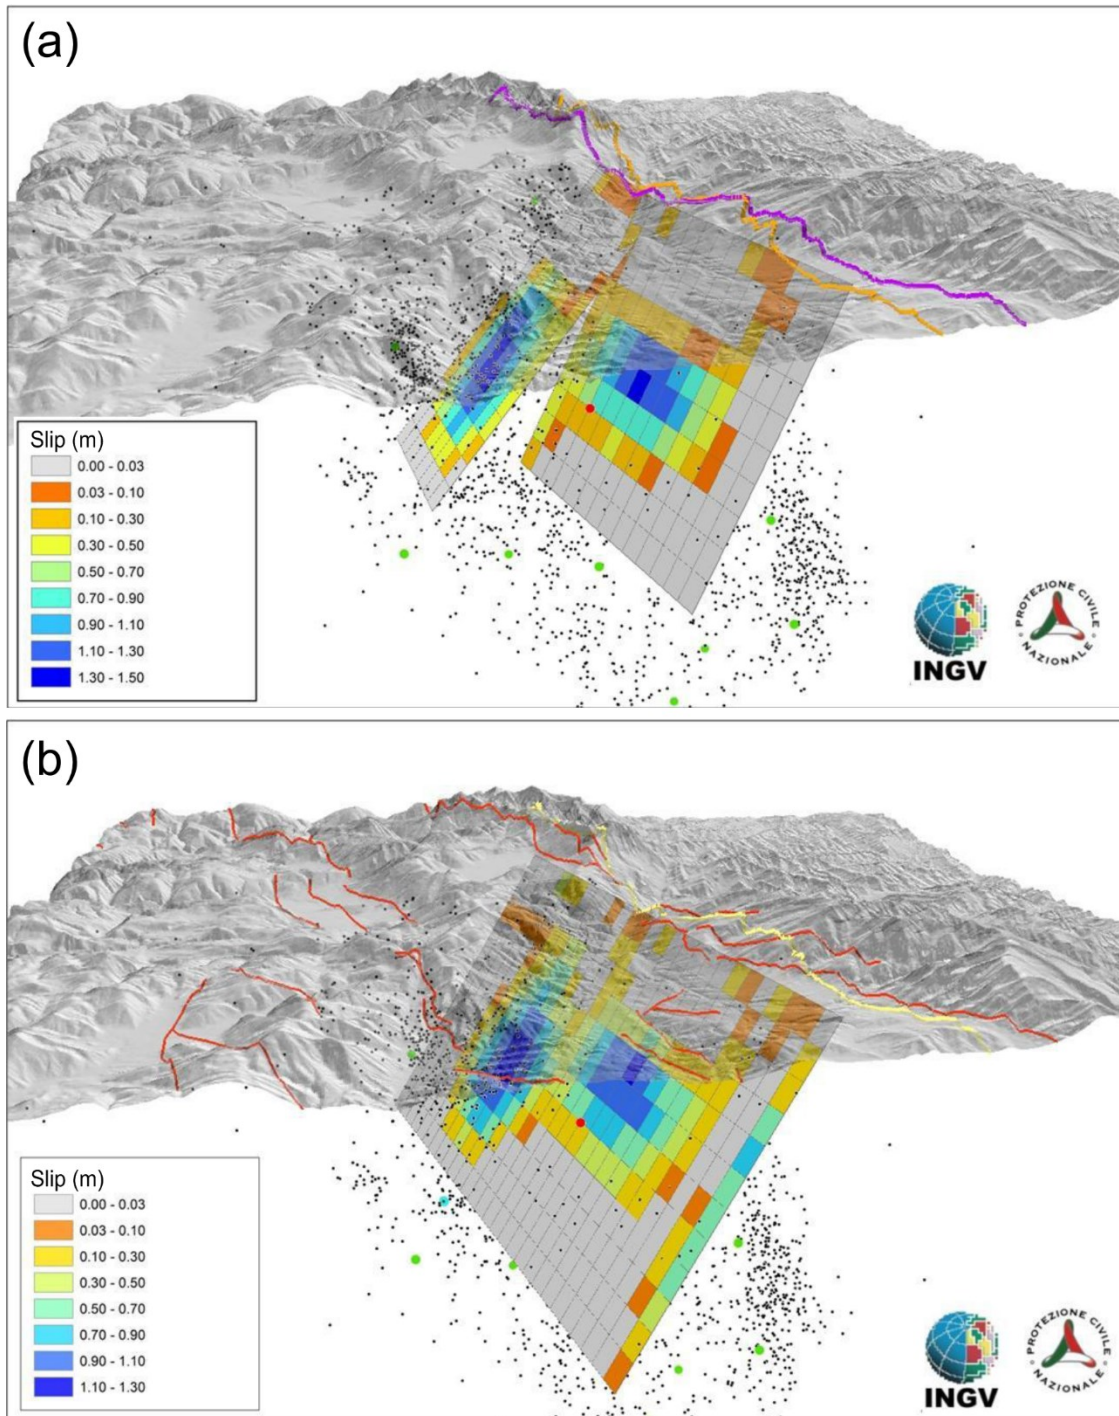
Figure 2.16. (a) Two-plane finite fault model; (b) Single-plane finite fault model. Adapted from IREA-CNR & INGV working group (2016).

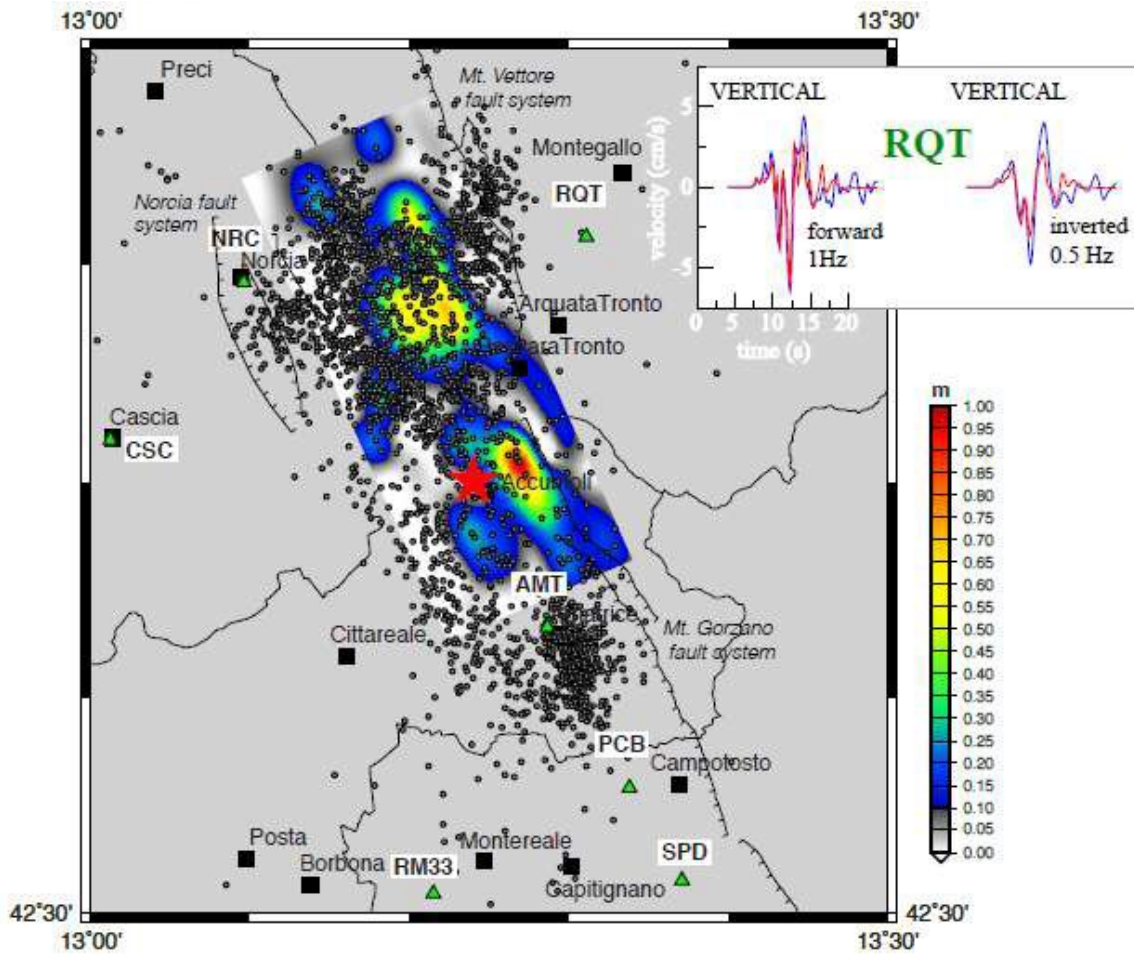
**Figure 2.17.** Single-plane finite fault model proposed by Tinti et al. (2016), along with slip distribution, recording station locations, 24 August 2016 mainshock and aftershocks.

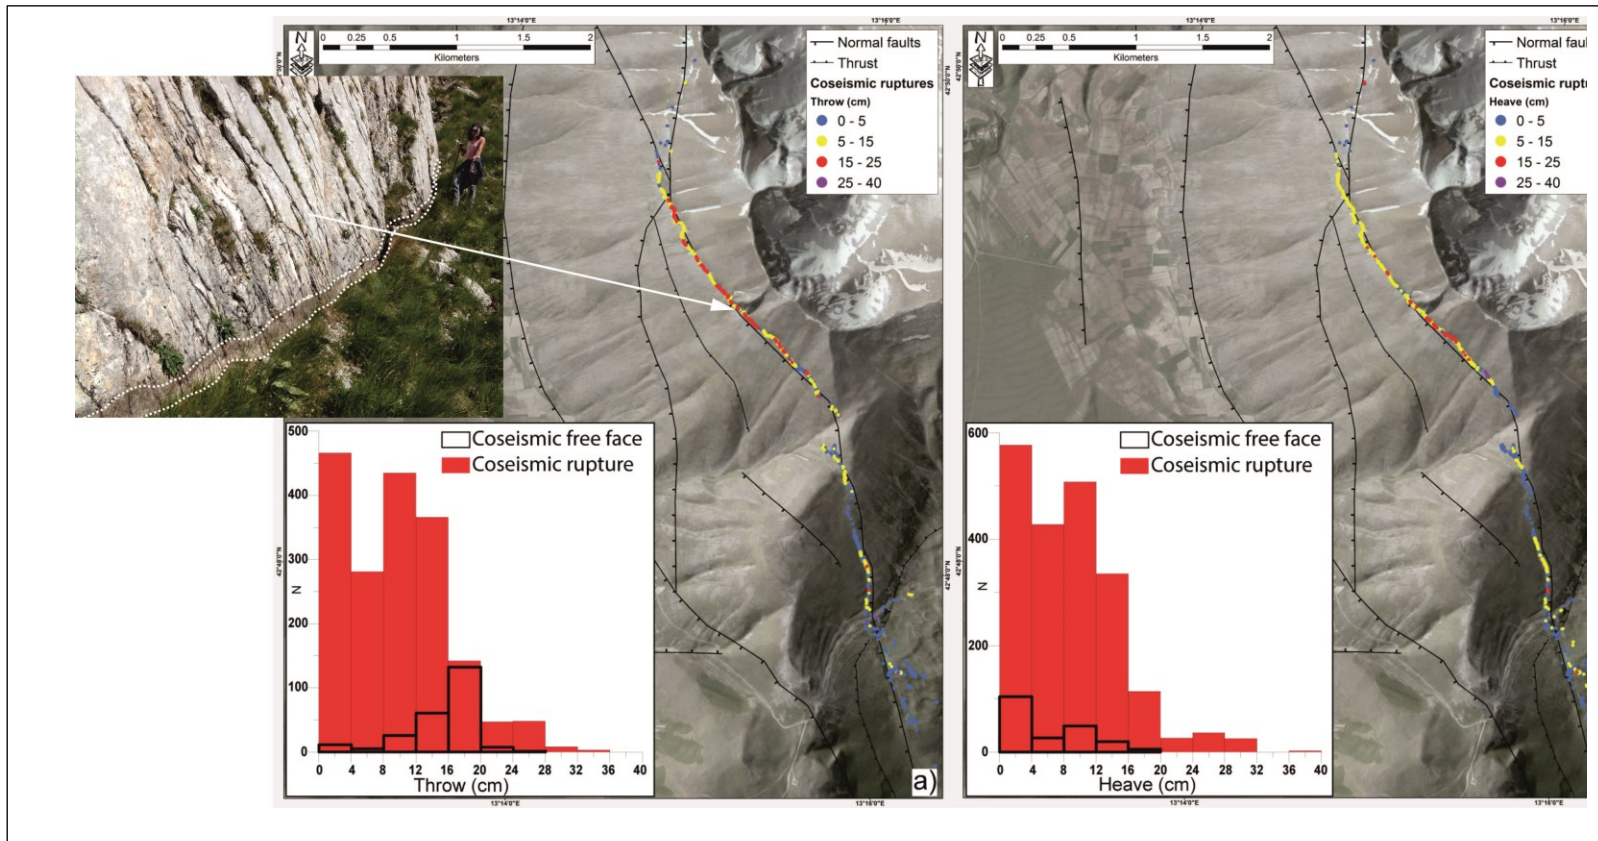
**Figure 2.18.** Relief map showing amounts of displacement down-dip and horizontally (from crack opening), and histograms of measured displacements (EMERGEO, 2016) along the Mt. Vettore fault splays. Free-face at the base of the fault plane, white dotted lines in inset.

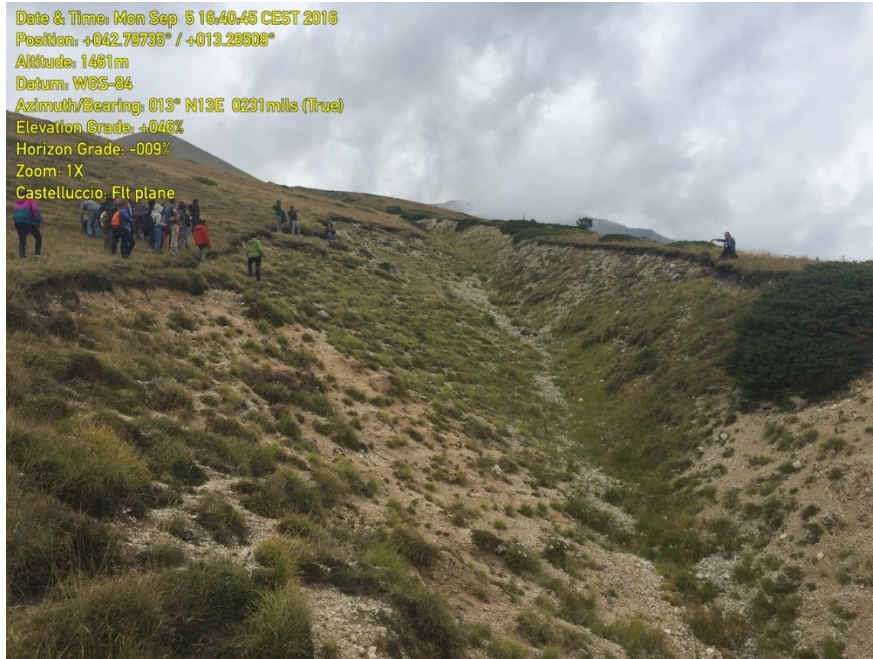
**Figure 2.19a.** The Mt. Vettore Fault as seen from the south near SP477 during our initial visit to the site on September 5 guided by Dr. Fabrizio Galadini.

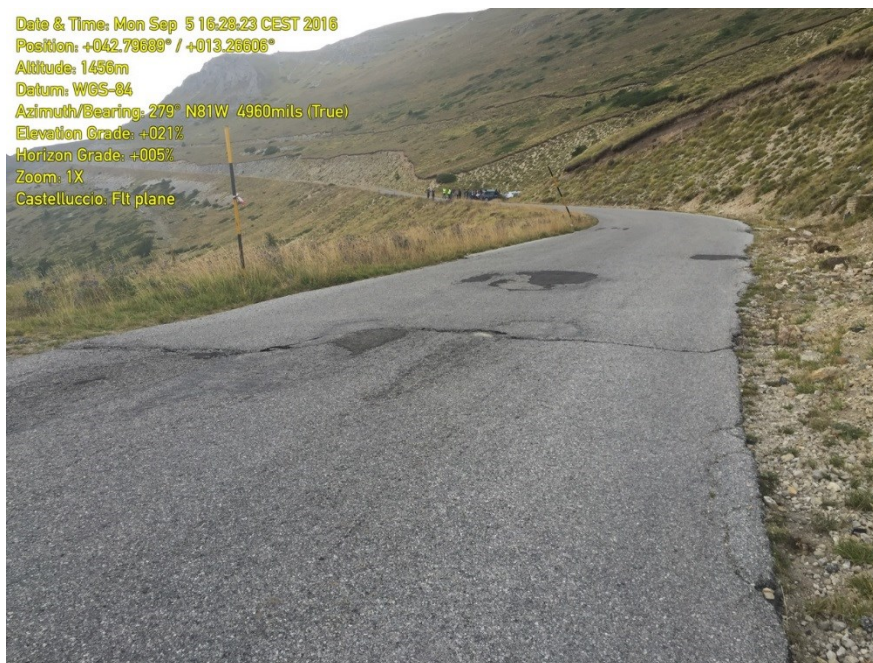
**Figure 2.19b.** Mt. Vettore fault: Damaged asphalt on SP477 at the fault crossing with less than 10cm of normal displacement down toward the west. Displacement are masked by bridging of the asphalt surface (Latitude and Longitude are annotated on the image).

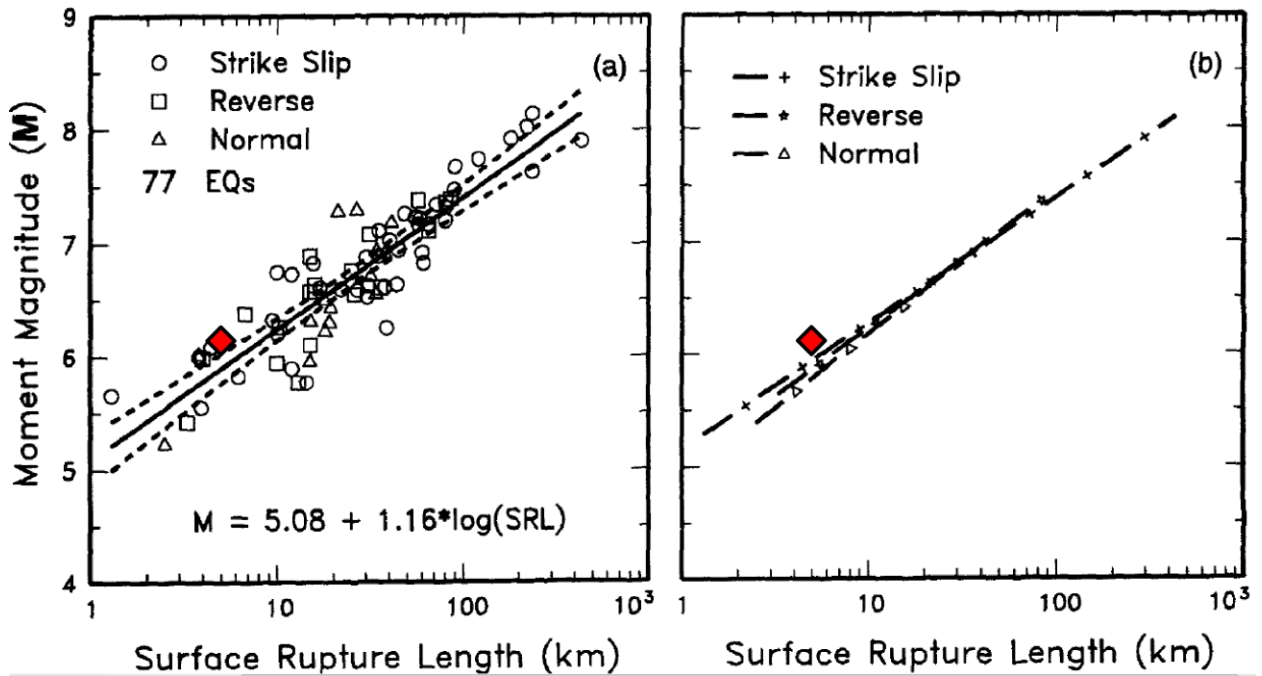
Figure 2.23. The surface fault rupture length plotted vs magnitude for the 24 Aug 2016 M6.1 event relative to the data set and regression fit from WC94.

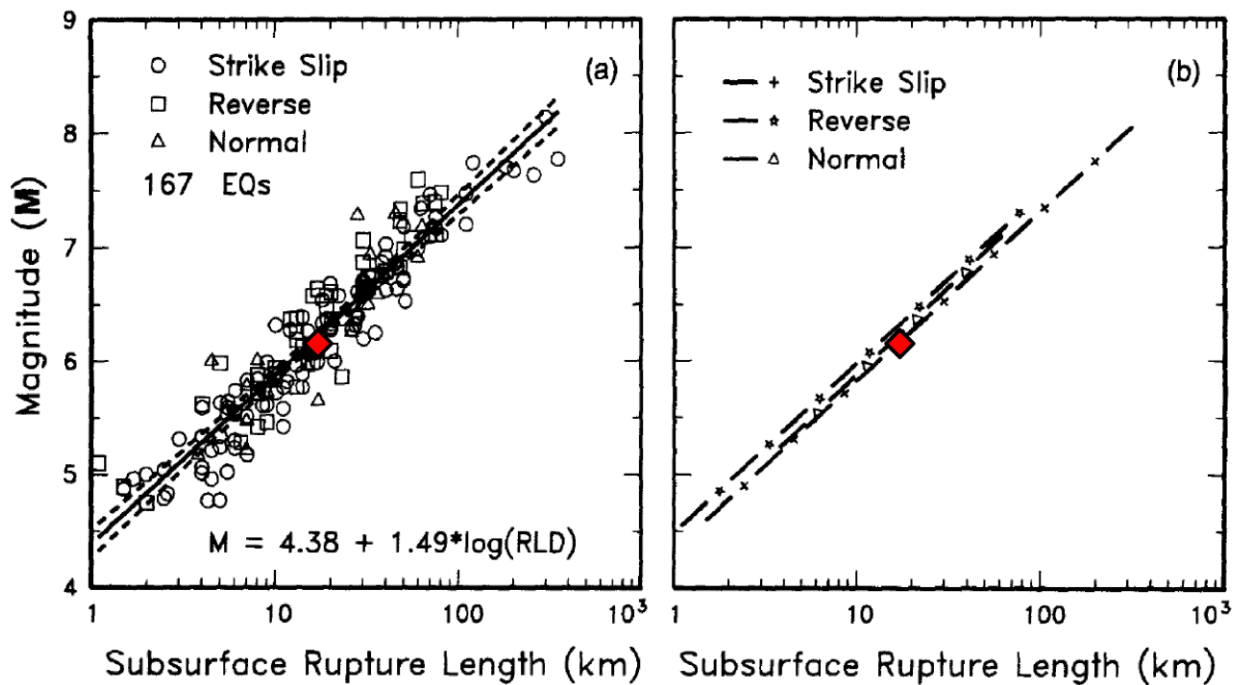
Figure 2.24. The subsurface (overall) rupture length plotted vs magnitude for the 24 Aug 2016 M6.1 event relative to the data set and regression fit from WC94.

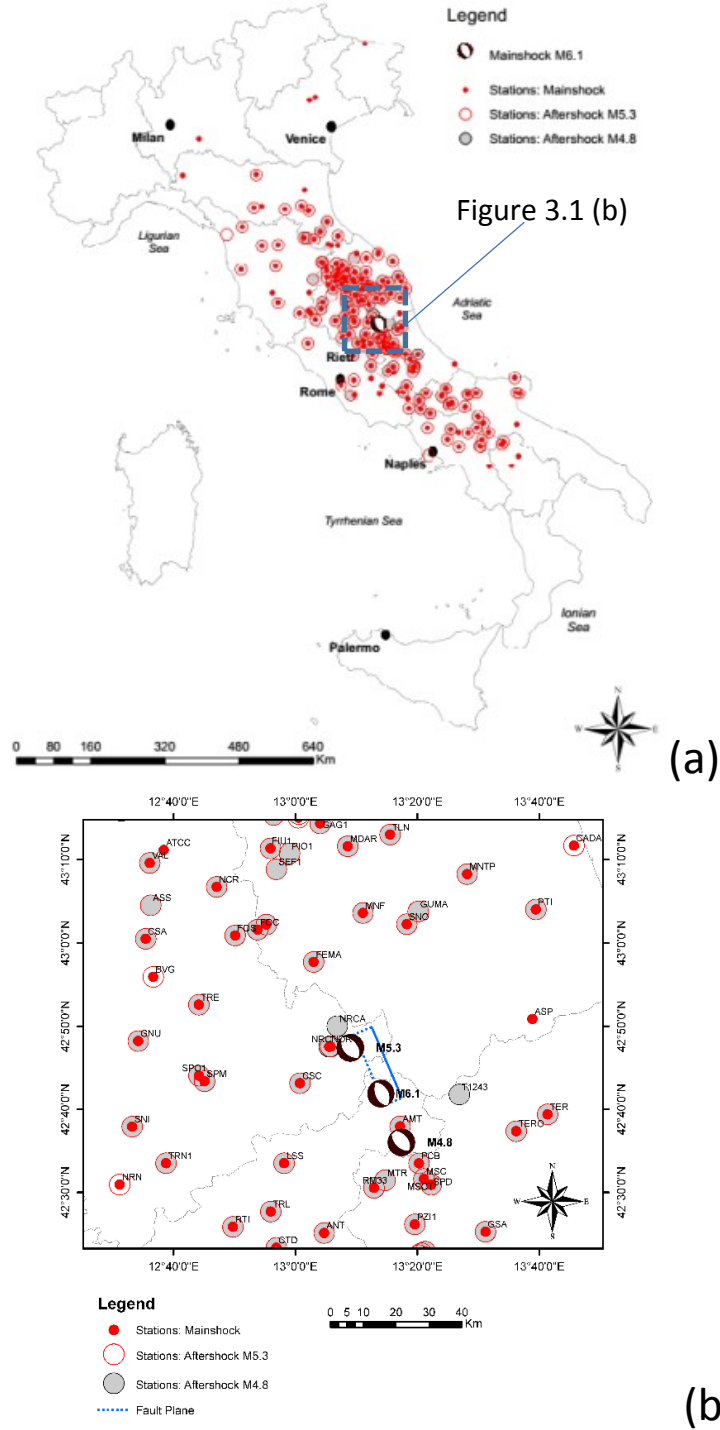
Figure 3.1. (a) Locations of instruments that recorded M6.1, M5.3 and M4.8 Aug 2016 events; (b) detail view of instruments in the epicentral area and which events they recorded.

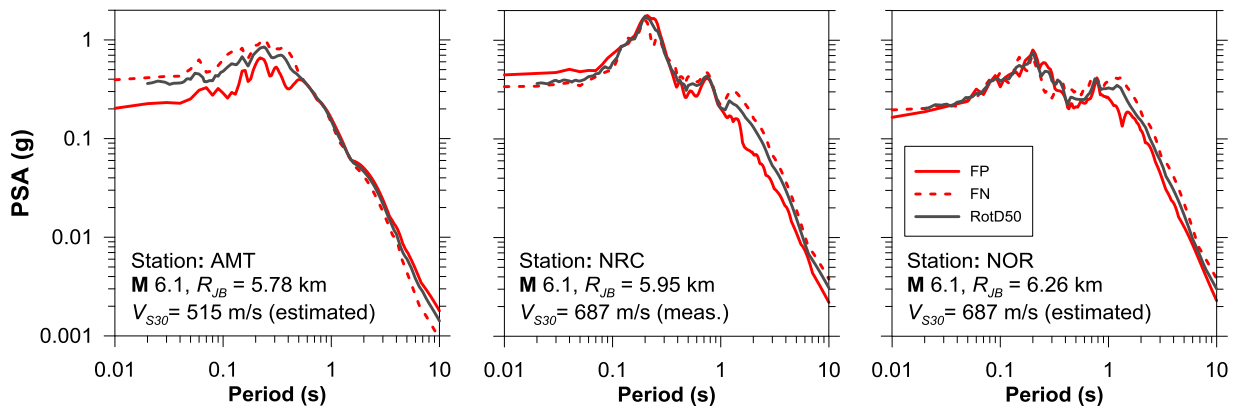
**Figure 3.5.** Mainshock pseudo acceleration response spectra (5% damping) for Amatrice (AMT) and Norcia (NRC, NOR) sites from the M6.1 mainshock.

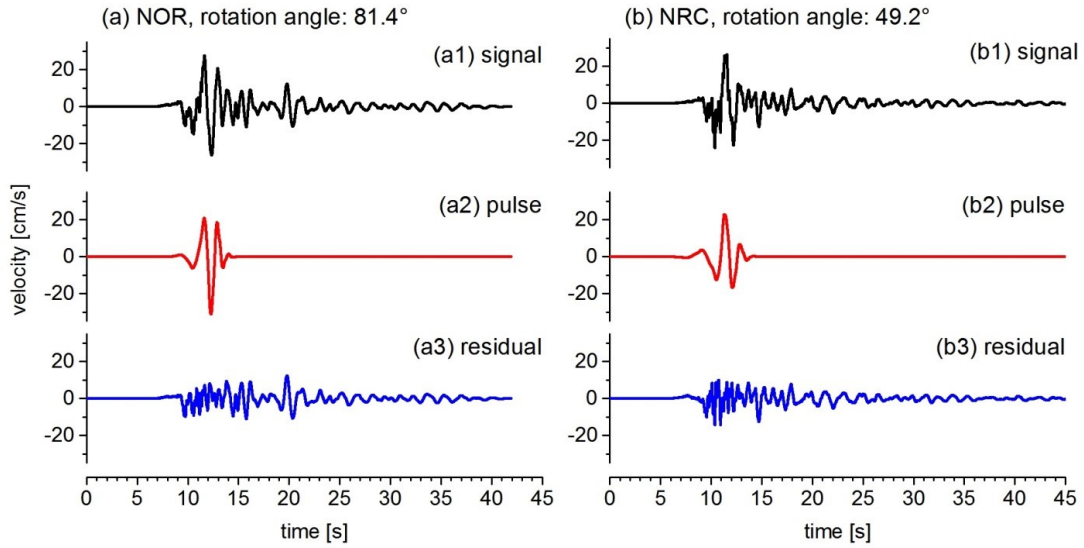
Figure 3.6. Original ground motion, extracted pulse, and residual ground motion for main shock recorded at the NOR (a) and NRC (b) stations.

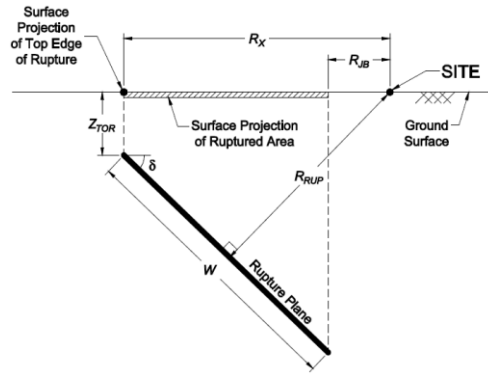
**Figure 3.8.** Scheme of an earthquake source and distance measures using a vertical cross-section through a fault rupture plane (from Kaklamanos et al., 2011).

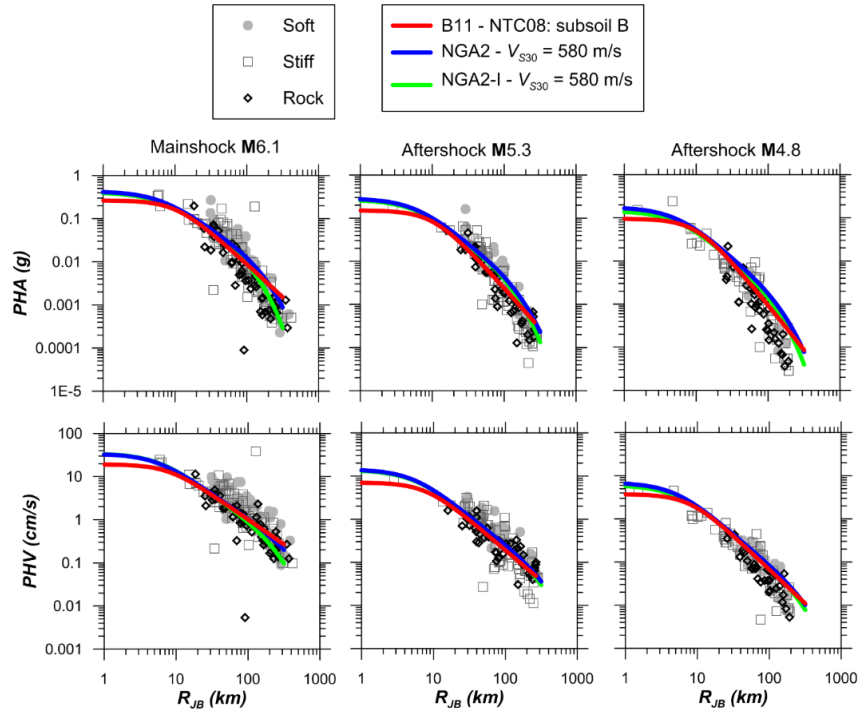
Figure 3.9. Variation of PHA and PHV with  $R_{JB}$  for rock (NTC08: A), stiff (NTC08: B), soft soil (NTC08: C, D, E).

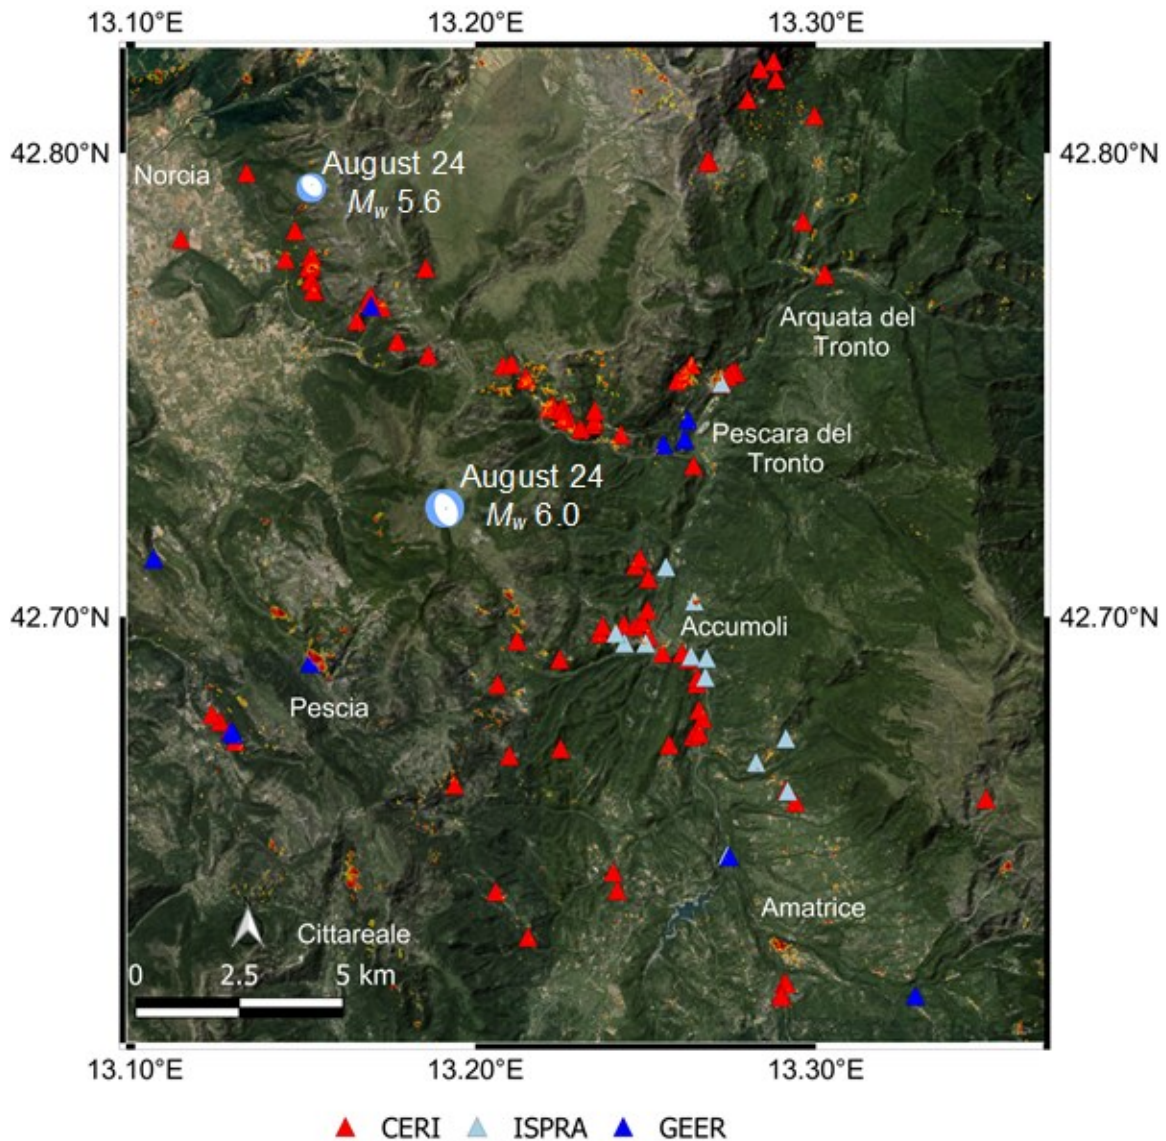
**Figure 4.1.** Mapped rockfalls and landslides from ISPRa (red circles), CERi (blue circles), and GEER (this study; white circles), along with the damage proxy map of the area produced by the ARIA project (Google earth kmz files used to produce this figure are available at: [http://aria-share.jpl.nasa.gov//events/20160824-Italy\\_EQ/DPM/](http://aria-share.jpl.nasa.gov//events/20160824-Italy_EQ/DPM/), last accessed 19 October, 2016).

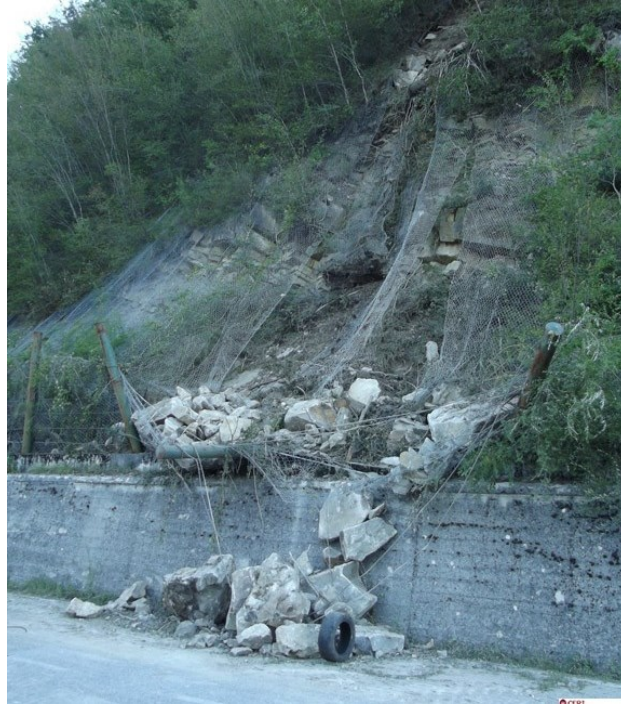
**Figure 4.5.** Rockfall involving sandstone slabs overlying marl layers (after CERI 2016).

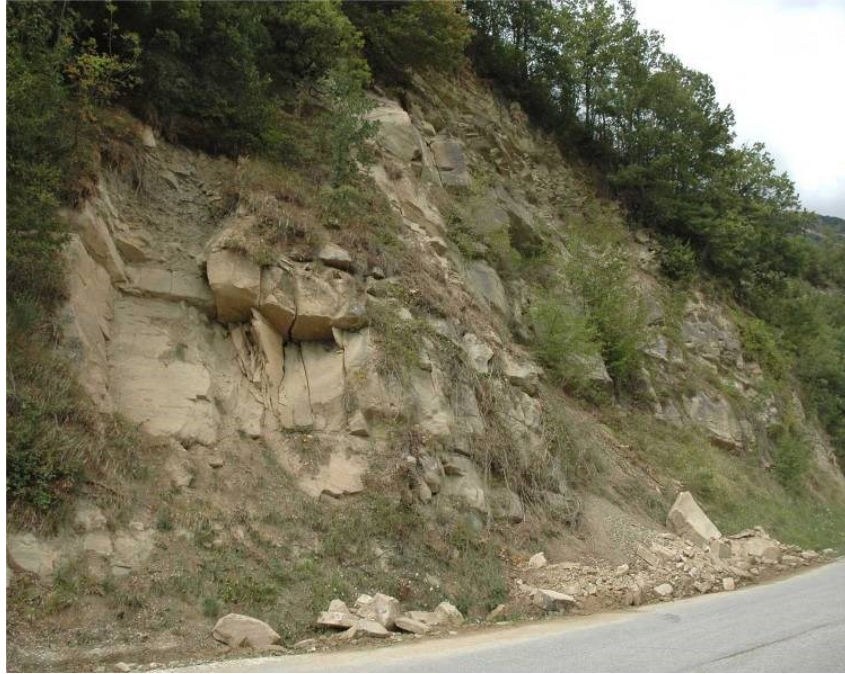
**Figure 4.6.** Free-face wedge sliding that is governed by bedding joint attitude.

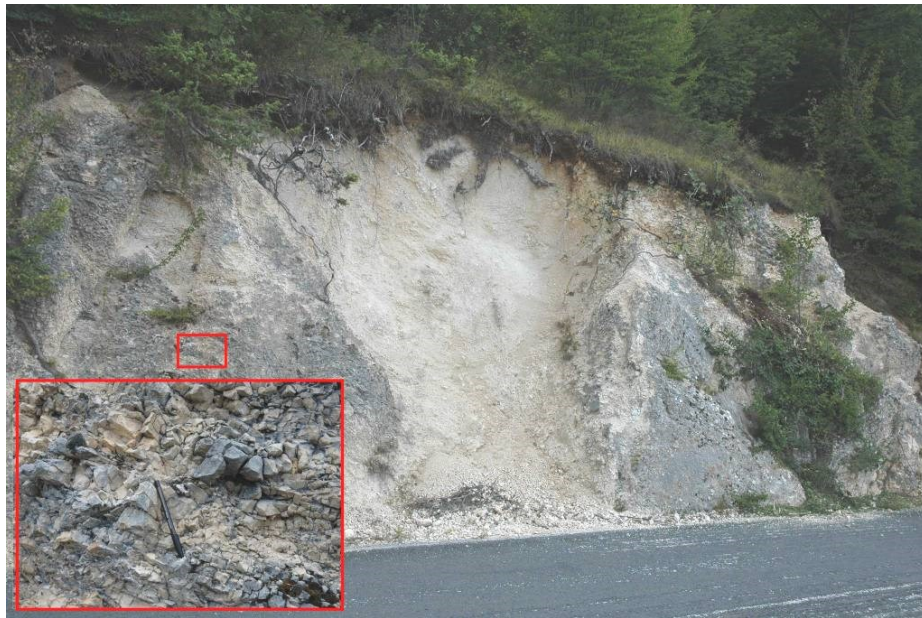
**Figure 4.7.** Failure in intensely fractured (i.e., sugar-cube) limestones (cataclasite).

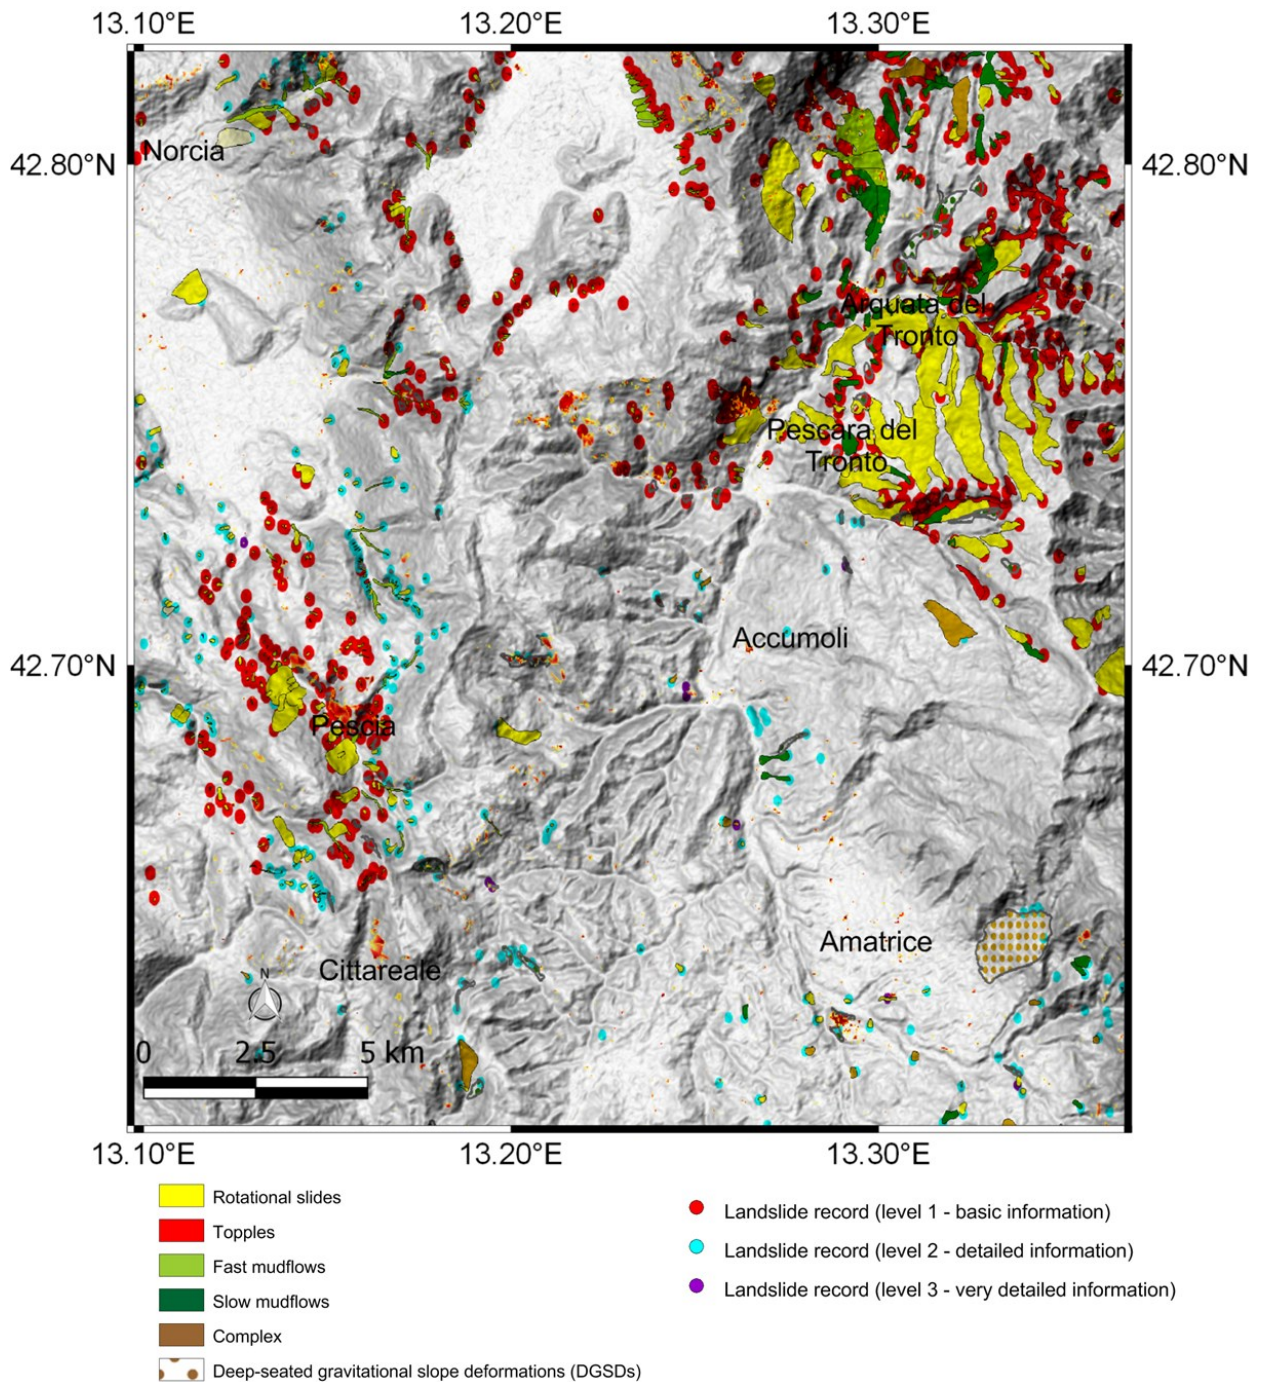
**Figure 4.8.** Italian landslide inventory (Inventario dei Fenomeni Franosi in Italia, IFFI project, ISPRA - Dipartimento Difesa del Suolo-Servizio Geologico d'Italia, available at: <http://www.progettoiffi.isprambiente.it>, last accessed October 24, 2016), along with the damage proxy map (DPM) of the area produced by the ARIA project (Google earth kmz files used to produce this layer are available at [http://aria-share.jpl.nasa.gov//events/20160824-Italy\\_EQ/DPM/](http://aria-share.jpl.nasa.gov//events/20160824-Italy_EQ/DPM/), last accessed 24 October 2016). In the DPM colored scale, yellow to red pixels indicate increasingly more significant potential damage.

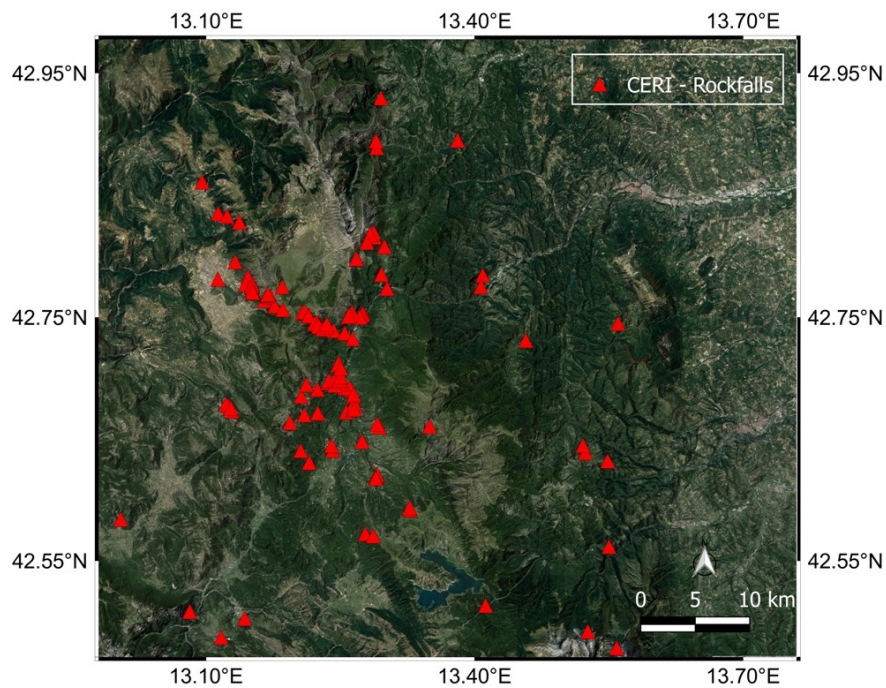
Figure 4.15. CERI catalog of rockfalls for the central Italian region affected by the 24 August 2016 M6.1 earthquake.

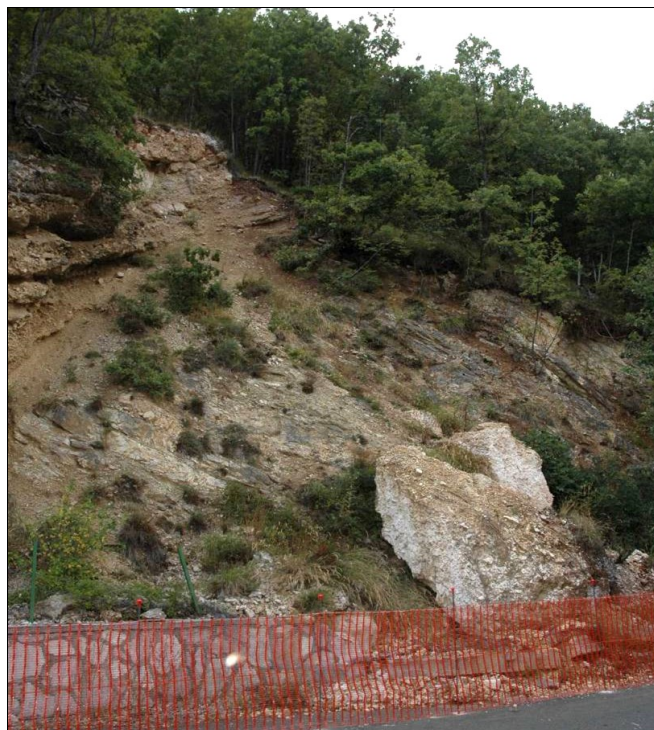
**Figure 4.16.** Failure in calcareous breccia along the SP11 road between Cittareale and Norcia.

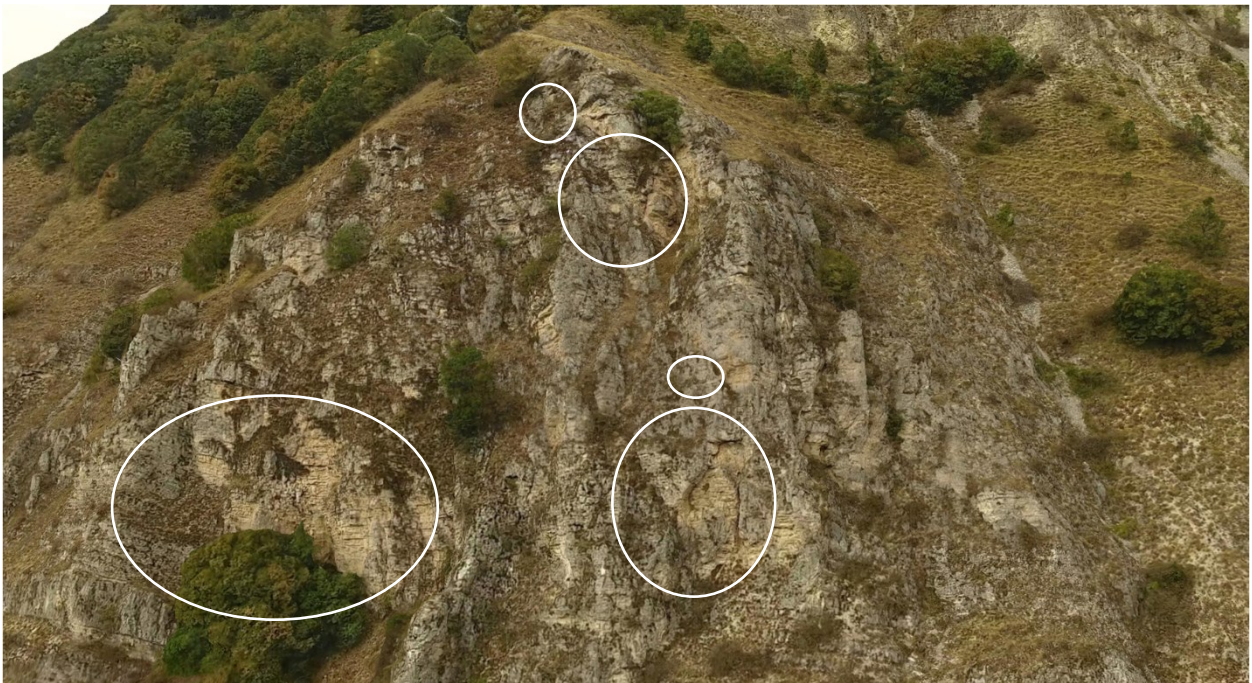
Figure 4.21. 3D surface model of the rockfall north of Pescia (42.6908 N 13.1537 E)

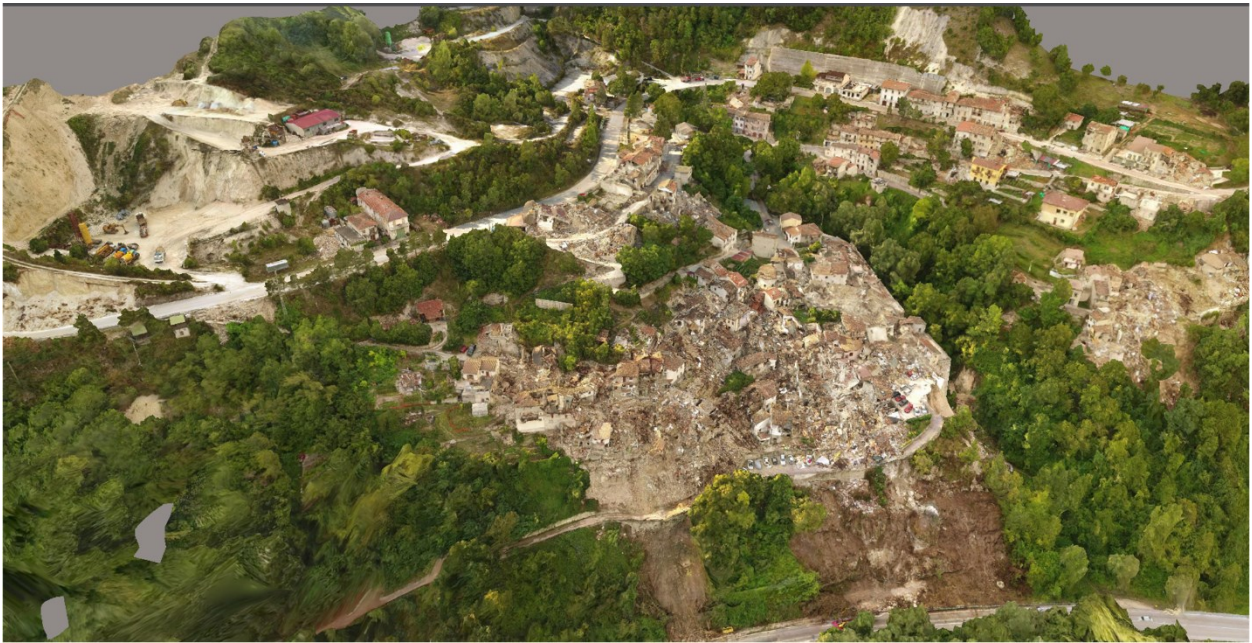
Figure 4.22. Screenshot of the 3D model of the town of Pescara del Tronto.
