Engineering Reconnaissance of the 24 August 2016 Central Italy Earthquake. Version 2

*Original*

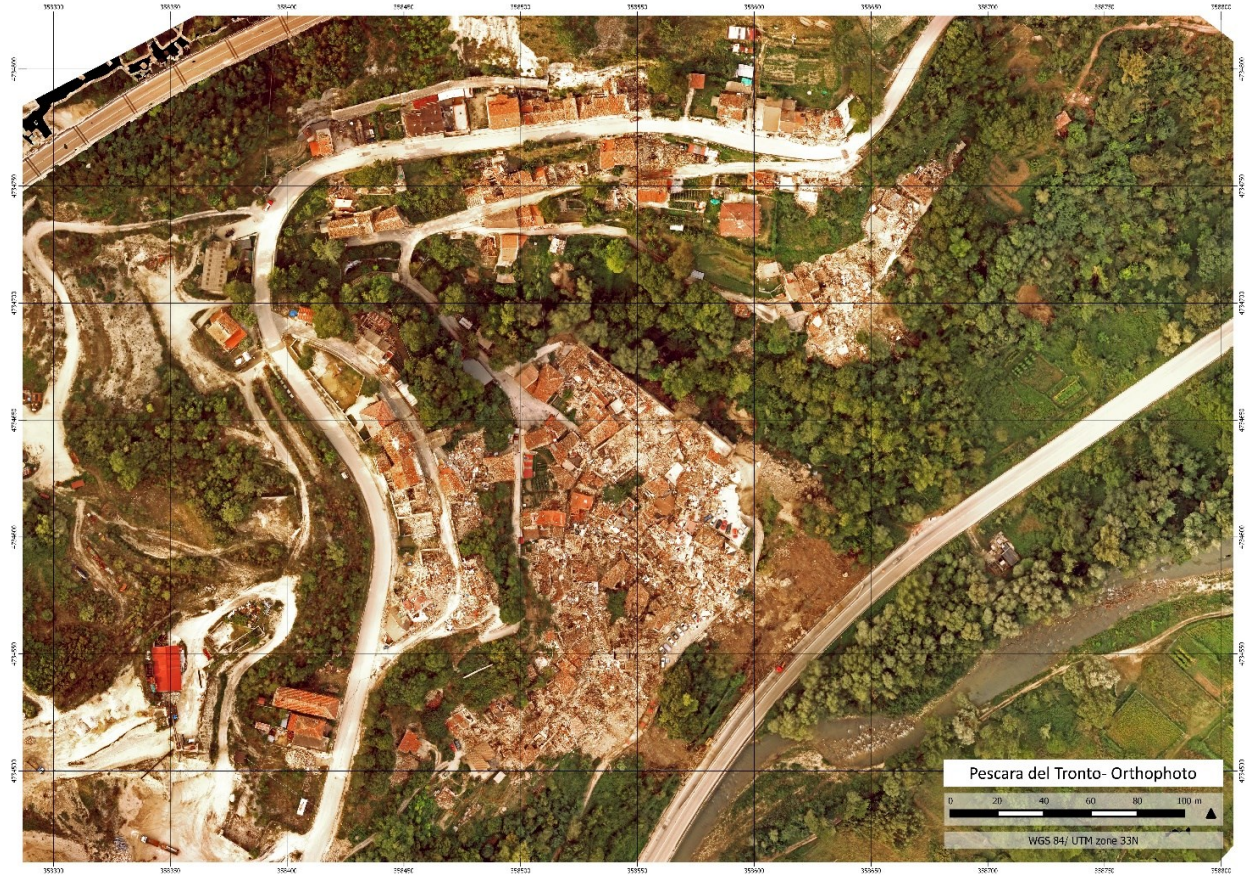
Figure 4.23. Orthophoto of Pescara del Tronto.

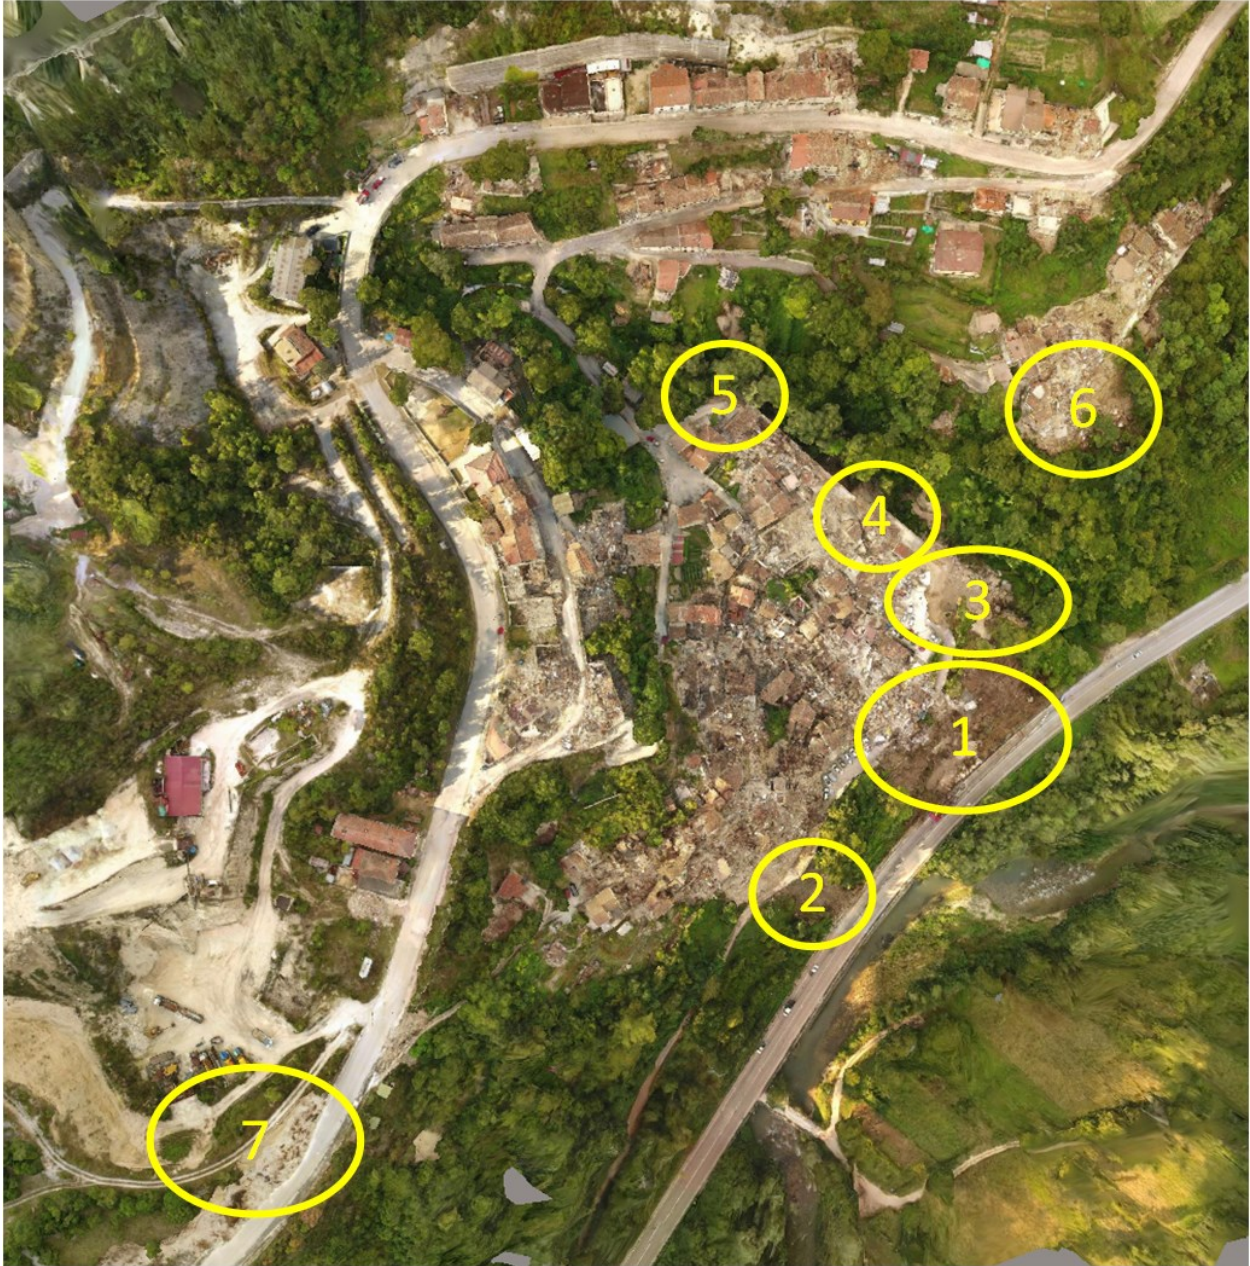
Figure 4.24. Site vicinity map showing the locations of the identified earthquake-induced landslides in Pescara del Tronto

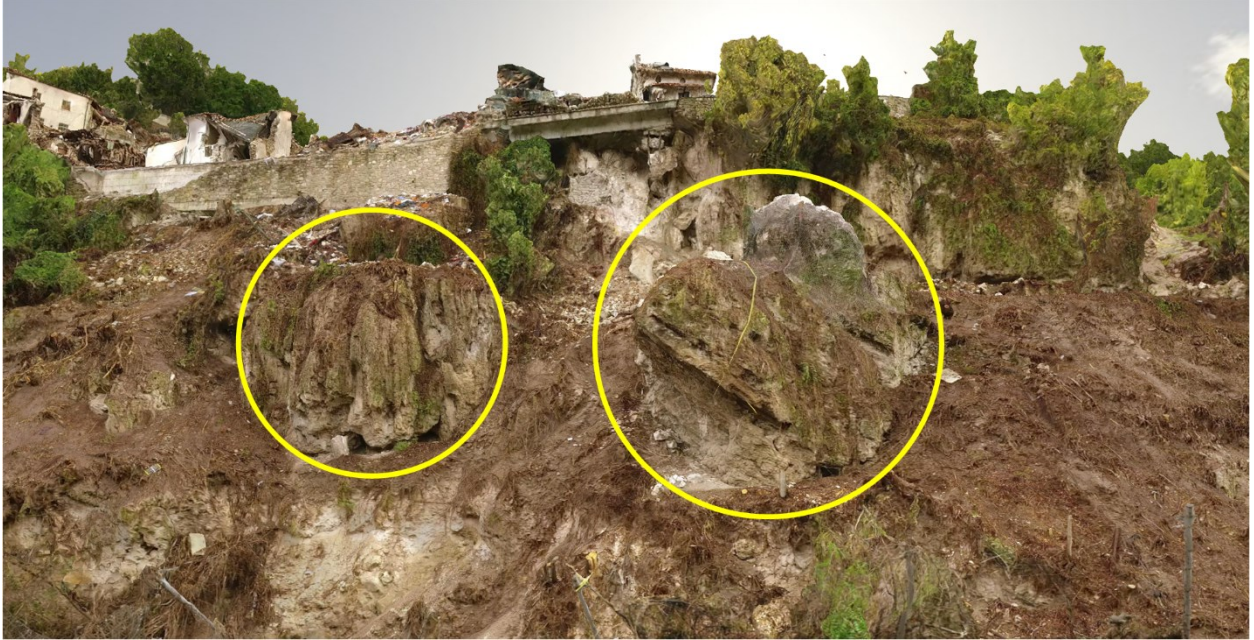
Figure 4.27. 3D model of two large protruding rock outcrops on the landslide below Pescara del Tronto (42.75057 N 13.27223 E).

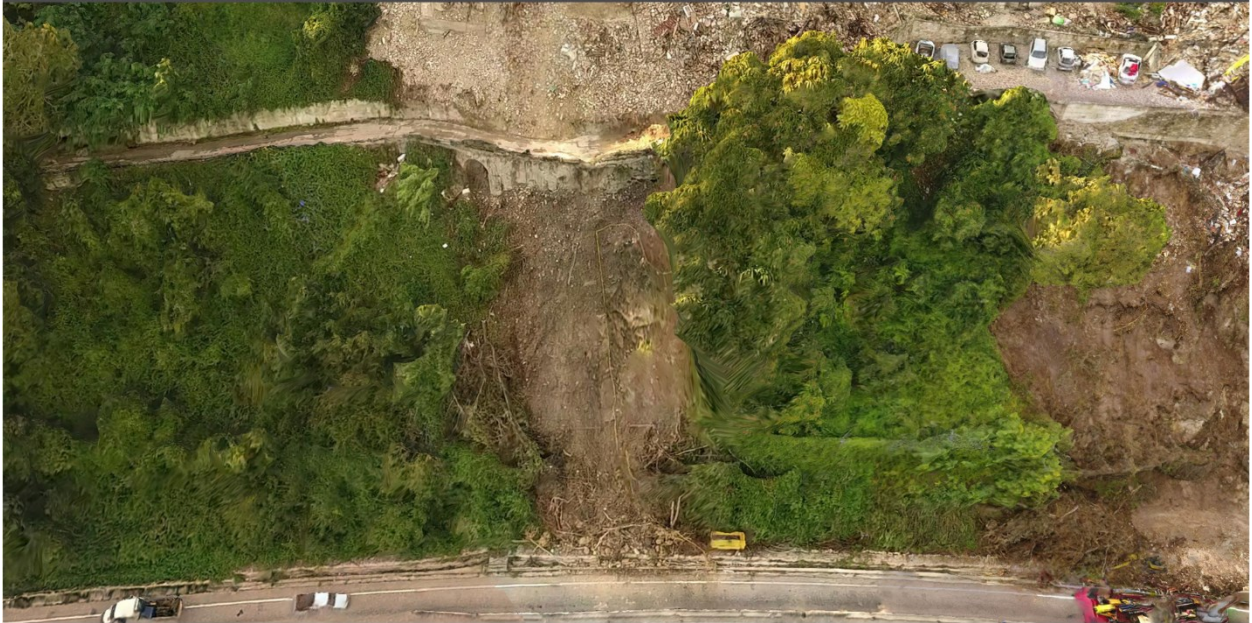
**Figure 4.29.** 3D model of smaller landslide adjacent to Highway SS4 (42.7501 N 13.2719 E).

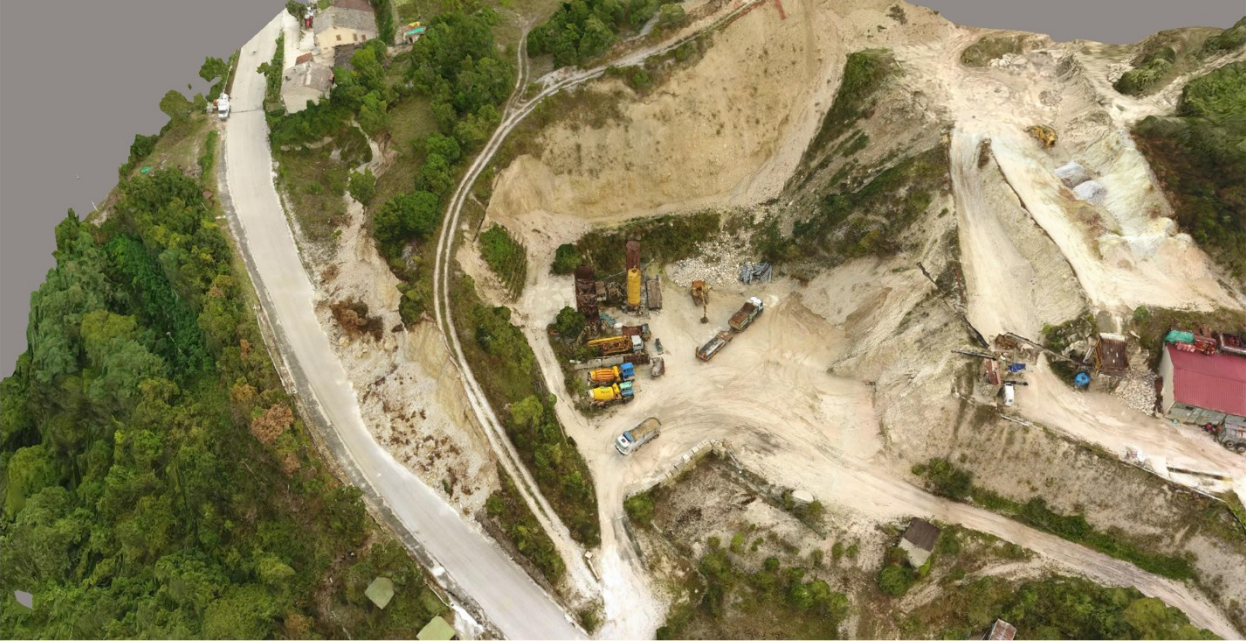
Figure 4.35. Overview model image of the gravel pit in Pescara del Tronto (42.74985 N 13.26893 E).

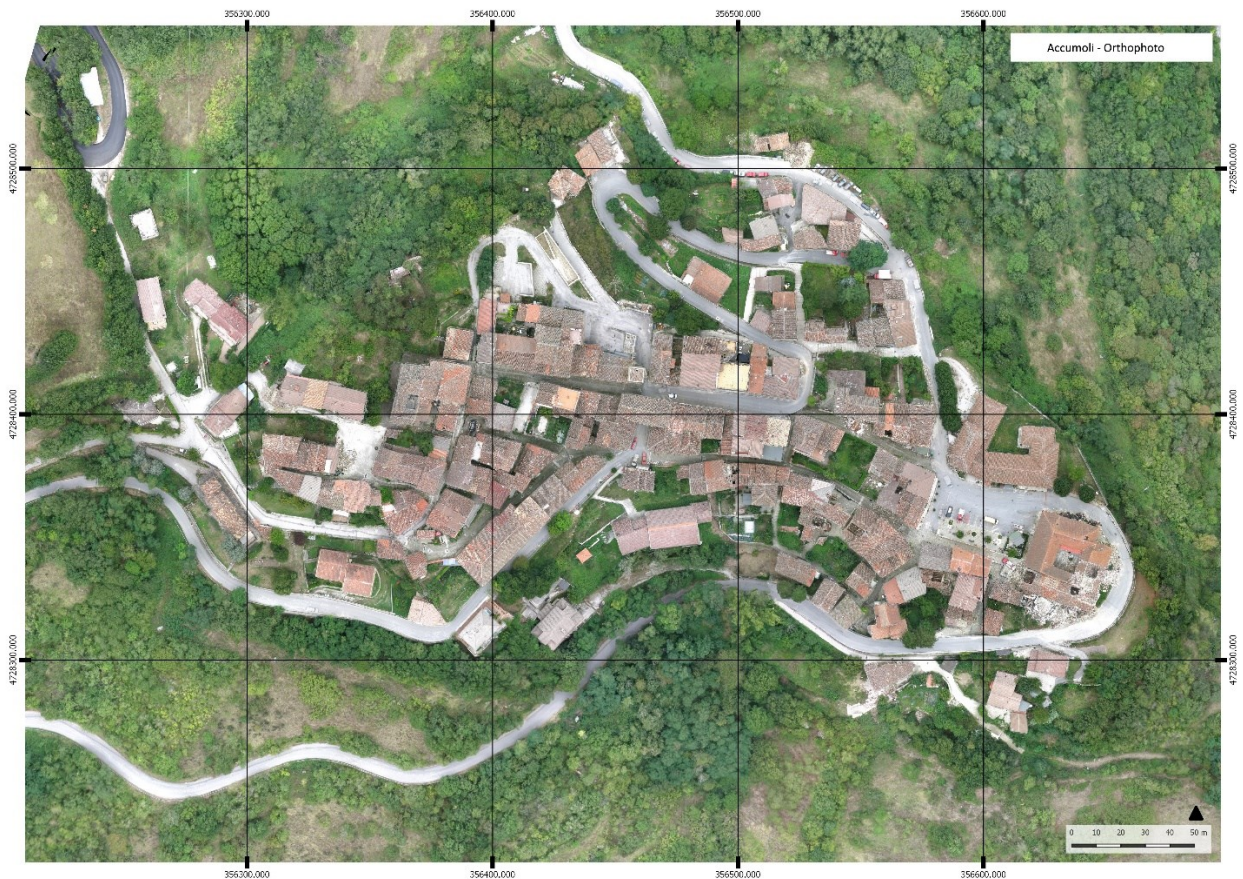
Figure 4.40. Orthophoto of the town of Accumoli (42.96467 N 13.24760 E).

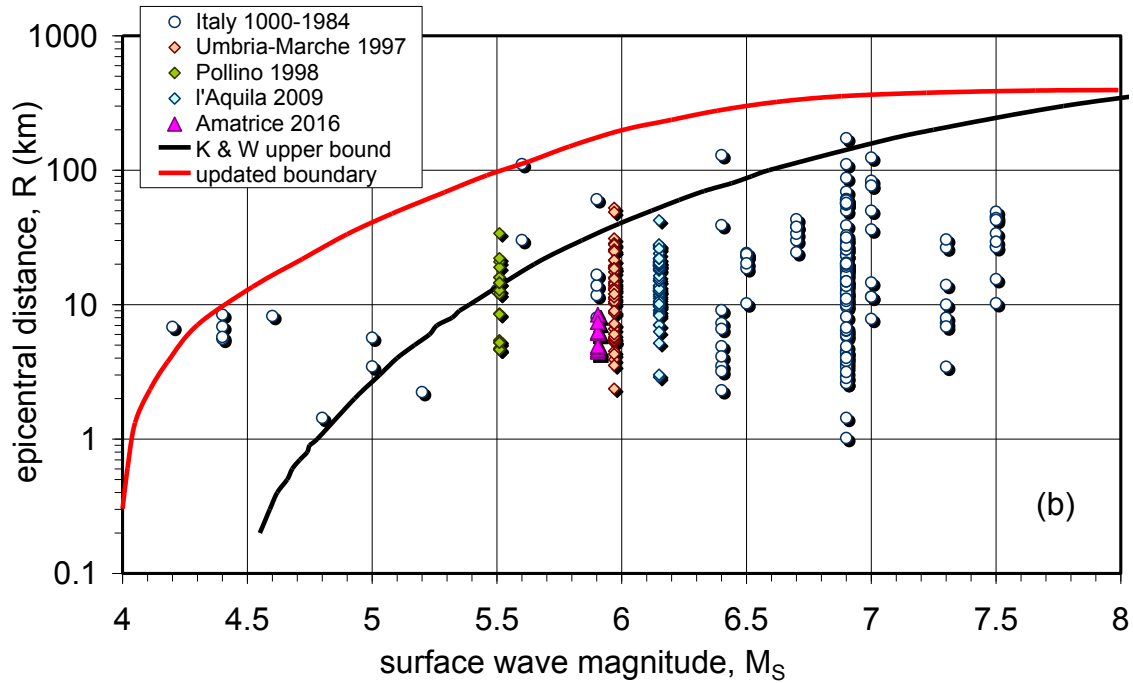
**Figure 4.47.** Data points showing surface wave magnitude and epicentral distance (km) for (a) Category I (rock falls and topples) and (b) Category II (rigid body landslides) inventoried in Italy together with those surveyed by GEER team after the 24 August 2016 earthquake (labelled as 'Amatrice 2016'). The data are compared to upper bound relationships for Category I and II instability mechanisms proposed by Keefer and Wilson (1989) (lower curves) and those updated by Silvestri et al. (2006) (upper curves).

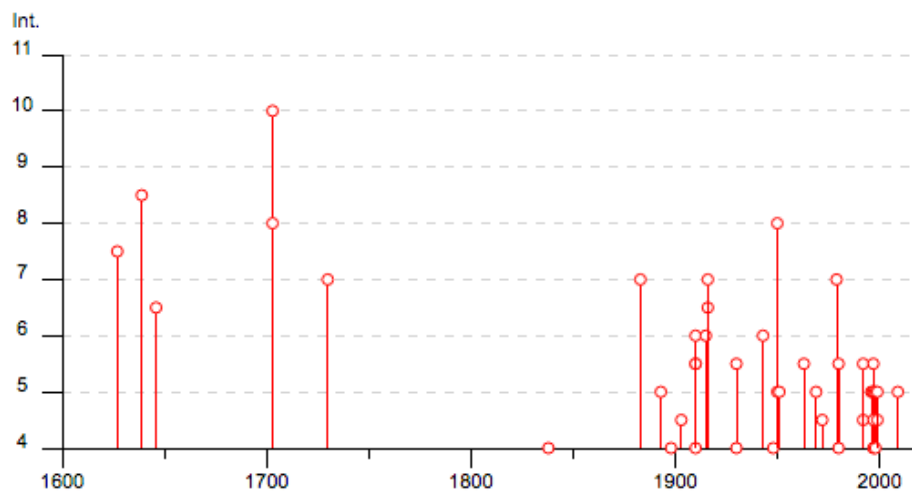
Figure 5.1. Historical seismicity in Accumoli (database CPTI15, Rovida et al., 2016).

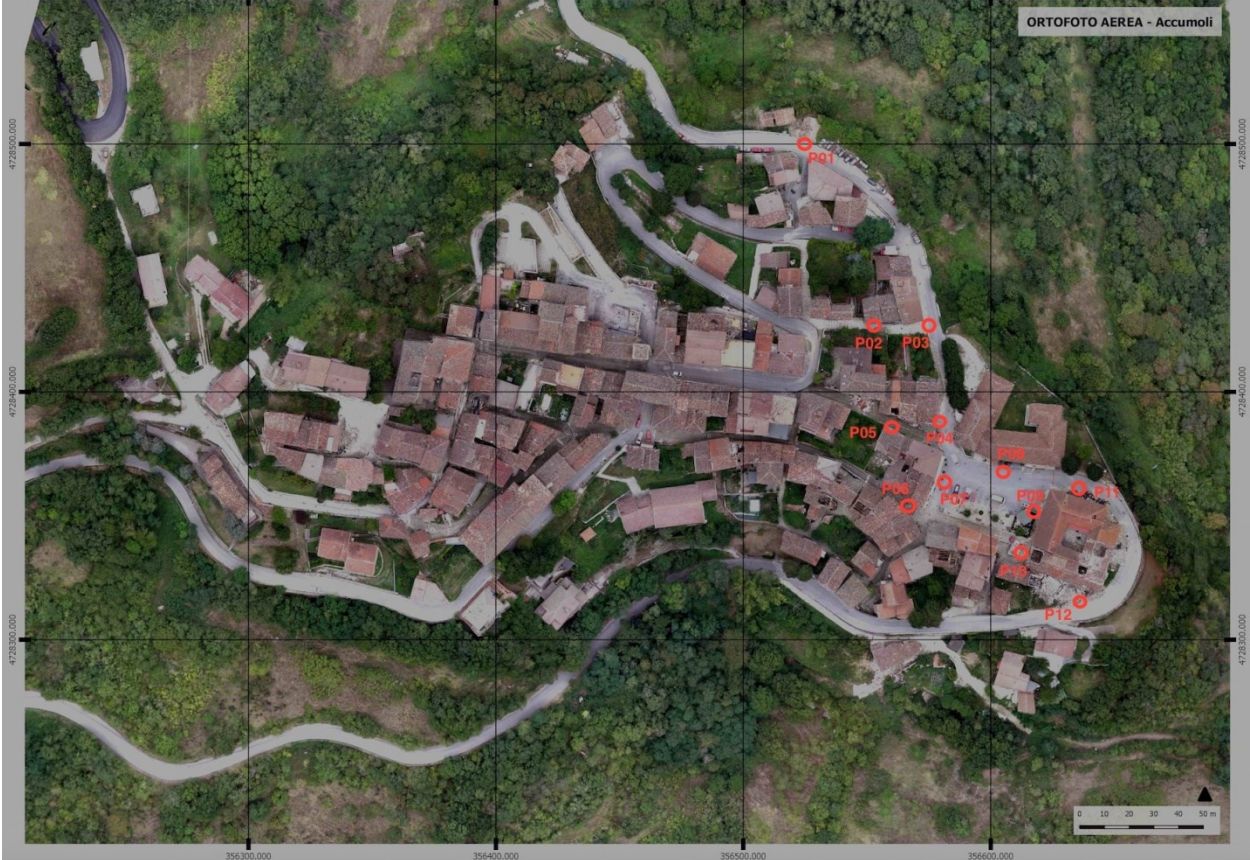
Figure 5.2. Locations of representative structures inspected in the village (see Table 5.2 for details).

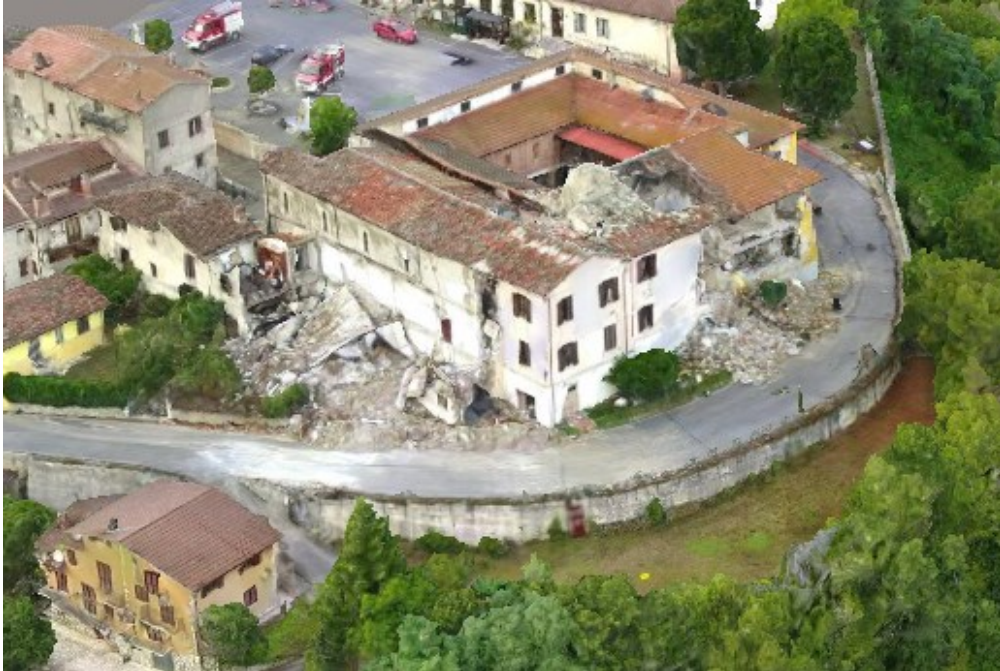
**Figure 5.3.** Excerpt of the 3D model with the most damaged portion of Accumoli (easternmost part of the village).

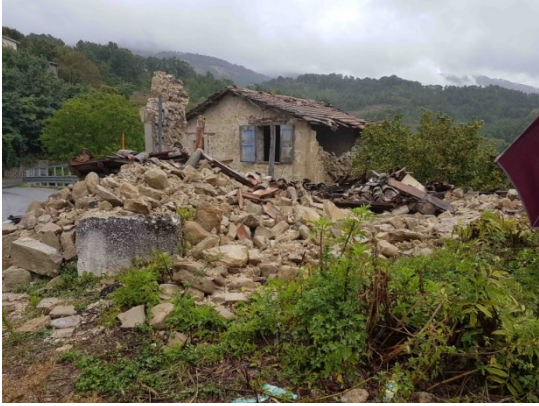
Picture	DATUM	Location		Damage Level
		Lat.	Long.	
P01	WGS-84	42.695561°	13.248314°	D5
P02	WGS-84	42.695010°	13.248600°	D2
P03	WGS-84	42.694972°	13.248886°	D3
P04	WGS-84	42.694611°	13.249071°	D3
P05	WGS-84	42.694635°	13.248798°	D4
P06	WGS-84	42.694215°	13.248842°	D3
P07	WGS-84	42.694304°	13.249263°	D3
P08	WGS-84	42.694428°	13.249379°	D3
P09	WGS-84	42.694325°	13.249507°	D3
P10	WGS-84	42.694073°	13.249509°	D4
P11	WGS-84	42.694346°	13.249726°	D3
P12	WGS-84	42.693962°	13.249787°	D5

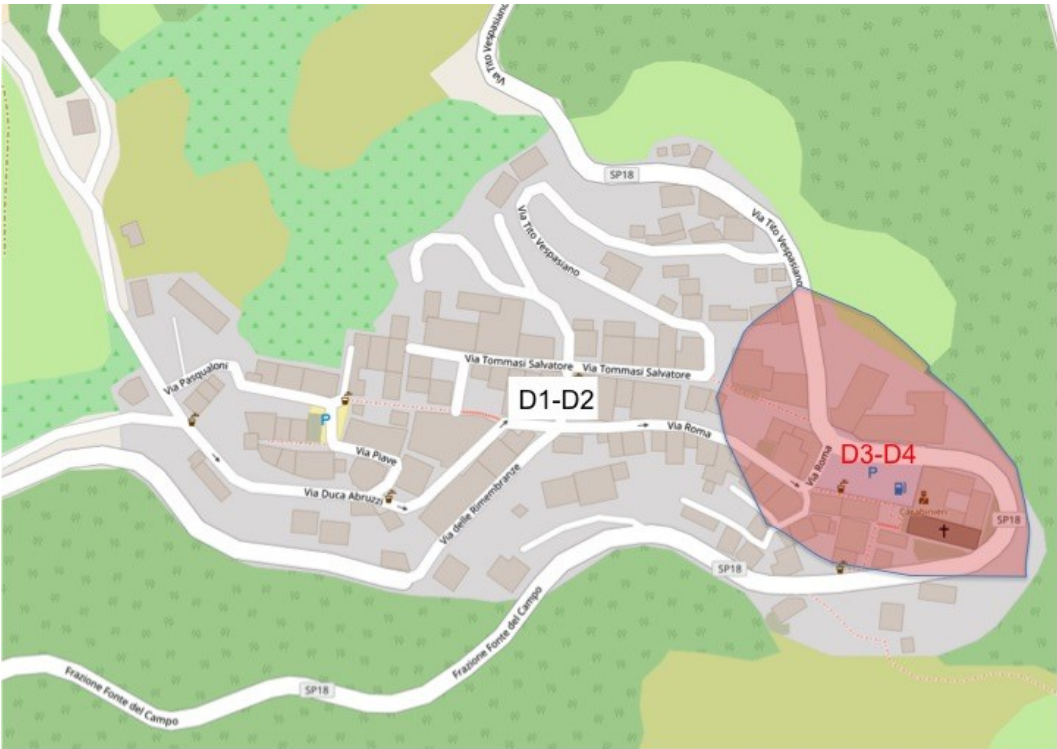
Figure 5.5. Damage zonation within the village of Accumoli.

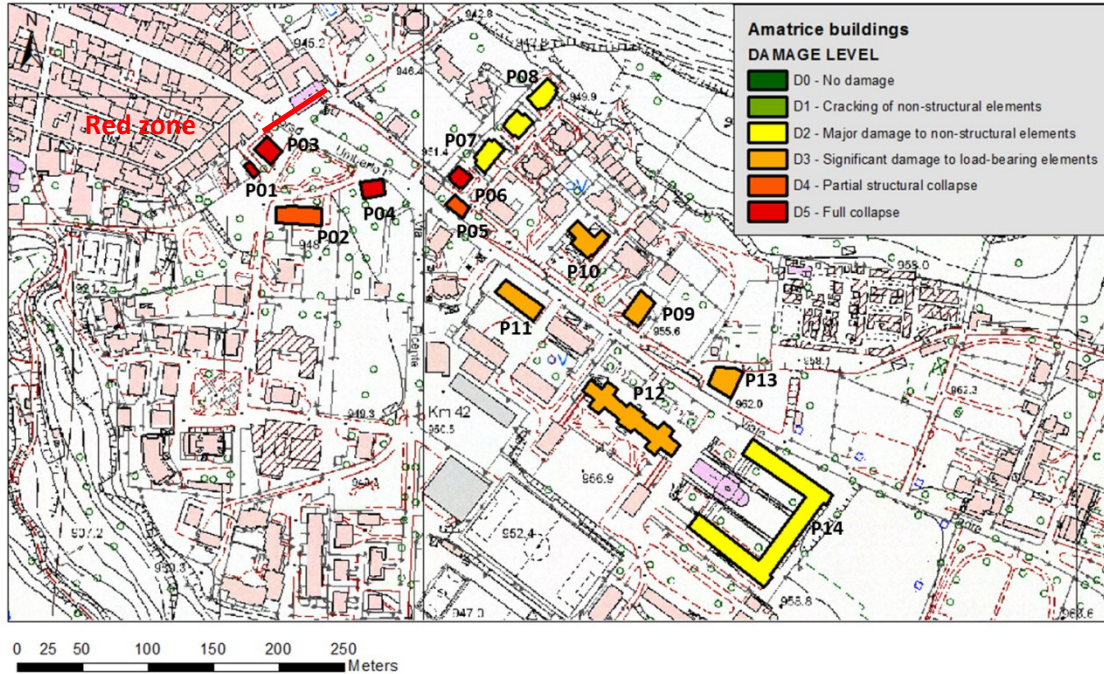
Figure 5.8. Locations of representative structures inspected in the village (see Table 5.4 for details).

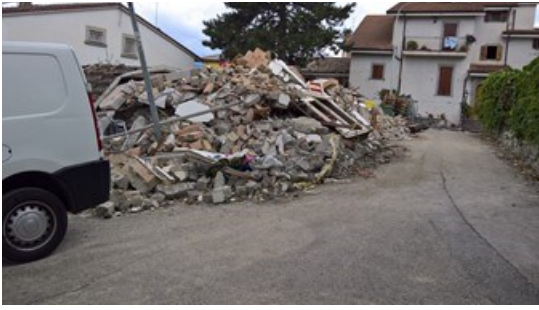
Picture	DATUM	longitude	latitude	Damage level	Note
P01	WGS- 84	13.29141	42.62804	D5	
P02	WGS- 84	13.29155	42.62845	D4	
P03	WGS- 84	13.29167	42.62806	D5	
P04	WGS- 84	13.2925	42.62806	D5	
P05	WGS- 84	13.29306	42.62778	D4	
P06	WGS- 84	13.29309	42.62791	D5	
P07	WGS- 84	13.2932	42.62821	D2	
P08	WGS- 84	13.29444	42.62694	D2	
P09	WGS- 84	13.29444	42.62722	D3	
P10	WGS- 84	13.29339	42.62788	D3	
P11	WGS- 84	13.29361	42.62722	D3	Police station
P12	WGS- 84	13.29639	42.62694	D3	
P13	WGS- 84	13.29578	42.62686	D3	
P14	WGS- 84	13.29553	42.62656	D2	
P15	WGS- 84	13.290809	42.62722	D3	Police station
P16	WGS- 84	13.290809	42.62722	D3	Police station
P17	WGS- 84	13.2913634	42.62684	D4	
P18	WGS- 84	13.2913634	42.62684	D3	
P19	WGS- 84	13.2901480	42.62609	D3	
P20	WGS- 84	13.2901480	42.62609	D3

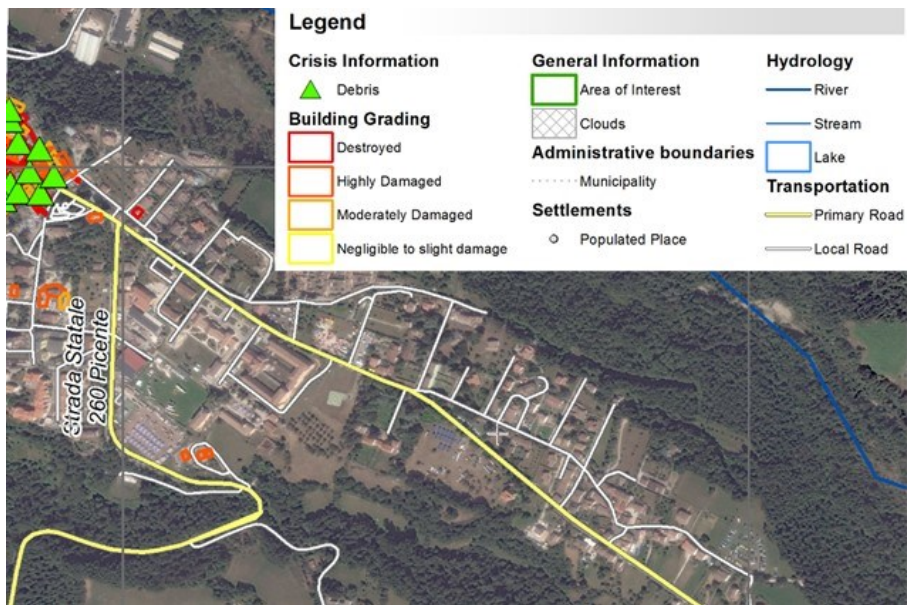
**Figure 5.10.** Damage pattern from Copernicus post event images for Amatrice suburb.

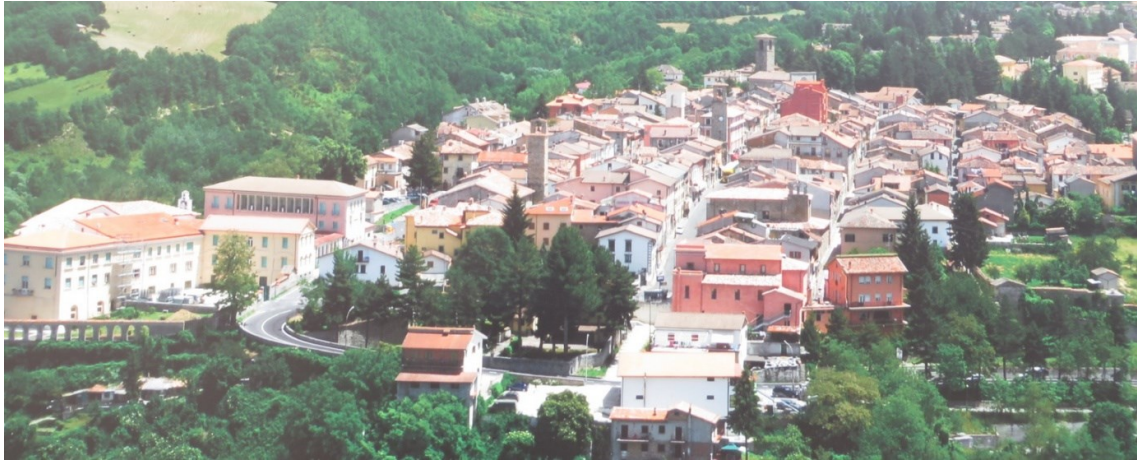
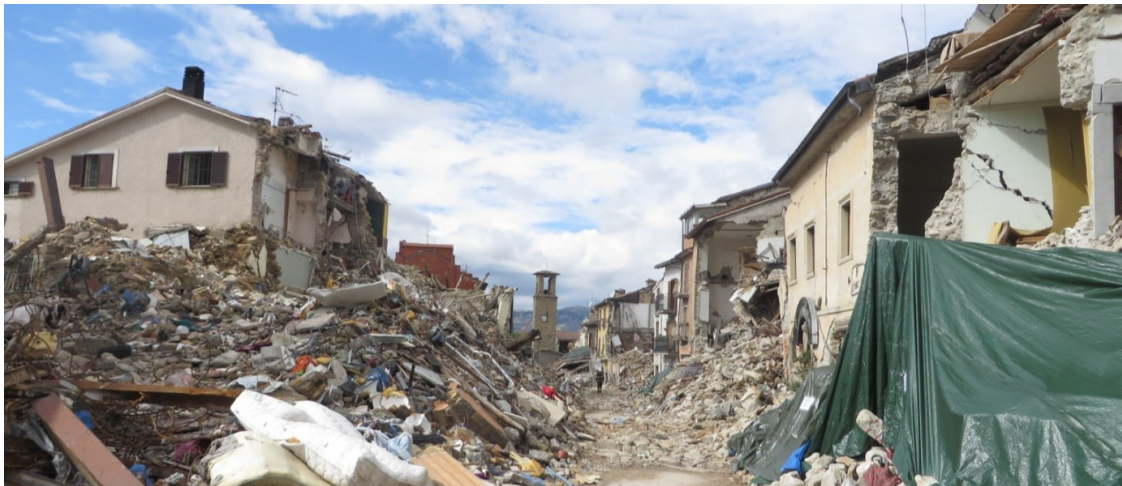
Figure 5.11. Overview of Amatrice Red Zone before and after the 24 August event.

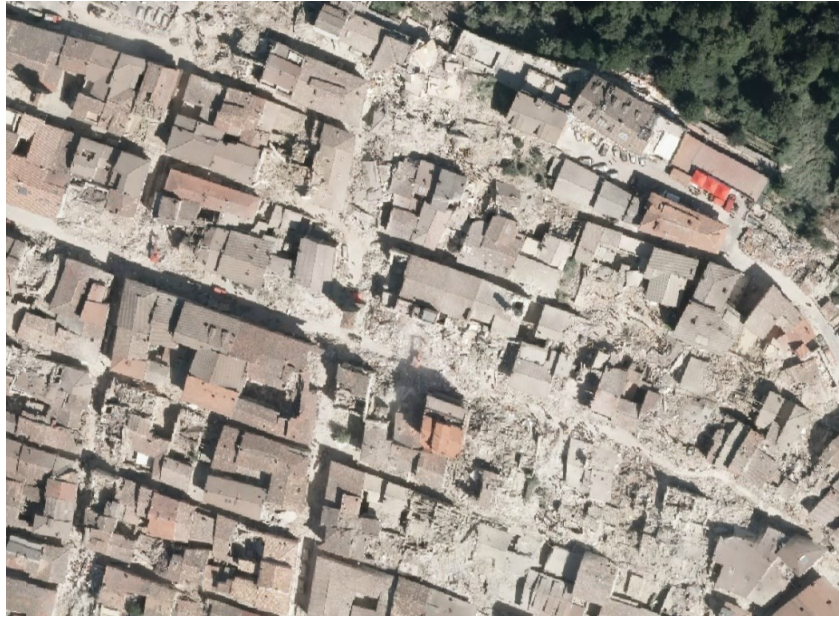
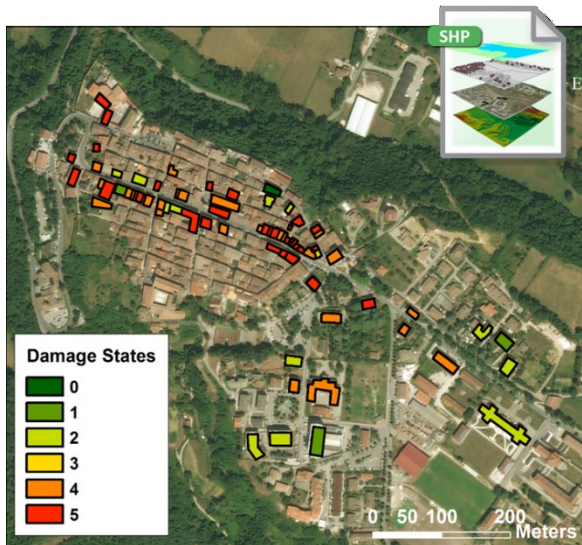
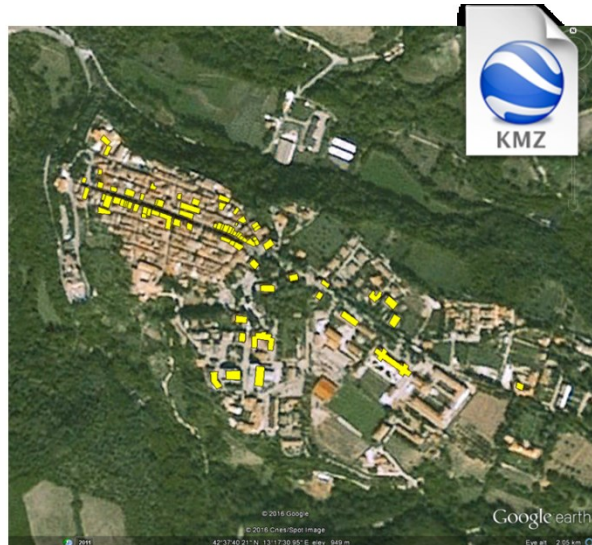
Figure 5.12. Overview of structural damage within the Amatrice Red Zone as seen by aerial image and after visual inspection (note that access to some streets within the Red Zone was not permitted and that additional inspection data are still under post-processing).

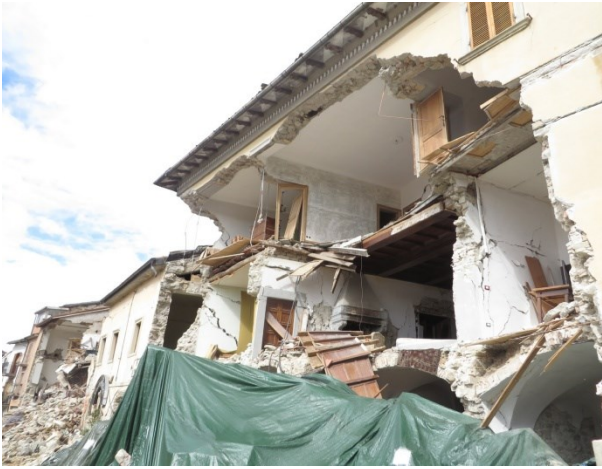
Picture	DATUM	longitude	latitude	Damage level	Note
P21	WGS- 84	13.291061	42.62863	D4	
P22	WGS- 84	13.29059	42.62862	D5	
P23	WGS- 84	13.29043	42.62889	D5	
P24	WGS- 84	13.29016	42.62894	D5	
P25	WGS- 84	13.28724	42.62971	D5	
P26	WGS- 84	13.28732	42.63057	D5	
P27	WGS- 84	13.28937	42.62907	D5	
P28	WGS- 84	13.29051	42.62929	D5	
P29	WGS- 84	13.28952	42.62892	D5	
P30	WGS- 84	13.28952	42.62892	D5	
P31	WGS- 84	13.28840	42.62923	D2	
P32	WGS- 84	13.28801	42.62955	D2	
P33	WGS- 84	13.29037	42.62945	D2	
P34	WGS- 84	13.29037	42.62945	D2	
P35	WGS- 84	13.28799	42.62977	D5	
P36	WGS- 84	13.28799	42.62977	D4

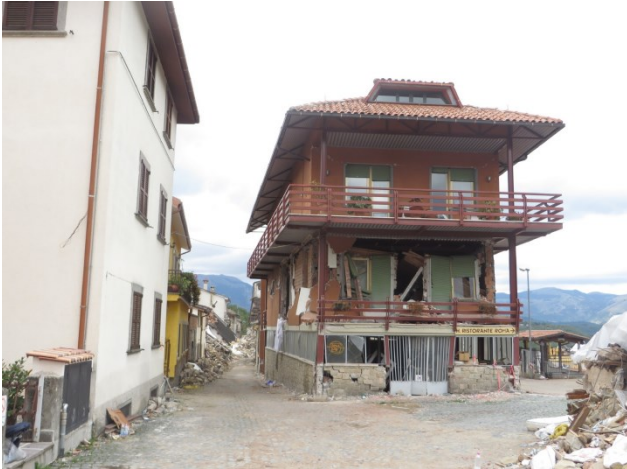
**Figure 5.14.** Photos of building collapse (P27, P28) but also mahor (P29 and P30) and minor (P31 and P32) damage along the main market street of Amatrice.

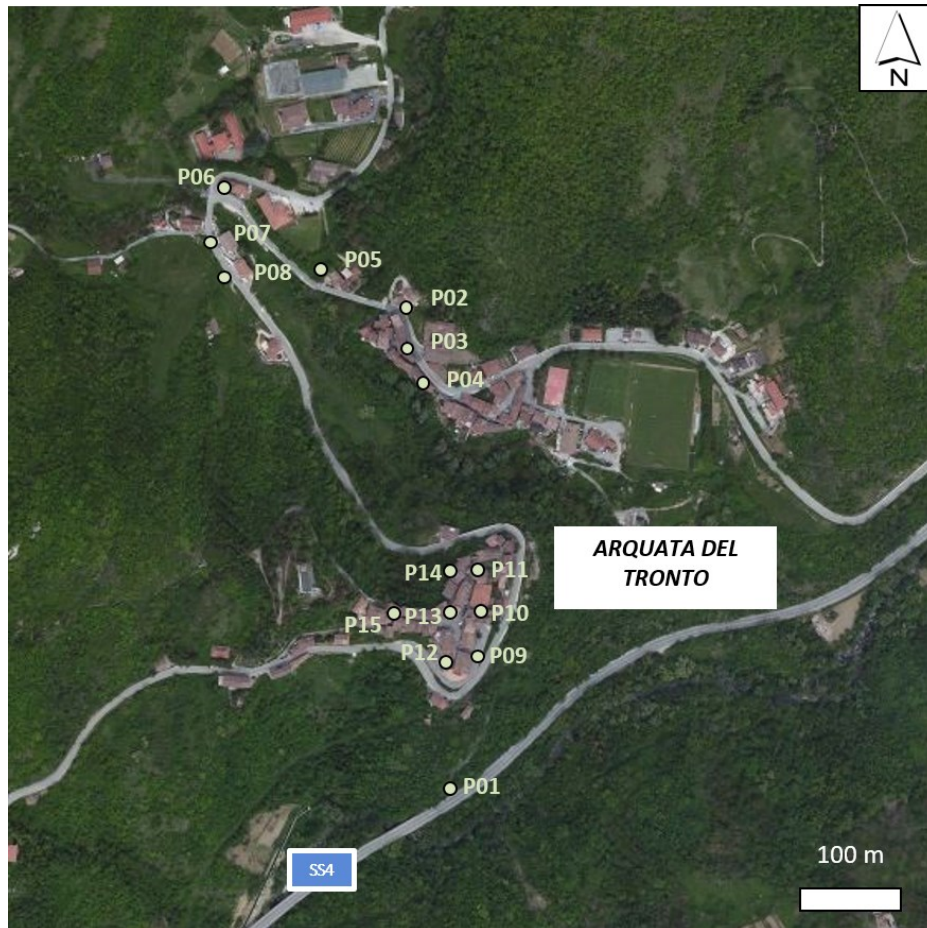
Figure 5.17. Locations of representative structures inspected in the village (see Table 5.6 for details).

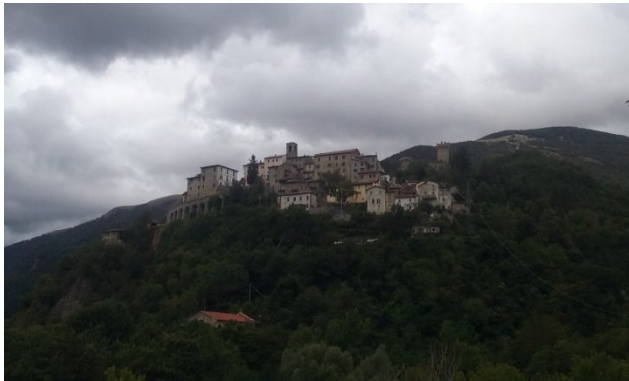
<a href="#">P15.jpg</a>	WGS-84	42.772398°	13.295842°	D2-D3

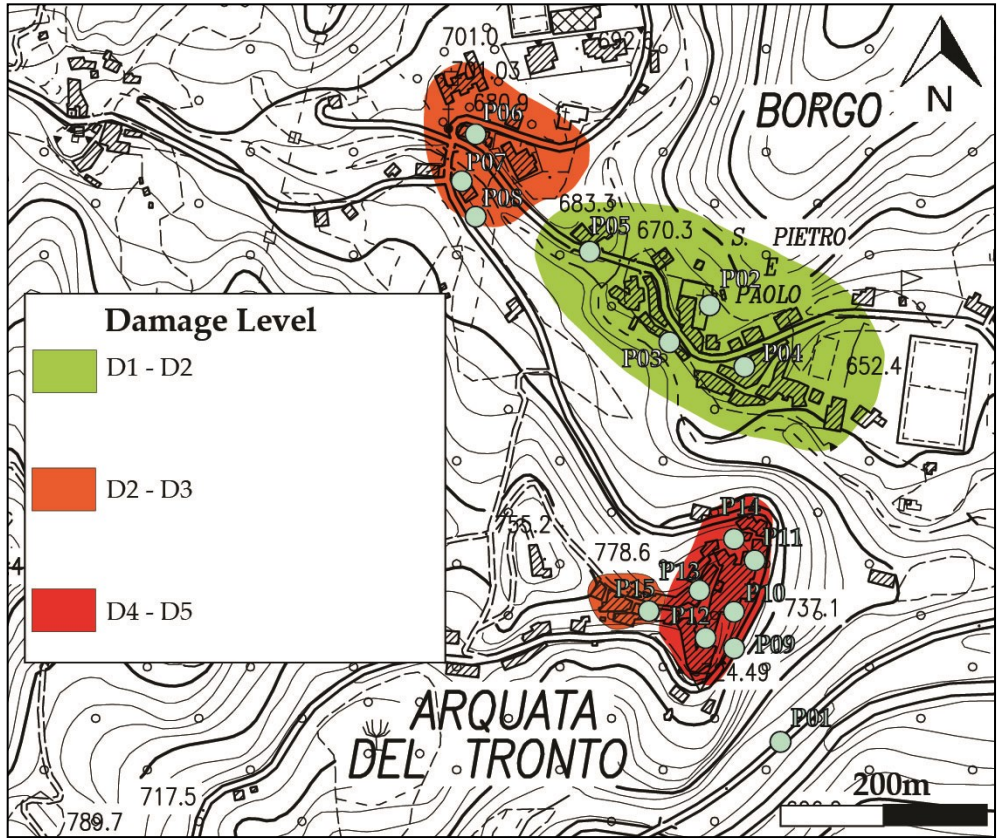
Figure 5.19. Damage zonation within the villages of Arquata and Borgo.

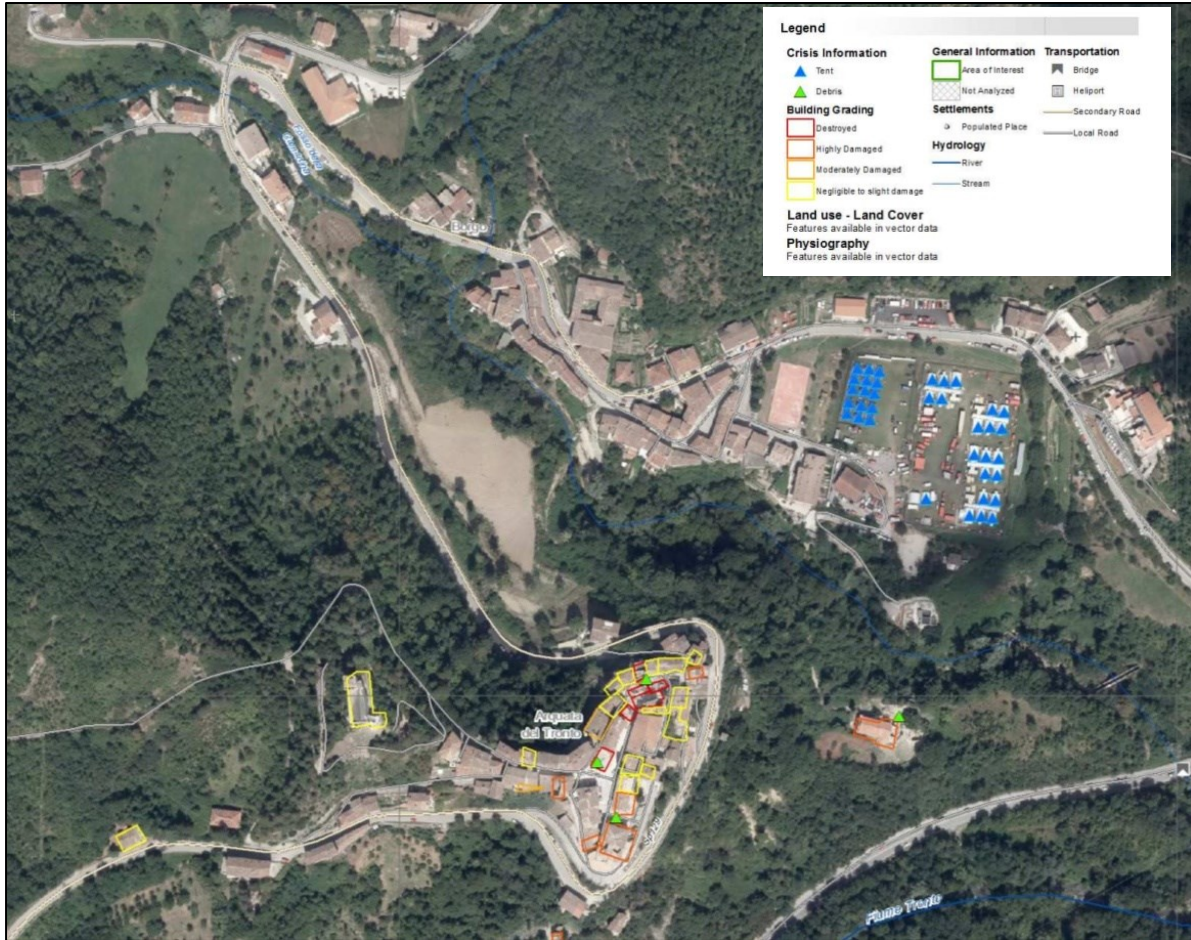
**Figure 5.20.** Damage pattern from Copernicus post event images  
[http://emergency.copernicus.eu/mapping/list-of-components/EMSR177/ALL/EMSR177\\_19ARQUATADELTRONTOAERIAL](http://emergency.copernicus.eu/mapping/list-of-components/EMSR177/ALL/EMSR177_19ARQUATADELTRONTOAERIAL)

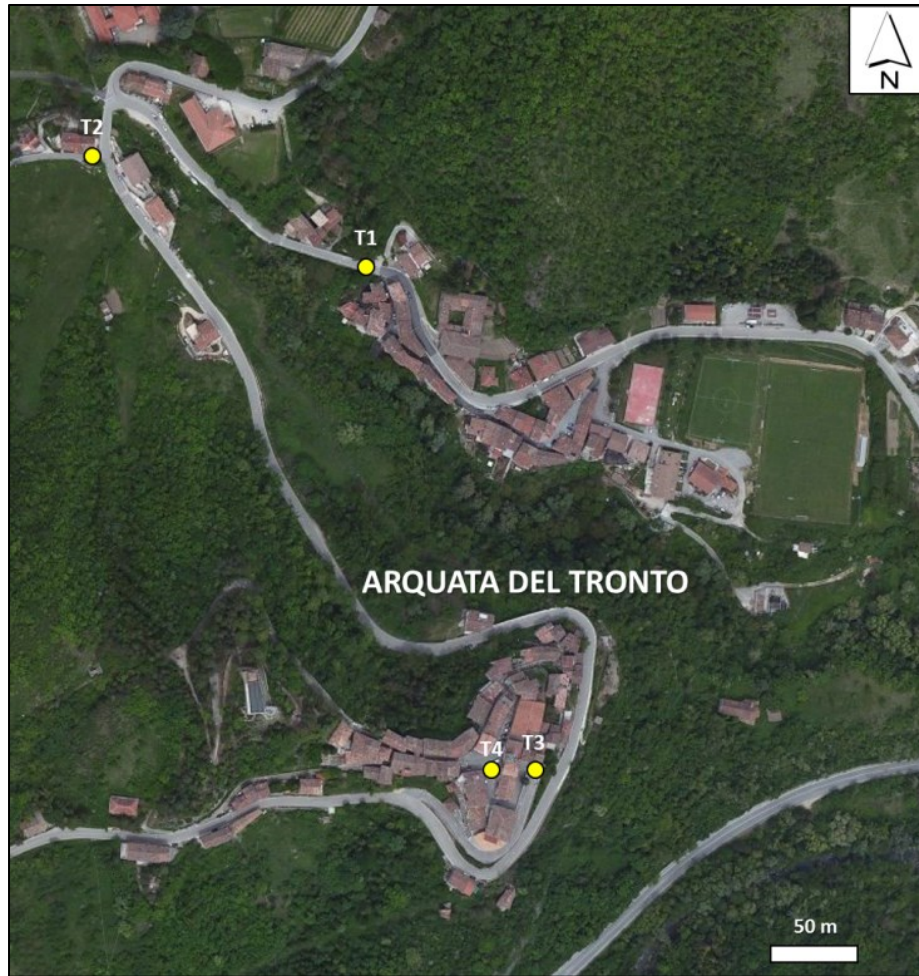
**Figure 5.21.** Locations of representative noise measurements carried out in the village.

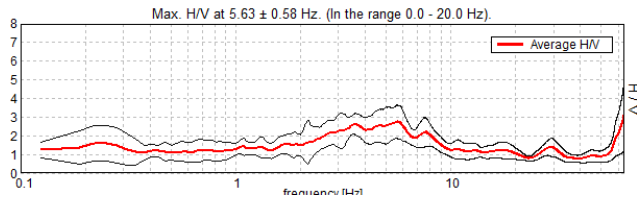
In Arquata, two noise measurements were carried out (T3 and T4) both of which indicate H/V peaks around 3 Hz, with horizontal motion polarized in the NS direction, i.e., roughly perpendicular to the axis of the major ridge. Close to the edge, a second peak at about 10 Hz was observed, again with NS polarization. These results are preliminary and the HVSR technique for complex topographies is far from ideal for the applicability of the method. Similar results for other regions have been obtained previously (Pagliaroli et al. 2015).

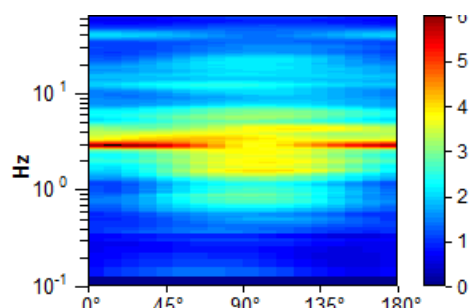
Figure 5.22. Noise measurements results in terms of H/V spectral ratio (on the left column) and H/V polar plots (on the right).

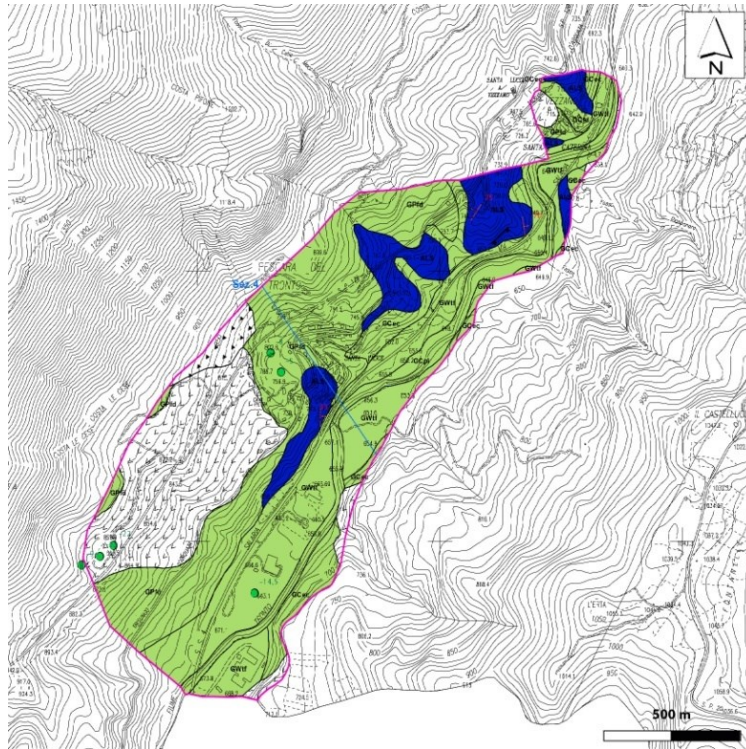
SEZIONE 4 Loc. Pescara del Tronto

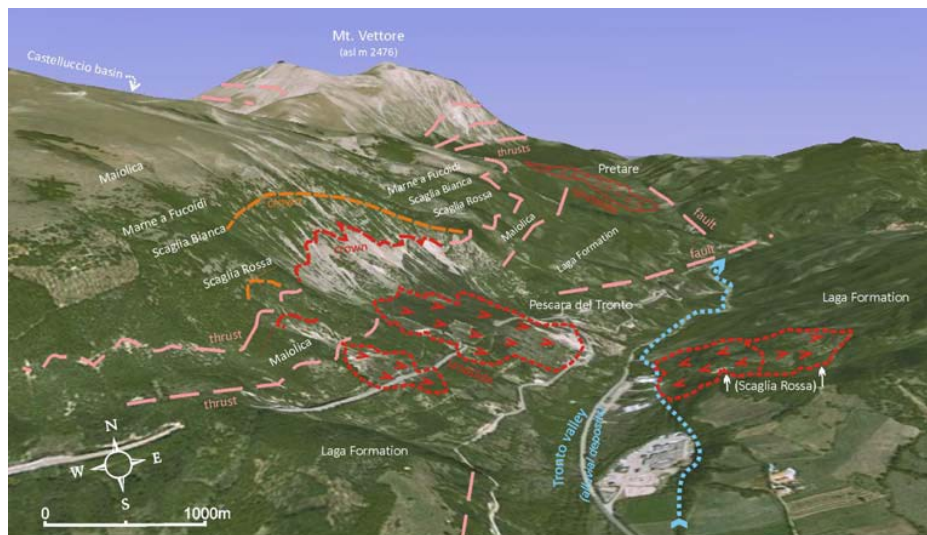
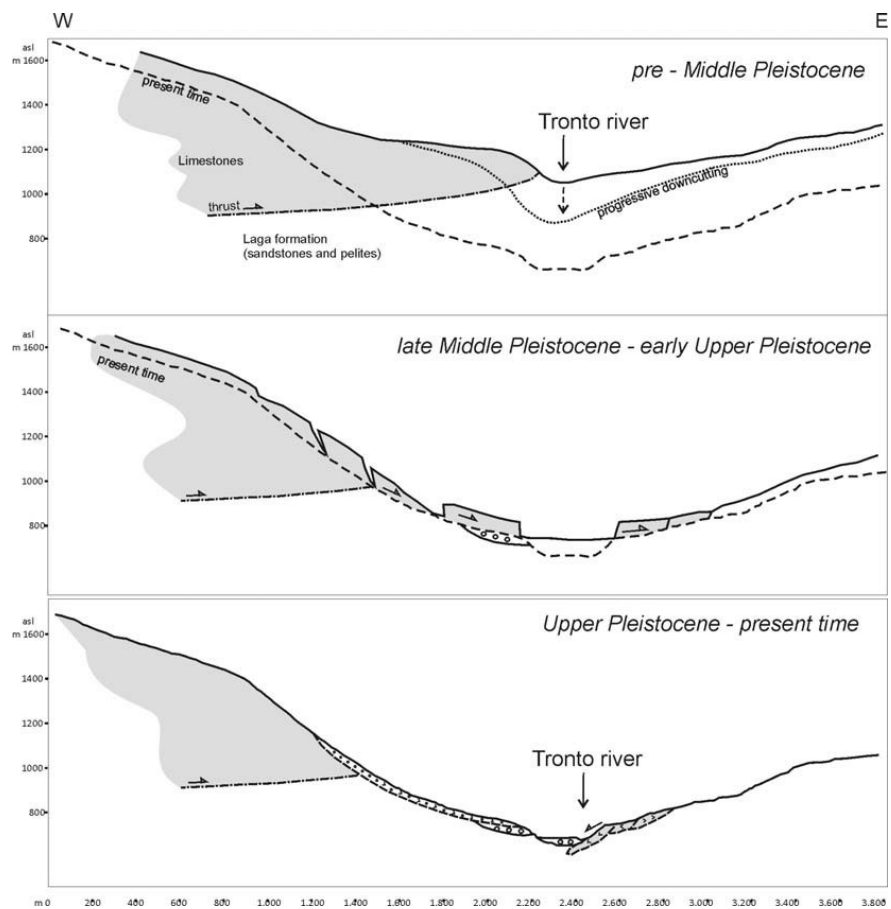
Figure 5.24. Pescara del Tronto: in the upper part geomorphological setting; in the bottom interpretative sketch of the mass movement (Aringoli et al., 2010).

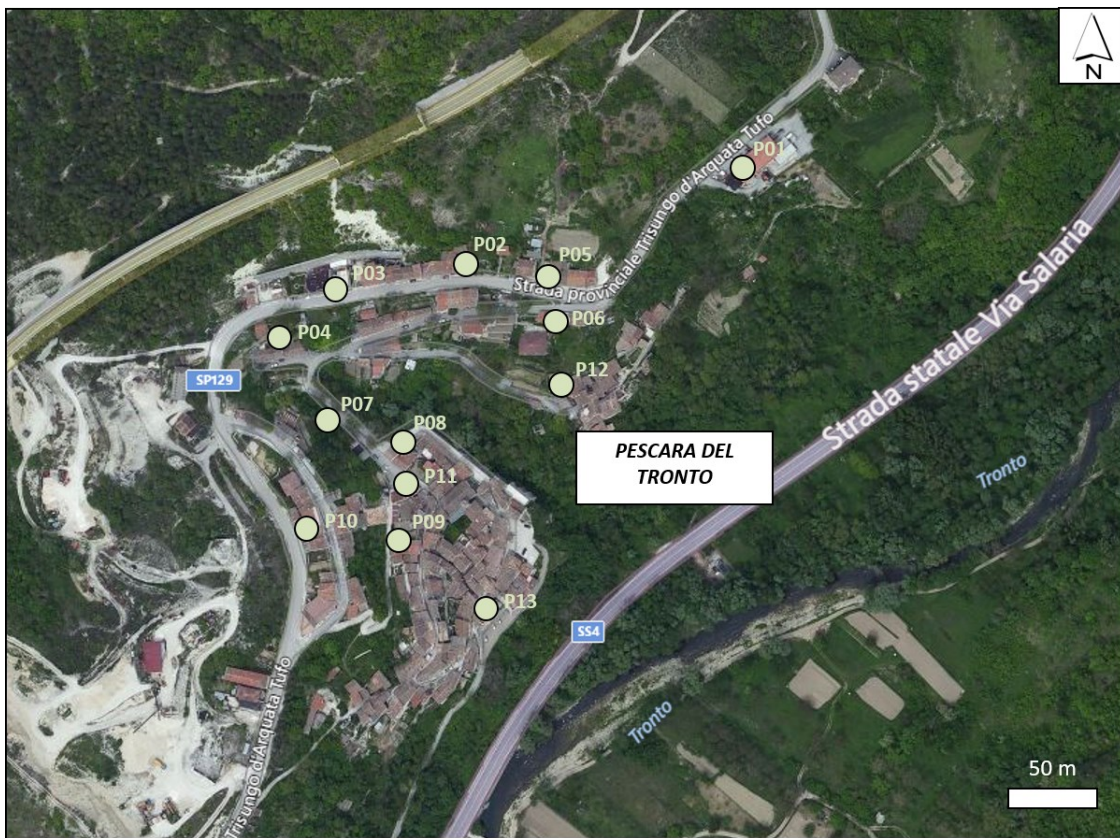
Figure 5.25. Locations of representative structures inspected in the village (see Table 5.7 for details)
