Engineering Reconnaissance of the 24 August 2016 Central Italy Earthquake. Version 2

*Original*

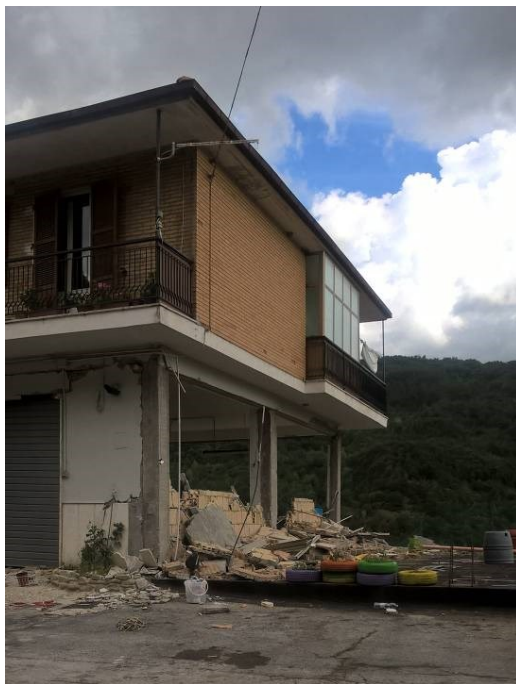
Picture	DATUM	Location		Damage Level	Notes
		Lat.	Long.		
P01	WGS-84	42.753147°	13.273536°	D3	
P02	WGS-84	42.752496°	13.271350°	D3	
P03	WGS-84	42.752434°	13.270156°	D2	
P04	WGS-84	42.752046°	13.270447°	D2-D3	<i>Partial collapse of the roof</i>
P05	WGS-84	42.752469°	13.272192°	D4	
P06	WGS-84	42.752295°	13.272490°	D5	
P07	WGS-84	42.751717°	13.270616°	-	<i>collapse of retaining wall (size: 0.25x1x5 m)</i>
P08	WGS-84	42.751558°	13.271005°	D5	
P09	WGS-84	42.750950°	13.270979°	D4-D5	
P10	WGS-84	42.751137°	13.270225°	D4-D5	
P11	WGS-84	42.751332°	13.271040°	D3	
P12	WGS-84	42.751986°	13.271575°	D4-D5	
P13	WGS-84	42.750423°	13.271891°	D4-D5

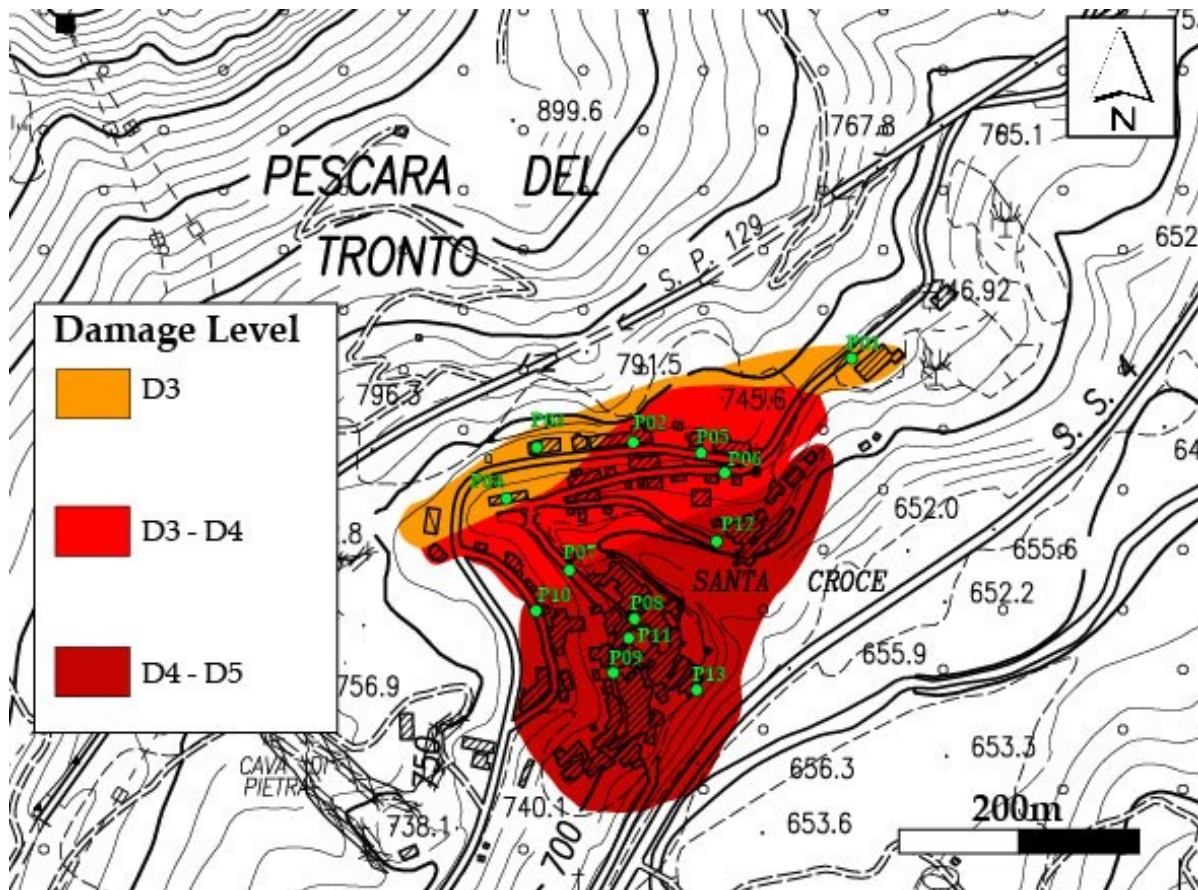
Figure 5.27. Tentative damage zonation within the village of Pescara del Tronto.

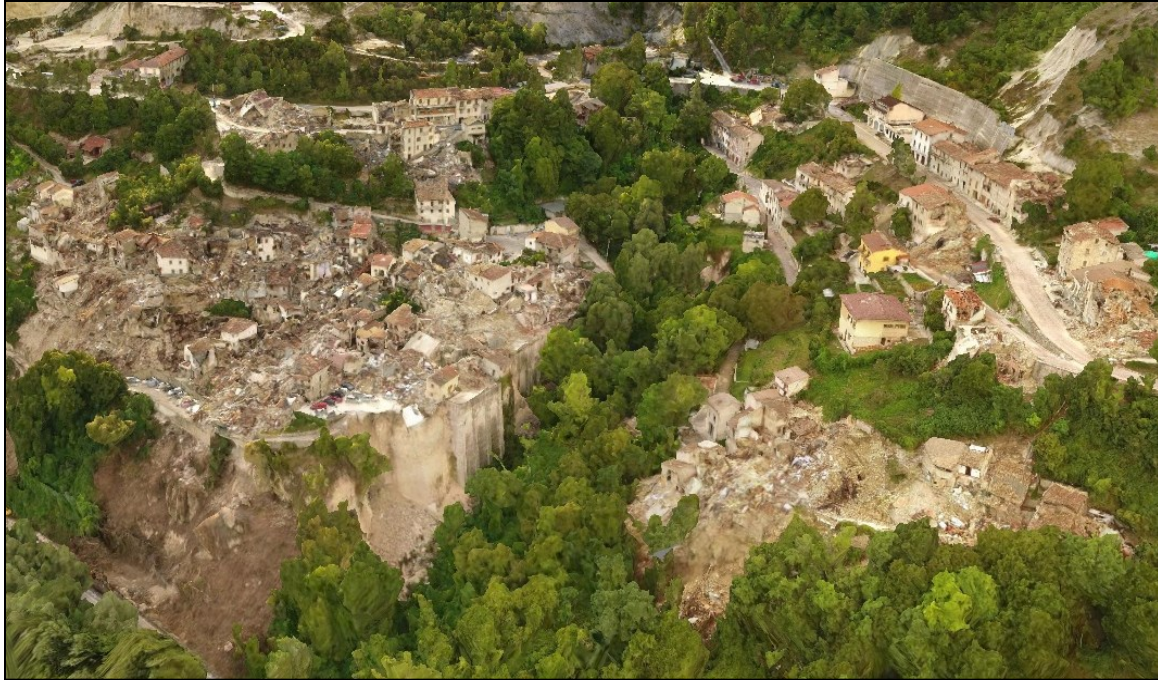
Figure 5.28. 3D model from drone flights on the village of Pescara del Tronto.

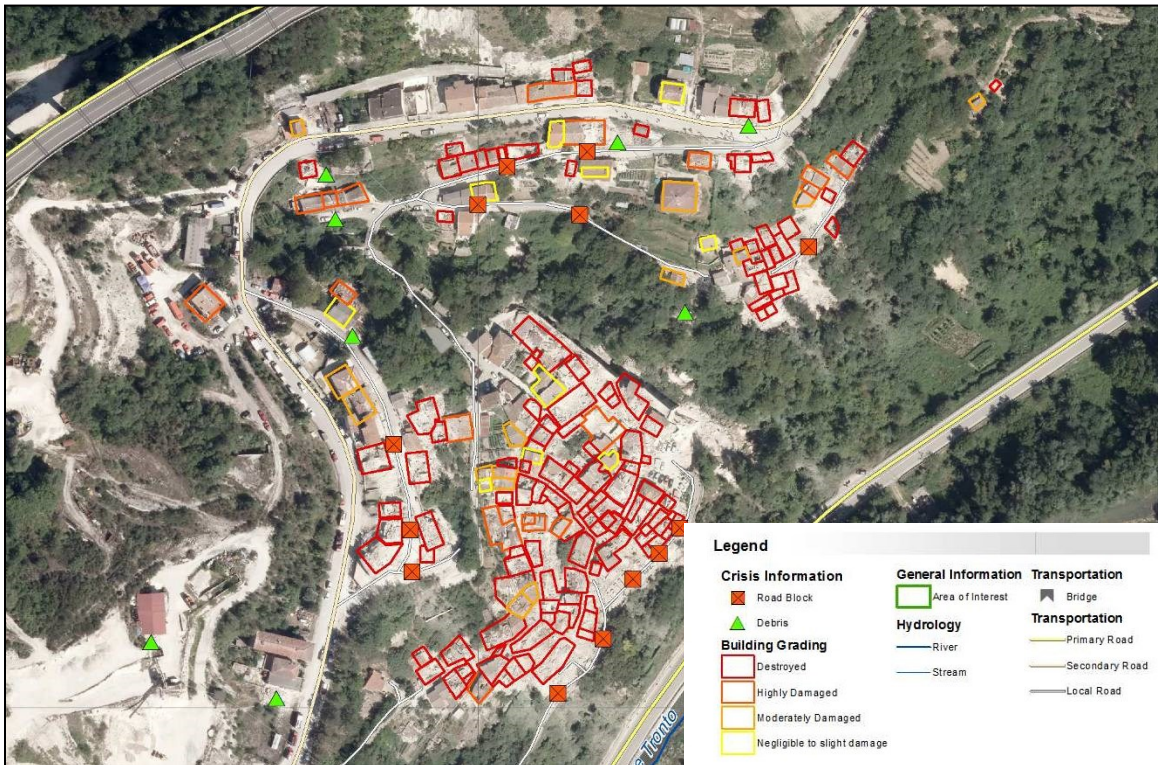
Figure 5.29. Damage pattern from Copernicus post event images ([http://emergency.copernicus.eu/mapping/list-of-components/EMSR177/ALL/EMSR177\\_17PESCARADELTRONTOAERIAL](http://emergency.copernicus.eu/mapping/list-of-components/EMSR177/ALL/EMSR177_17PESCARADELTRONTOAERIAL)).

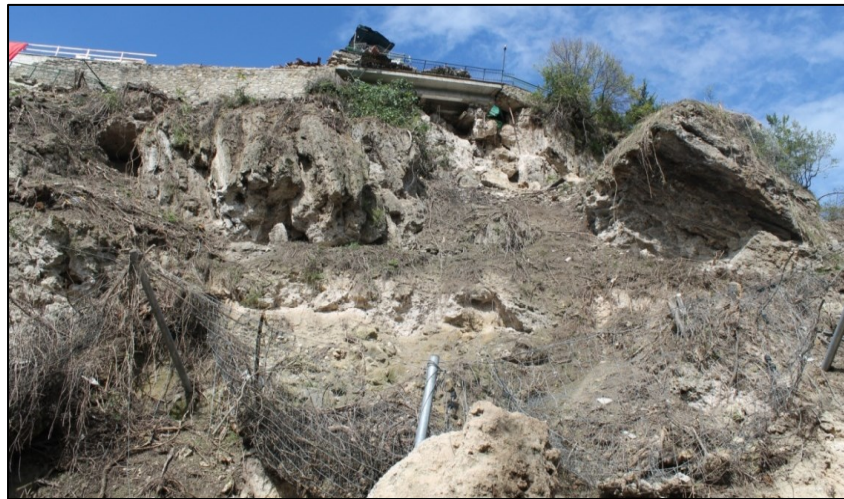
Figure 5.30. Landslide affecting the southern portion of Pescara del Tronto.

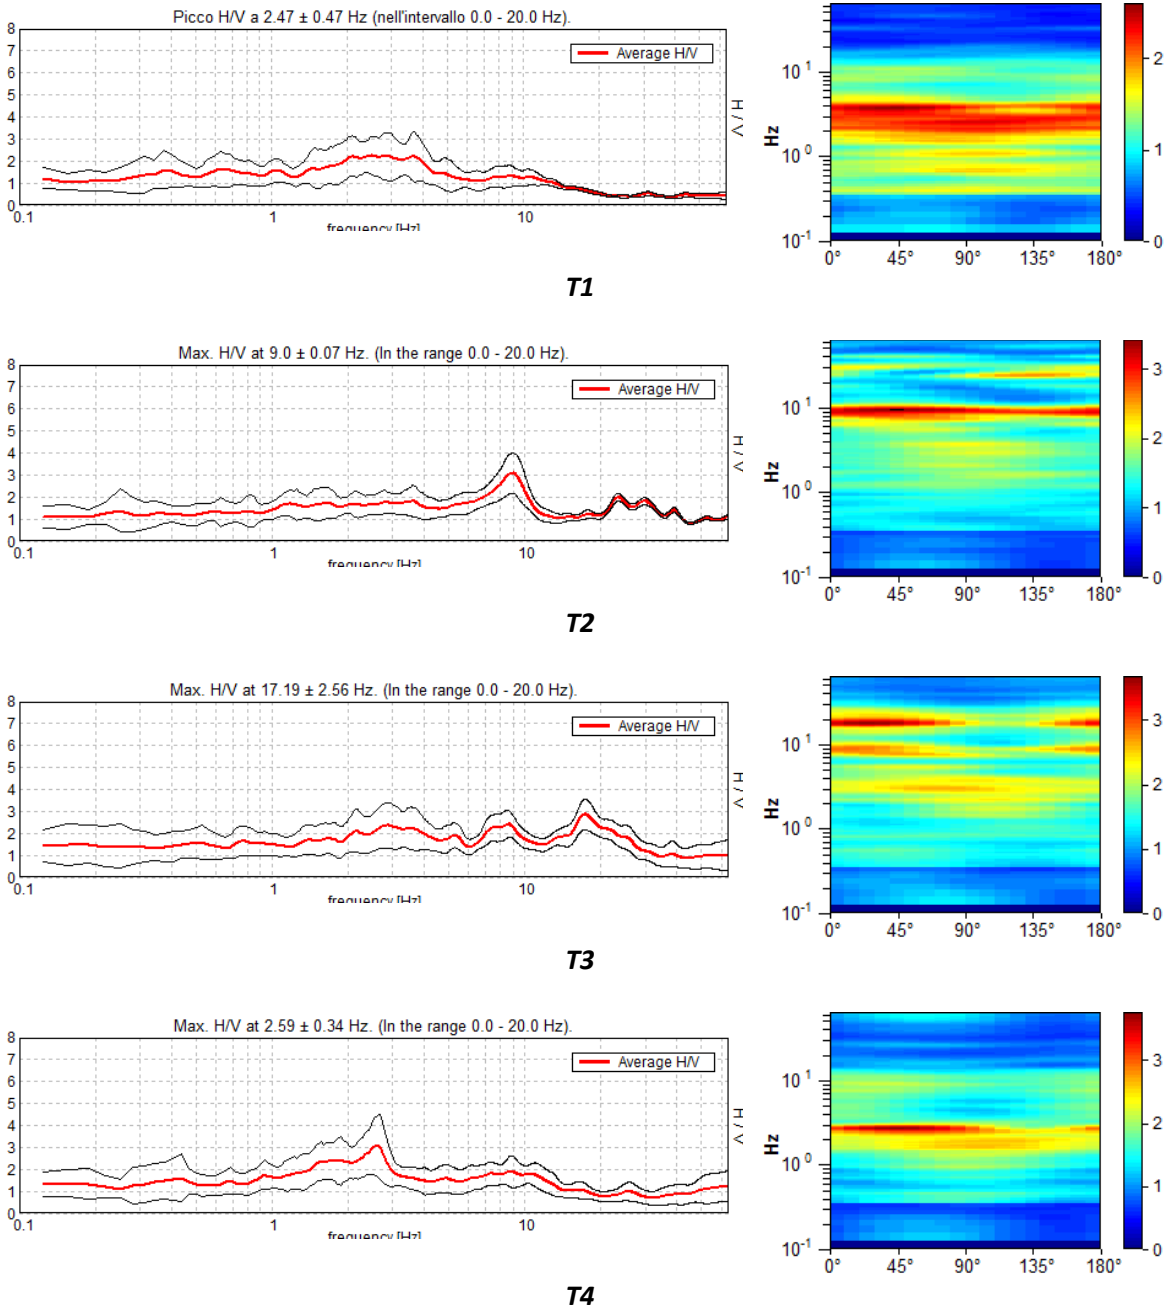
Figure 5.32. Noise measurements results in terms of H/V spectral ratio (on the left column) and H/V polar plots (on the right).

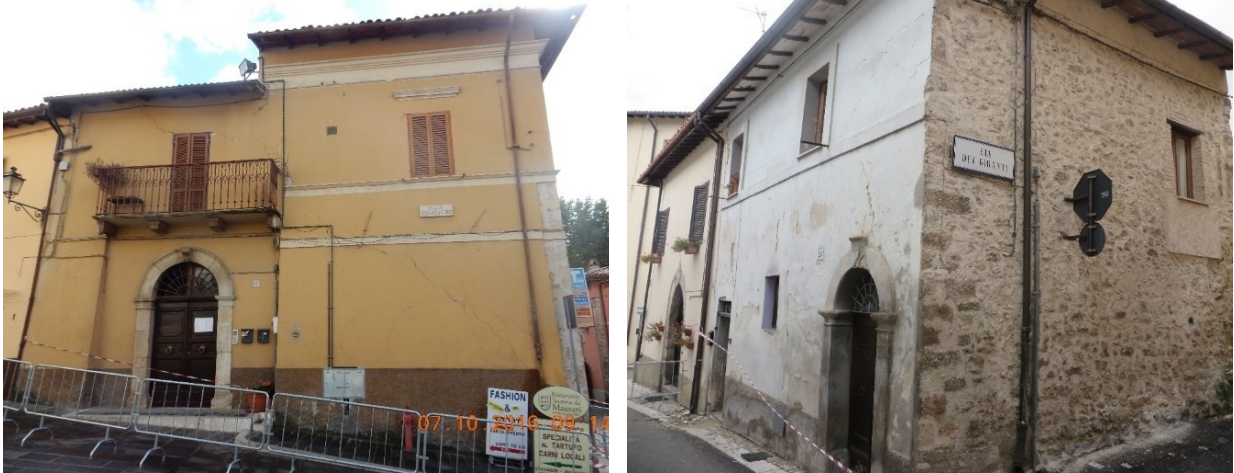
Figure 5.33. Limited damage was observed in the buildings of Norcia.

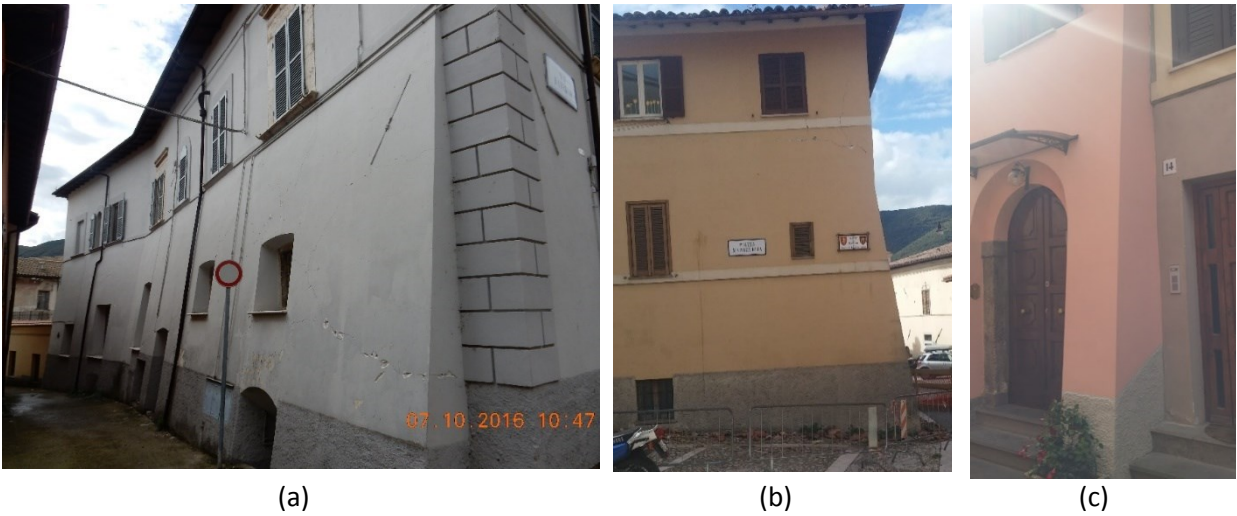
Figure 5.34. Earthquake resistant construction practices in the center of Norcia – linearly varying thickness of the first story.

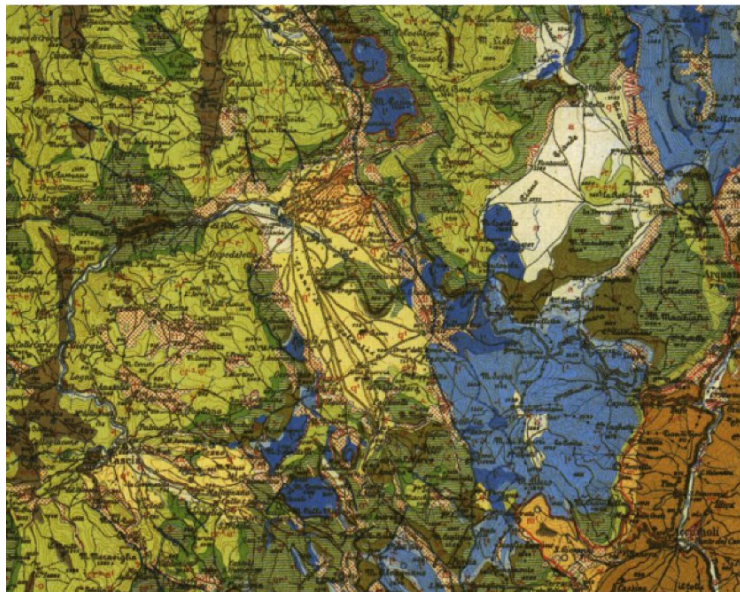
**ISPRA**  
Istituto Superiore per la Protezione  
e la Ricerca Ambientale

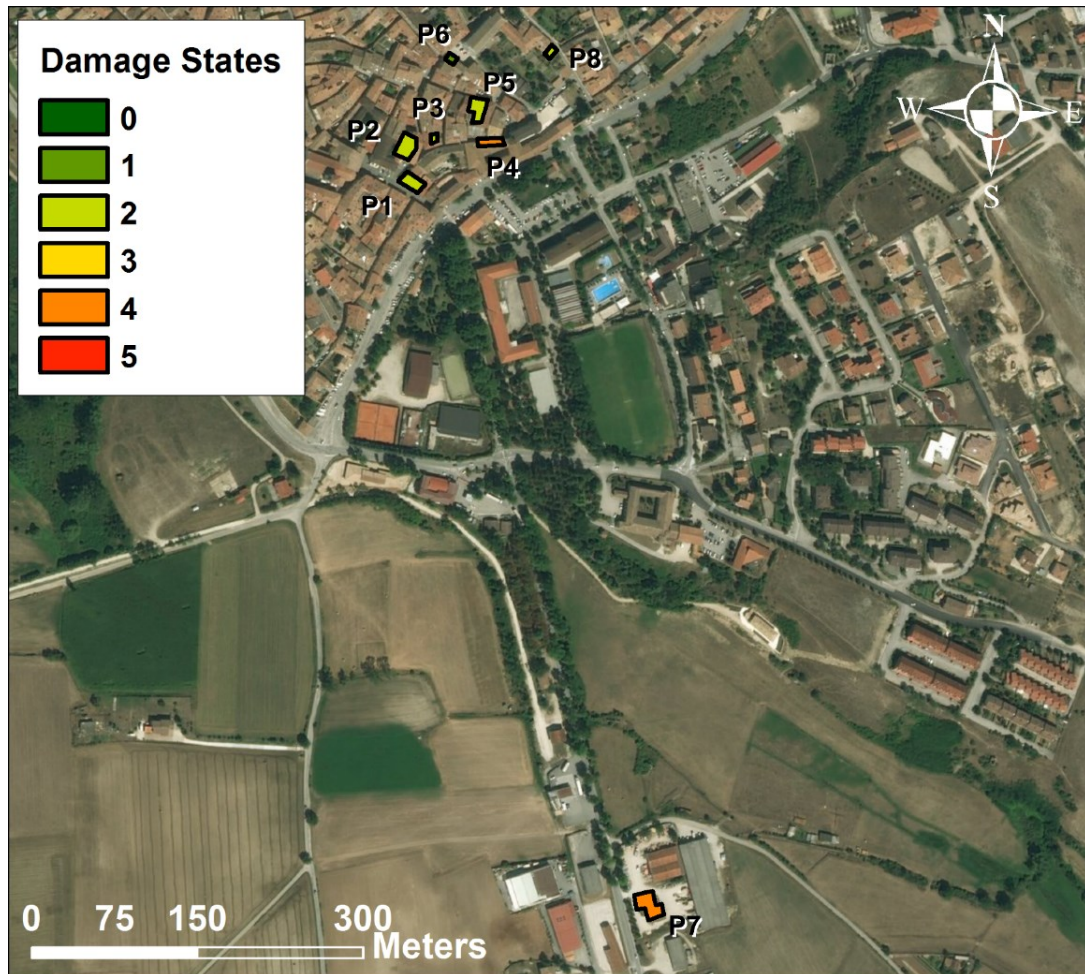
**Figure 5.37.** Location of surveyed buildings and their damage state.

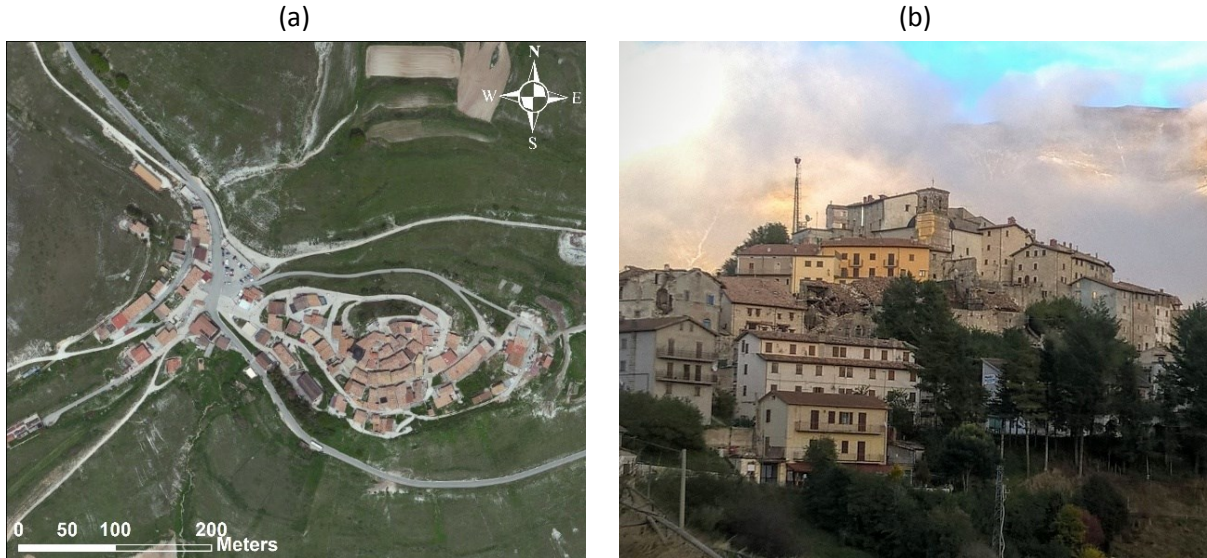
**Figure 5.38.** (a) Aerial photo of Castelluccio di Norcia, (b) Panoramic view of the hamlet.

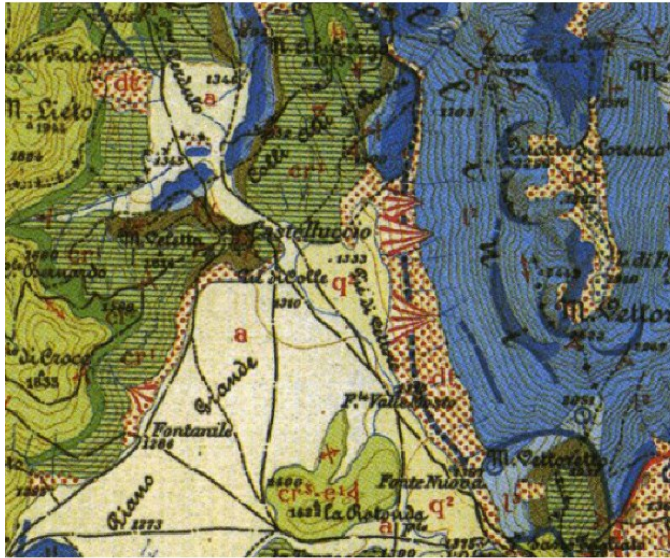
ISPRA  
Istituto Superiore per la Protezione  
e la Ricerca Ambientale

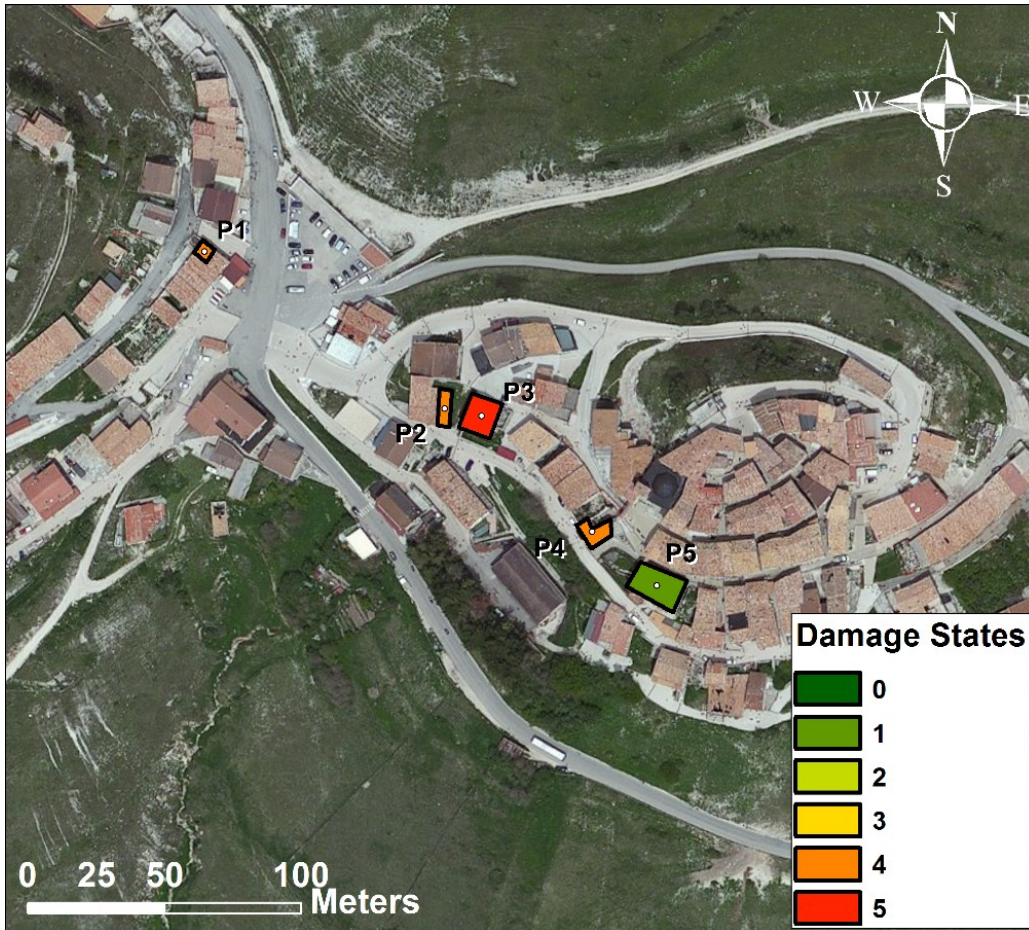
Figure 5.40. Location of surveyed buildings and their damage state.

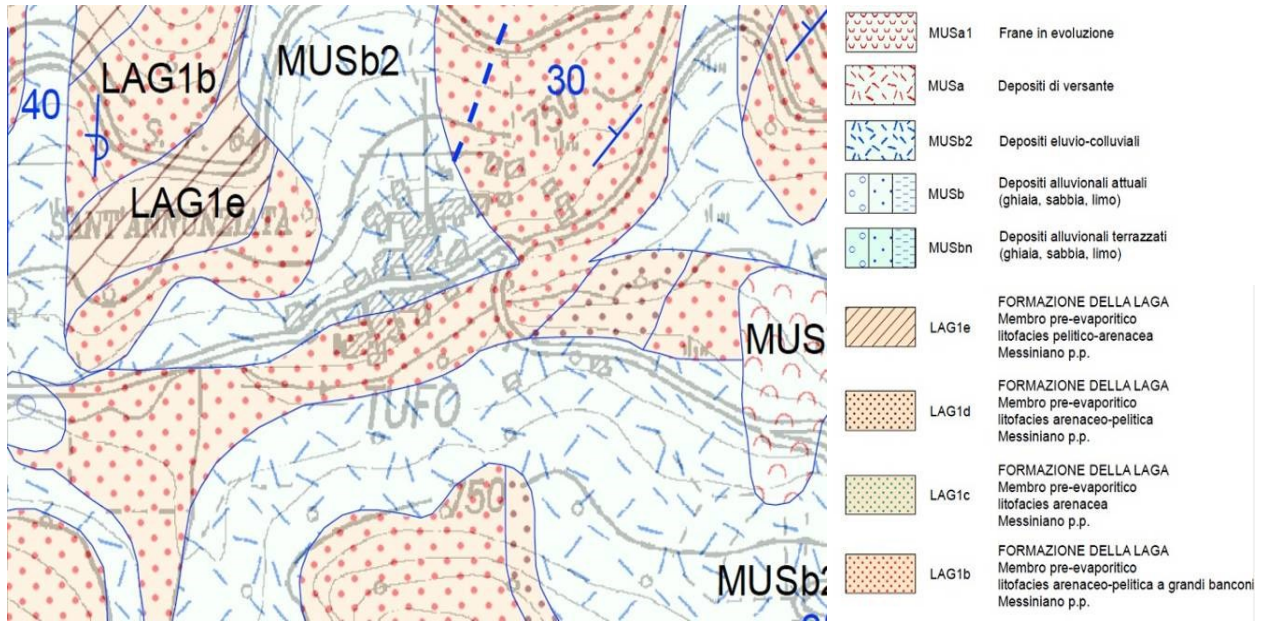
**Figure 5.42.** Geological map (provided by Marche region (section 337080)

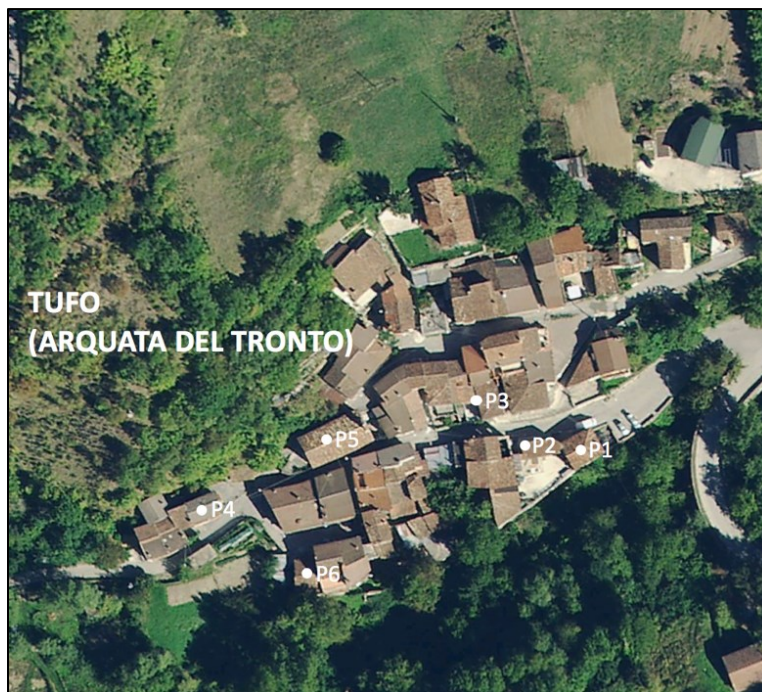
**Figure 5.43.** Locations of representative structures in the hamlet (see Table 5.10 for details).

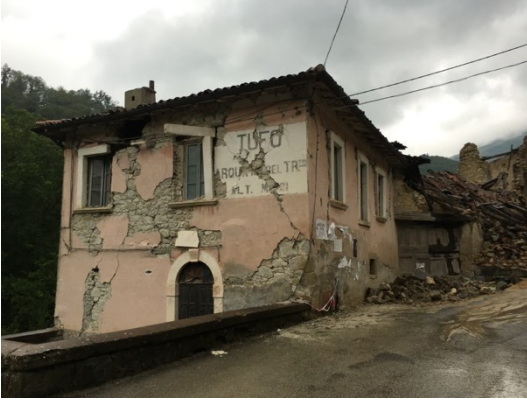
TAG	DATUM	Location		Damage level	Notes
		Lat.	Long.		
P1	WGS-84	42.7353°	13.2532°	D3	Diffused cracks
P2	WGS-84	42.7353°	13.2530°	D5	Collapse of the entire structure
P3	WGS-84	42.7354°	13.2528°	D2	Crack starting from the window corner
P4	WGS-84	42.7351°	13.2519°	D0	No damage
P5	WGS-84	42.7351°	13.2522°	D0	No damage
P6	WGS-84	42.735°	13.2522°	D4	Partial collapse of the structure

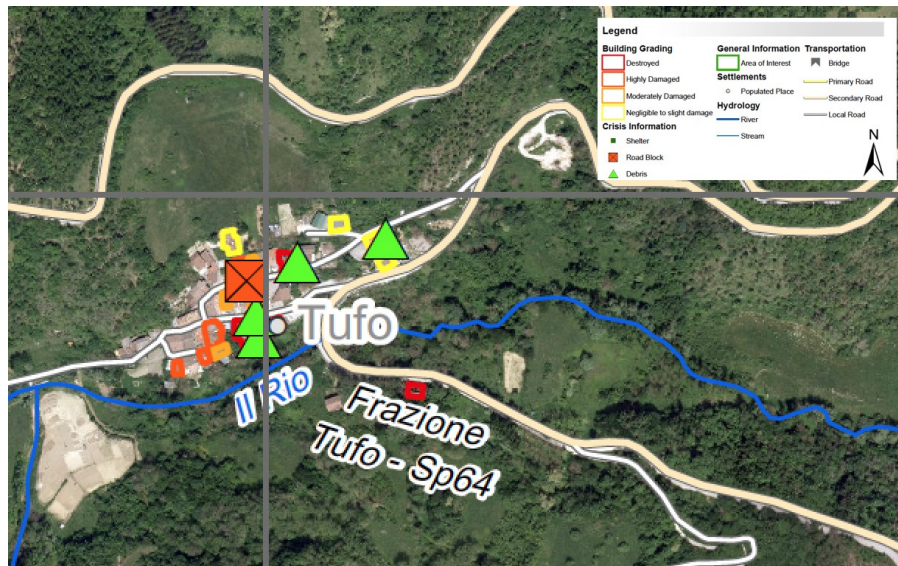
Figure 5.45. Damage pattern from Copernicus post event images

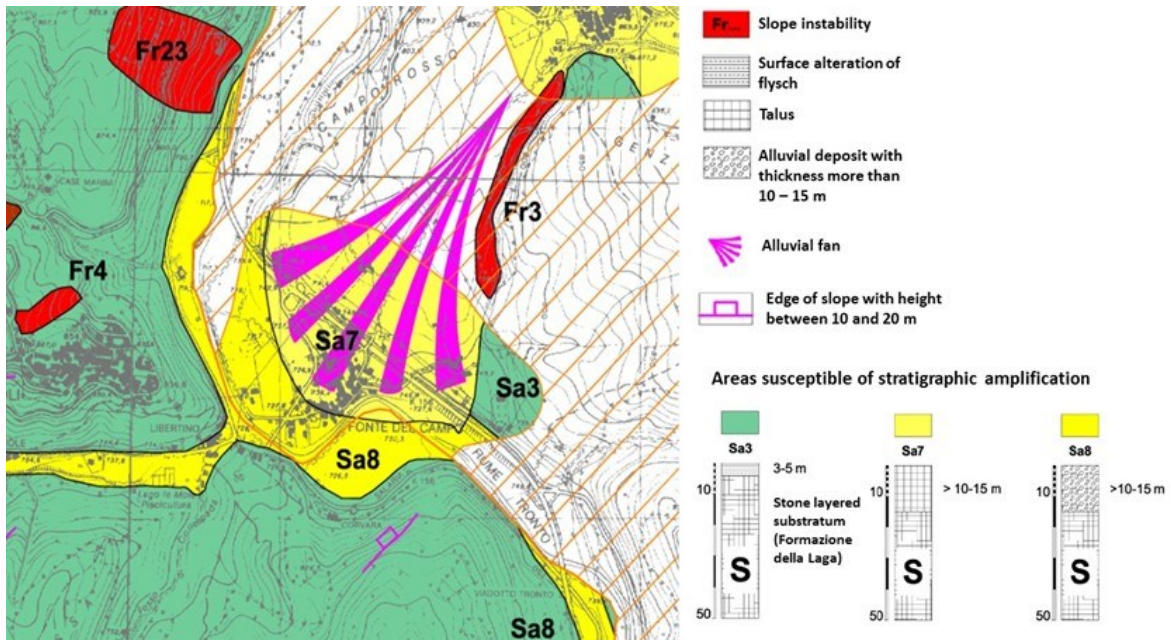
Figure 5.47. Fonte del Campo: grade 1 seismic zonation 1: 10000 (Regione Lazio, 2013).

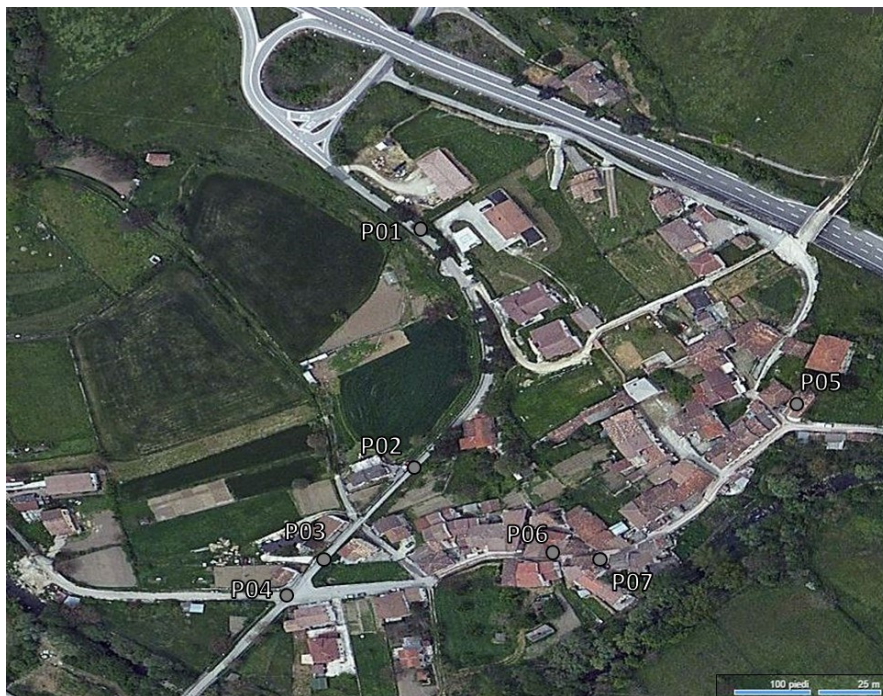
Figure 5.48. Locations of representative structures inspected in the hamlet (see Table 5.11 for details)

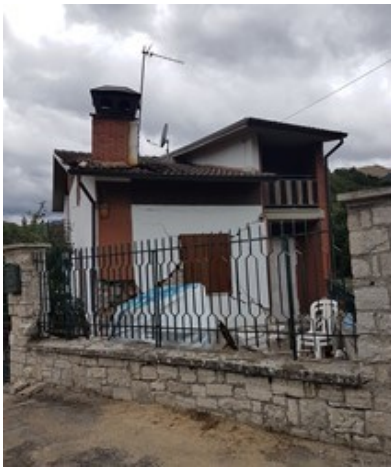
Picture	DATUM	longitude	latitude	Damage level	Note
P01.jpg	WGS- 84	13.255	42.69528	D3	
P02.jpg	WGS- 84	13.255	42.69417	D4	View of several buildings
P03.jpg	WGS- 84	13.255	42.69528	D3	View of several buildings
P04.jpg	WGS- 84	13.255	42.69528	D3	
P05.jpg				D3	Downloaded from <a href="http://www.fontedelcampo.it/foto/foto-terremoto/">http://www.fontedelcampo.it/foto/foto-terremoto/</a>
P06.jpg				D5	Downloaded from <a href="http://www.fontedelcampo.it/foto/foto-terremoto/">http://www.fontedelcampo.it/foto/foto-terremoto/</a>
P07.jpg				D3	Downloaded from <a href="http://www.fontedelcampo.it/foto/foto-terremoto/">http://www.fontedelcampo.it/foto/foto-terremoto/</a>

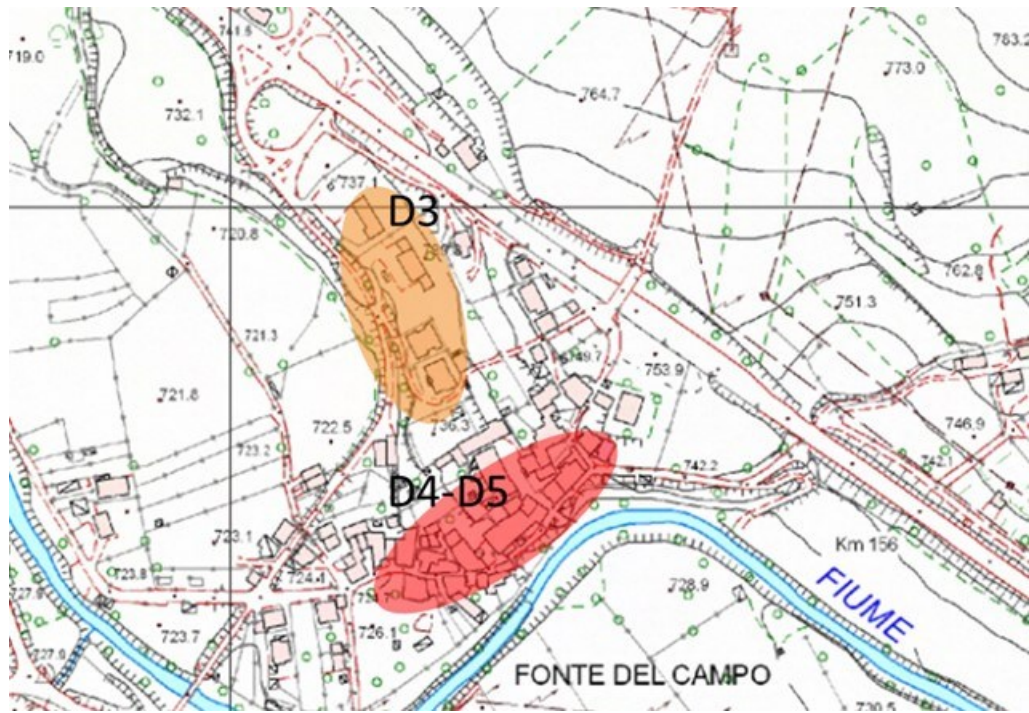
Figure 5.50. Damage zonation within the village.

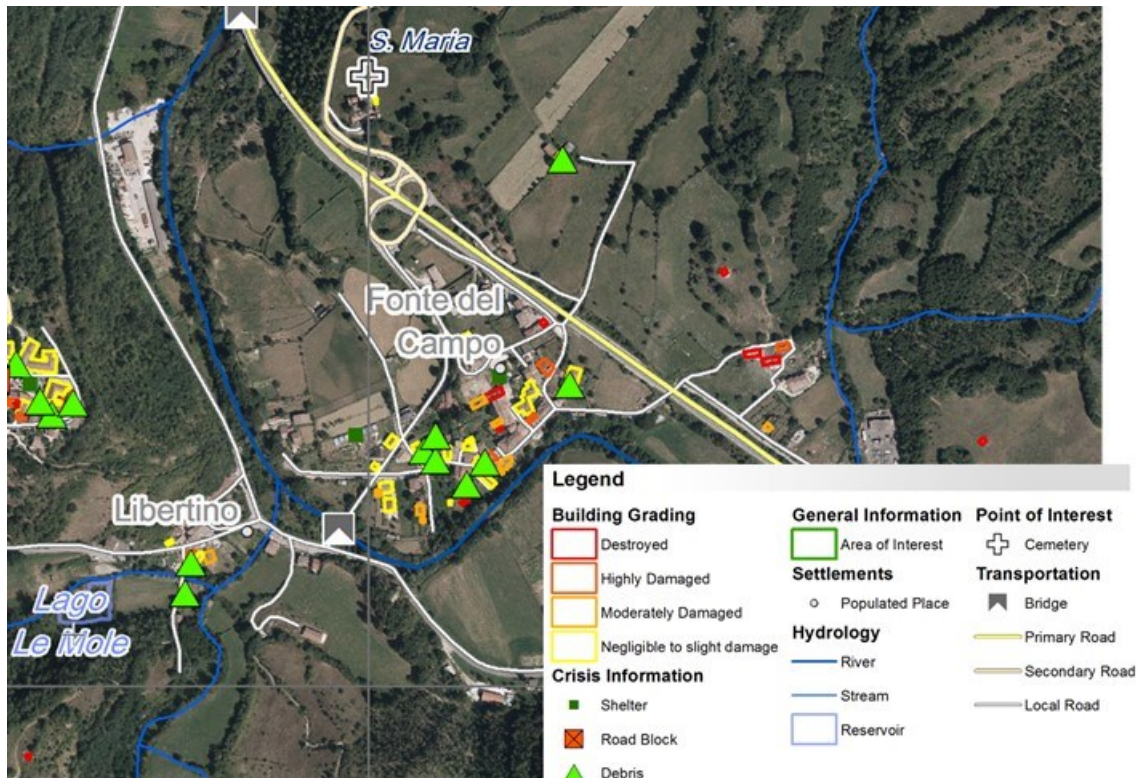
Figure 5.51. Damage pattern from Copernicus post event images.

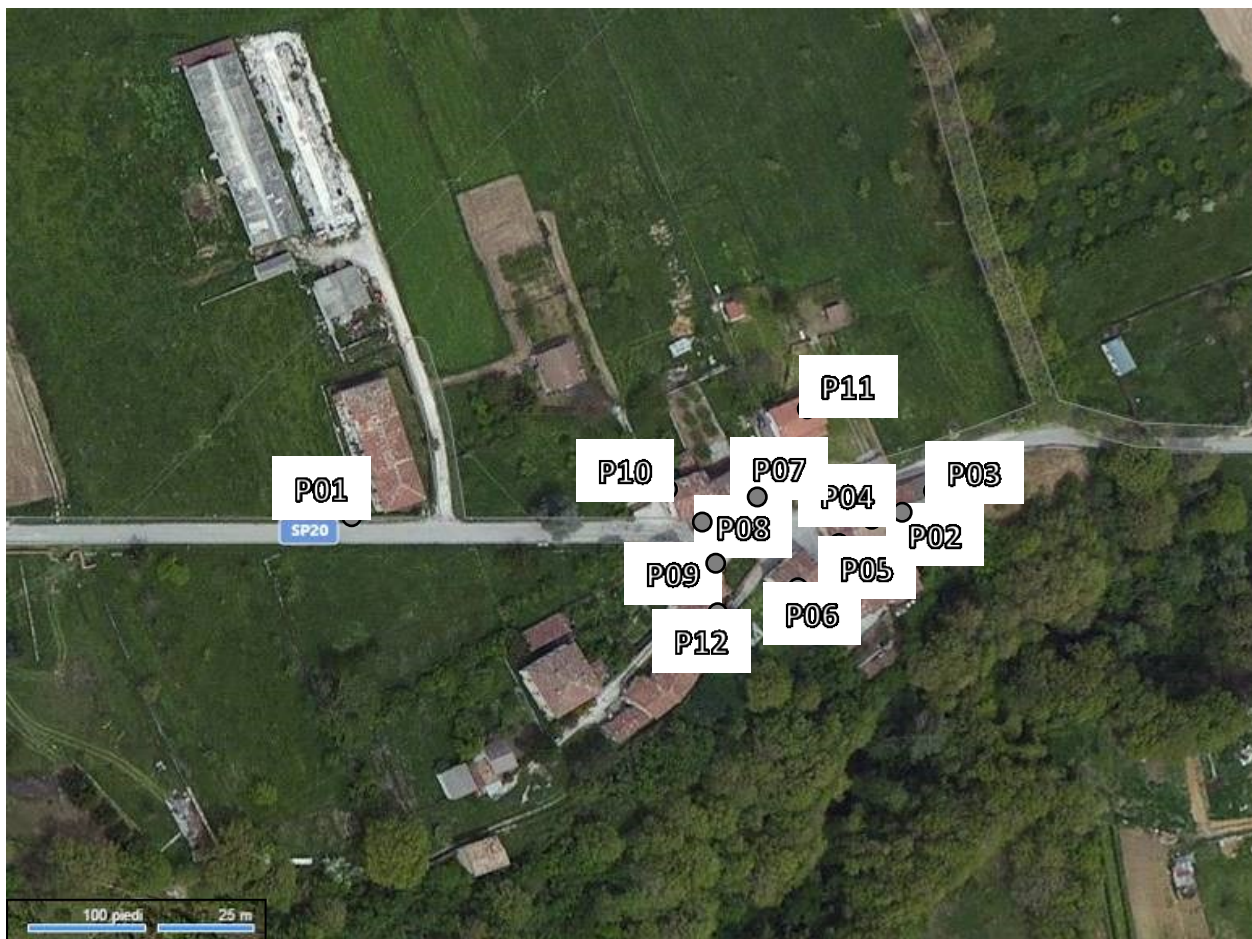
**Figure 5.55.** Location of representative pictures taken at Cascello (see Table 5.13 for details).

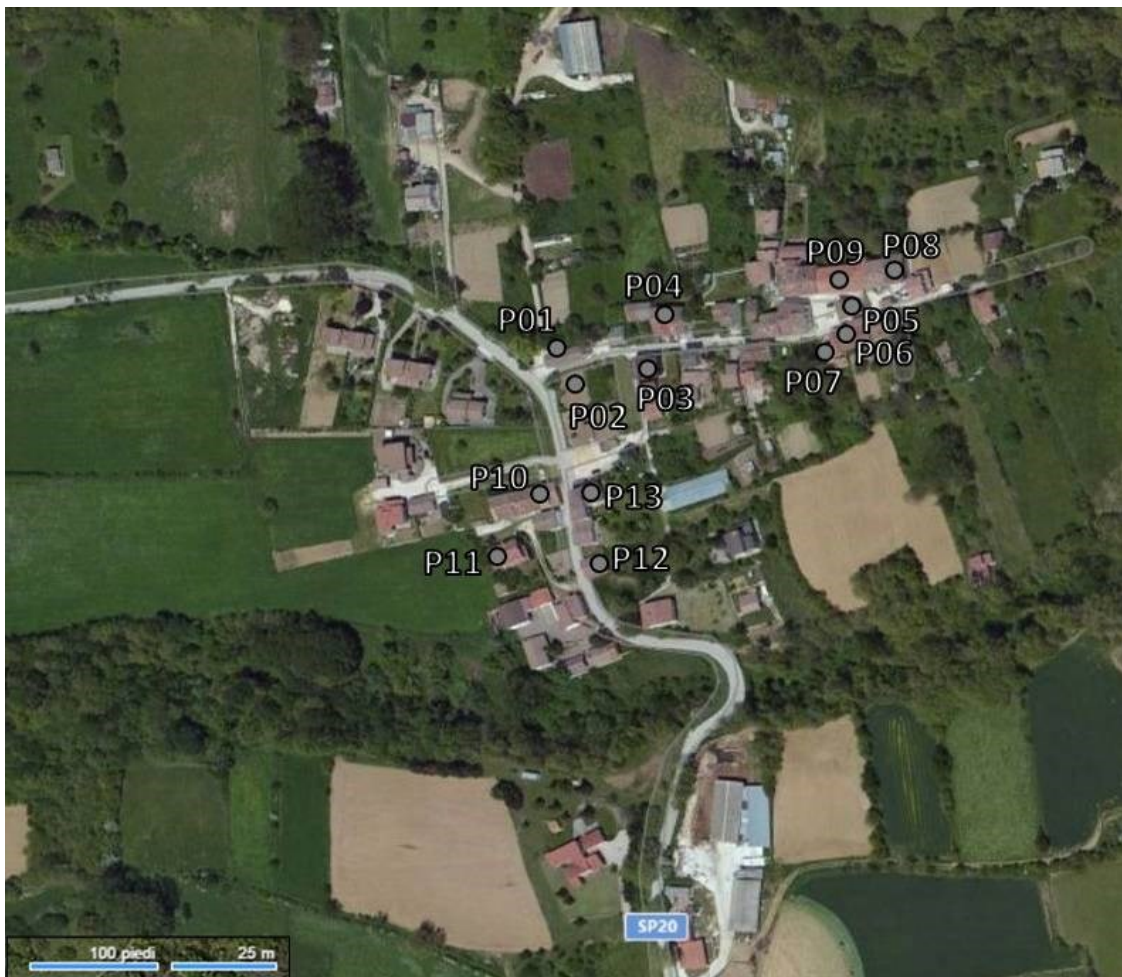
Figure 5.57. Locations of representative structures inspected in Voceto (see Table 5.14 for details).

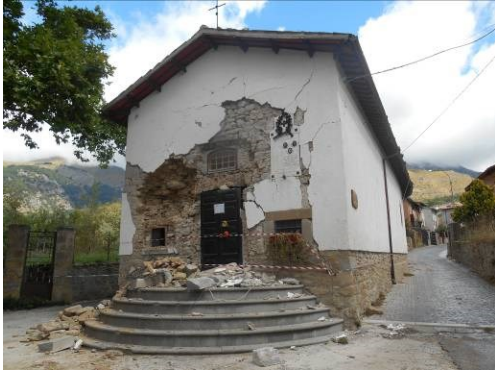
P11	WGS- 84	13.324422	42.633758	D3	Recent brickwork cracked and displaced
P12	WGS- 84	13.324433	42.633853	D3	Bulged and cracked poor masonry wall
P13	WGS- 84	13.324433	42.634000	D2	Partial damage even with tie rods

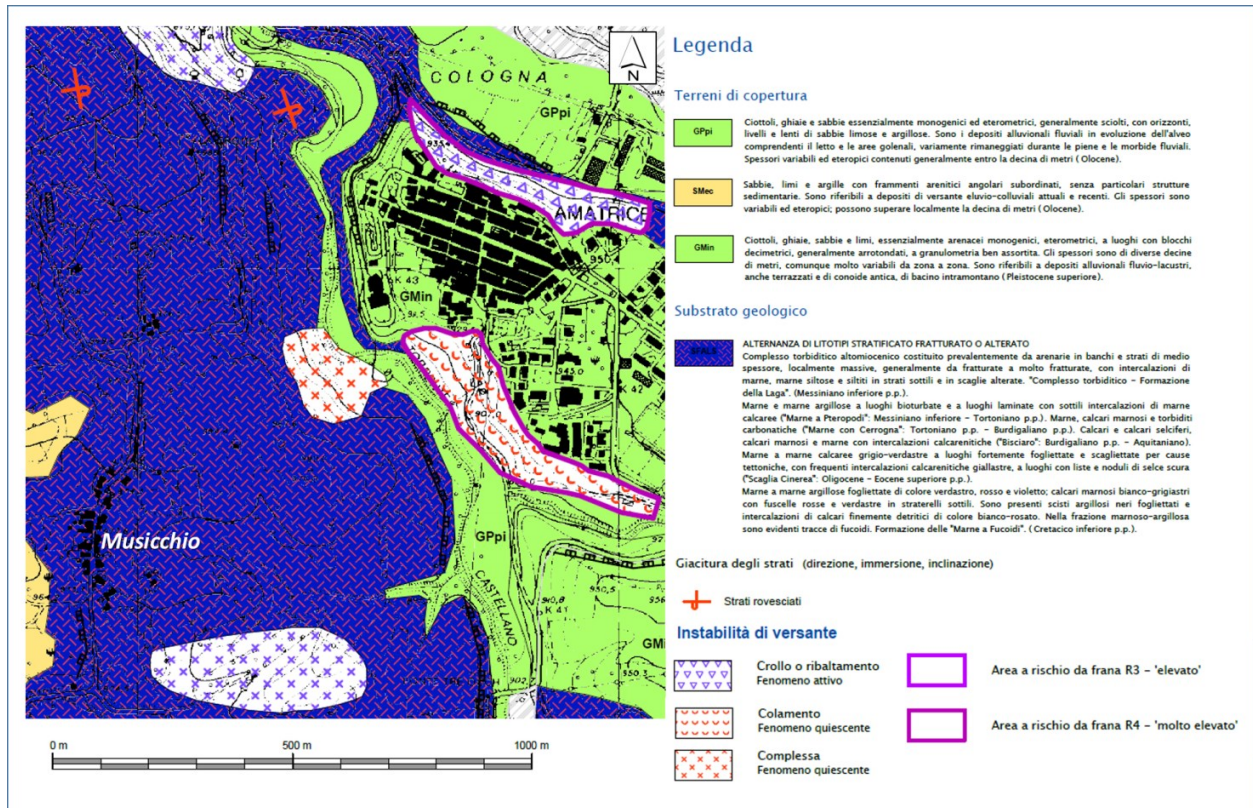
Figure 5.59. Geological map of Mosicchio and Amatrice (Regione Lazio, 2016).

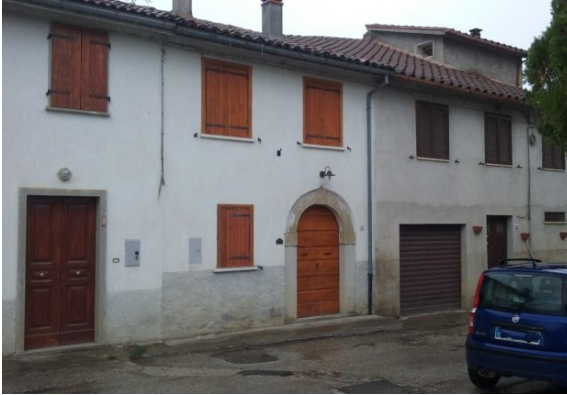
Photos of representative structures inspected in Mosicchio are shown in Figure 5.60, with further details provided in Table 5.15 (WGS-84 coordinates, damage level of buildings, other notes). The hamlet consists mainly of unreinforced masonry structures, 2-3 stories in height. The damage was quite low, on average classified as D2. Only one case of partial collapse (D4) was observed in a poorly constructed, unreinforced masonry building (see P4).

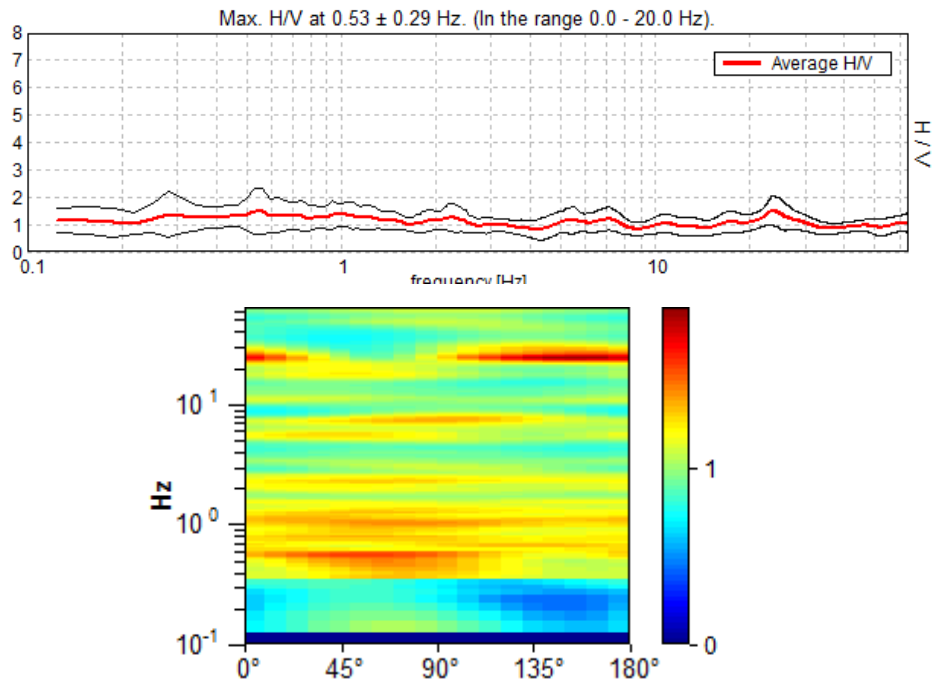
**Figure 5.61.** Noise measurements results in terms of H/V spectral ratio (on top) and H/V polar plots (on the bottom).

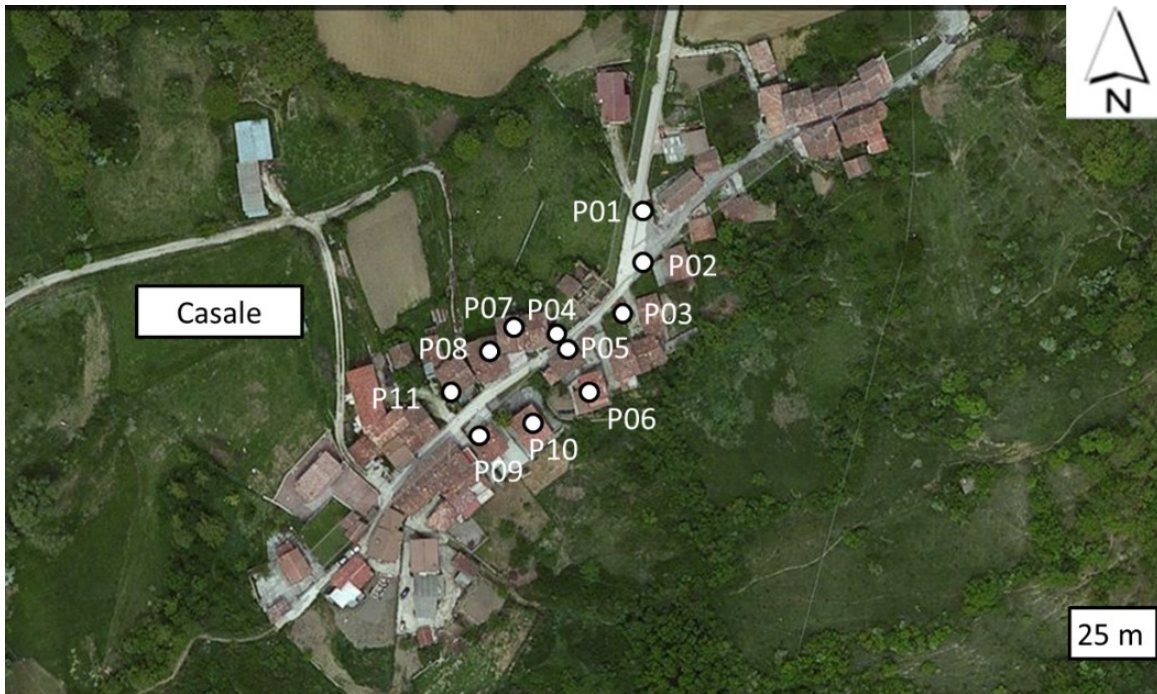
Figure 5.63. Locations of the representative structures inspected in Casale (see Table 5.16 for details).

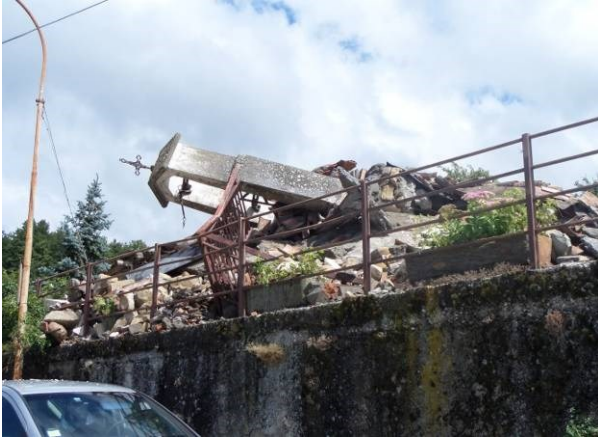
Picture	DATUM	Location		Damage Level	Notes
		Lat.	Long.		
P01	WBG-84	42.670069	13.286015	D5	
P02	WBG-84	42.669812	13.285955	D5	
P03	WBG-84	42.669689	13.285857	D4	
P04	WBG-84	42.669553	13.285667	D3	
P05	WBG-84	42.669553	13.285667	D4	
P06	WBG-84	42.669596	13.285710	D0	
P07	WBG-84	42.669514	13.285550	D4	
P08	WBG-84	42.669473	13.285491	D5	
P09	WBG-84	42.669293	13.285254	D3	
P10	WBG-84	42.669330	13.285297	D3	
P11	WBG-84	42.669293	13.285254	D5

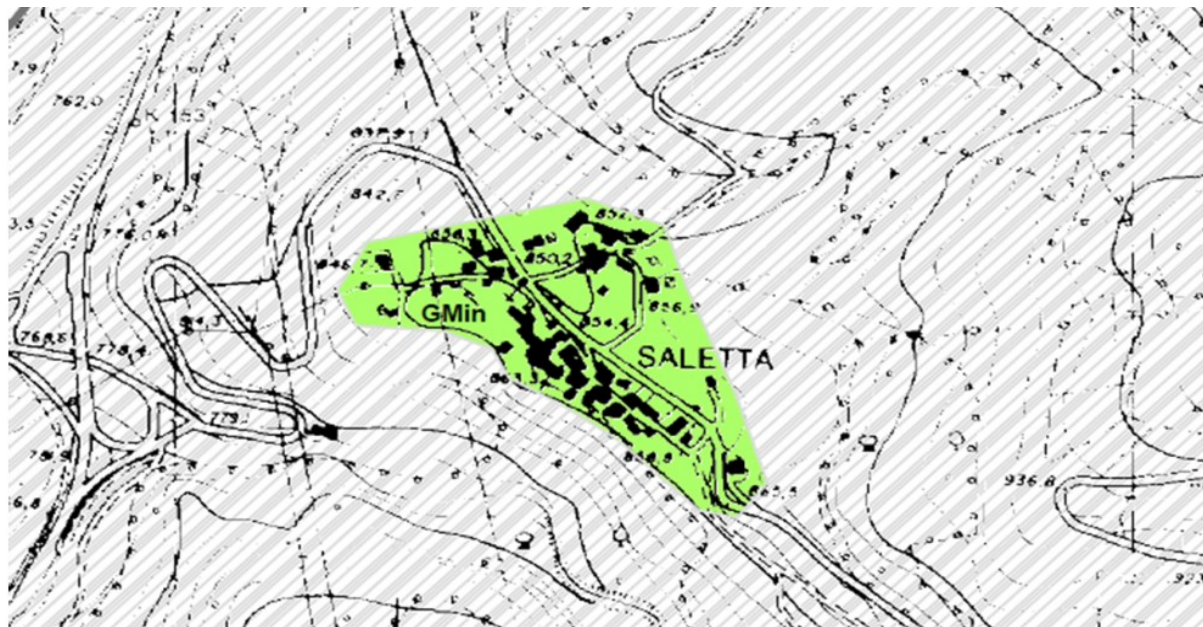
**GMin** Ciottoli, ghiaie, sabbie e limi, essenzialmente arenacei monogenici, eterometrici, a luoghi con blocchi decimetrici, generalmente arrotondati, a granulometria ben assortita. Gli spessori sono di diverse decine di metri, comunque molto variabili da zona a zona. Sono riferibili a depositi alluvionali fluvio-lacustri, anche terrazzati e di conoide antica, di bacino intramontano (Pleistocene superiore).
