Engineering Reconnaissance of the 24 August 2016 Central Italy Earthquake. Version 2

*Original*

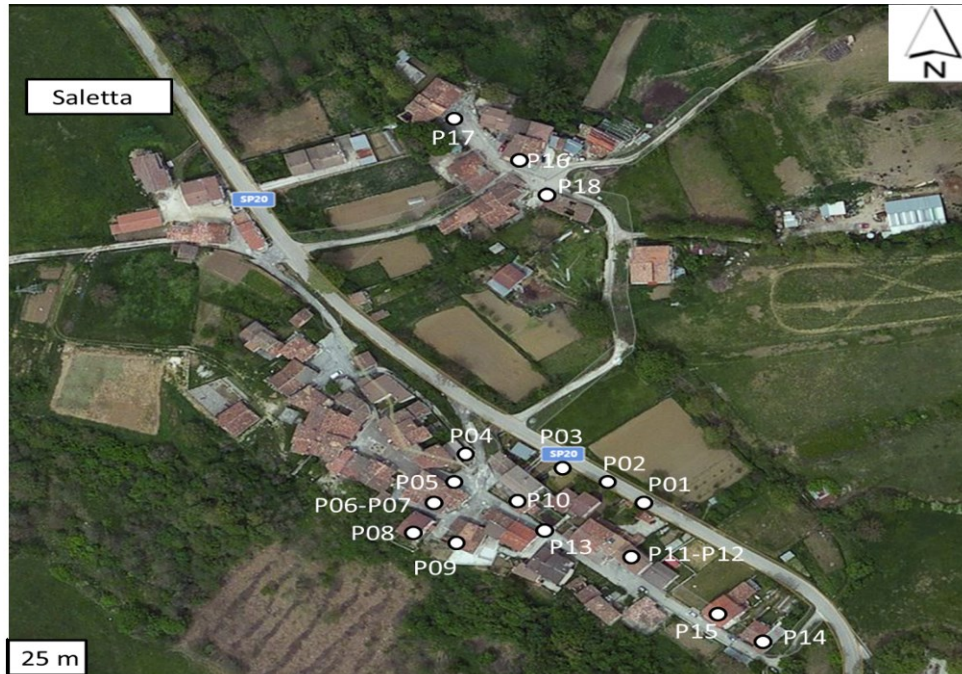
Figure 5.66. Locations of representative structures inspected in Saletta (see Table 5.17 for details).

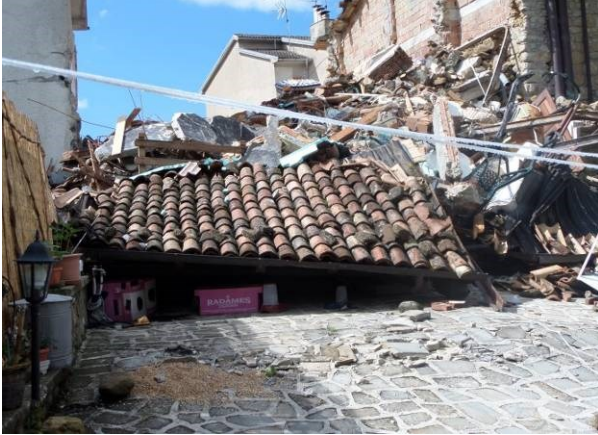
Picture	DATUM	Location		Damage Level	Notes
		Lat.	Long.		
P01	WBG-84	42.670660	13.273112	D5	
P02	WBG-84	42.670803	13.272817	D4	
P03	WBG-84	42.670873	13.272713	D5	
P04	WBG-84	42.670823	13.272245	D5	
P05	WBG-84	42.670770	13.272265	D5	
P06	WBG-84	42.670791	13.272260	D4	
P07	WBG-84	42.670791	13.272260	D3	
P08	WBG-84	42.670740	13.272282	D3	
P09	WBG-84	42.670740	13.272282	D3	
P10	WBG-84	42.670647	13.272412	D3	
P11	WBG-84	42.670332	13.272980	D3	
P12	WBG-84	42.670332	13.272980	D3	
P13	WBG-84	42.670427	13.272803	D5	
P14	WBG-84	42.670056	13.273478	D3	
P15	WBG-84	42.670137	13.273330	D4	
P16	WBG-84	42.672120	13.272418	D4	
P17	WBG-84	42.672120	13.272418	D4	
P18	WBG-84	42.672005	13.272686	D5

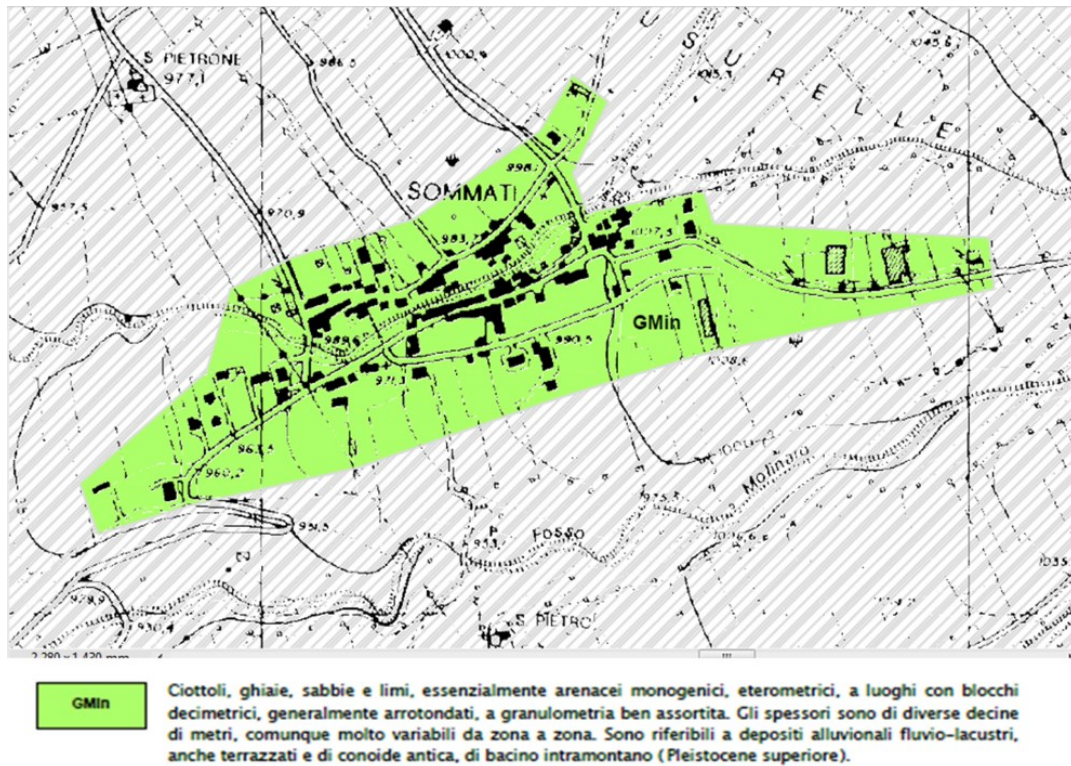
**Figure 5.68.** Geological map of Sommati hamlet retrieved from the Level 1 Microzonation map of Amatrice (Regione Lazio, 2016).

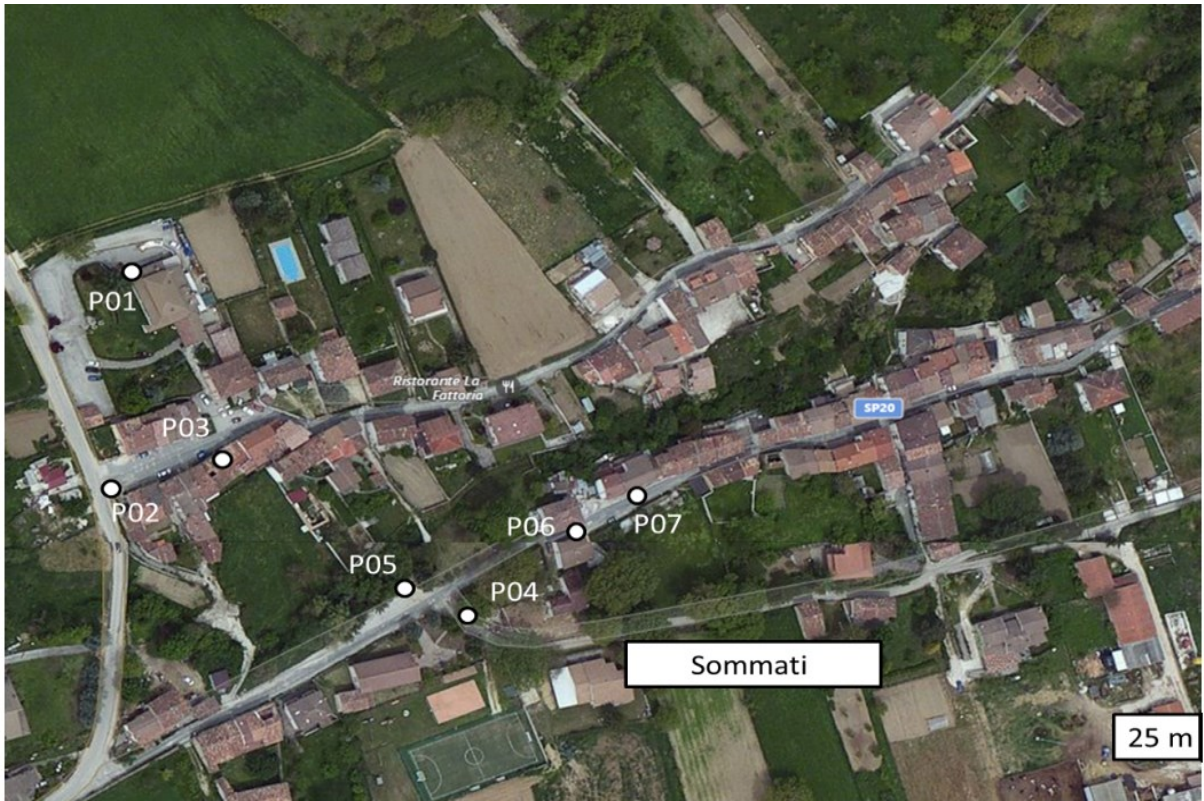
Figure 5.69. Locations of representative structures inspected in Sommati (see Table 5.18 for details).

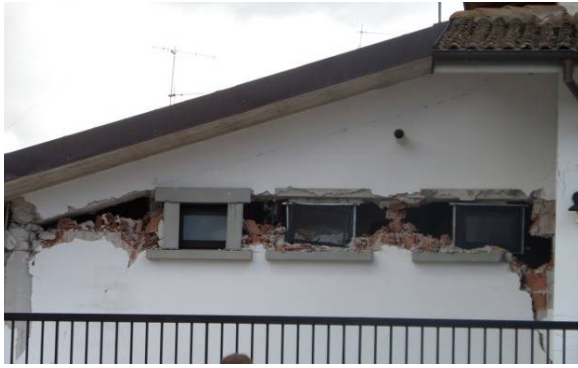
Picture	DATUM	Location		Damage Level	Notes
		Lat.	Long.		
P01	WBG-84	42.642058	13.304934	D2	
P02	WBG-84	42.641640	13.305167	D4	
P03	WBG-84	42.641709	13.305461	D5	
P04	WBG-84	42.641251	13.306553	D1-D2	
P05	WBG-84	42.641172	13.306394	D3	
P06	WBG-84	42.641388	13.306857	D3	
P07	WBG-84	42.641438	13.307067	D3-D4

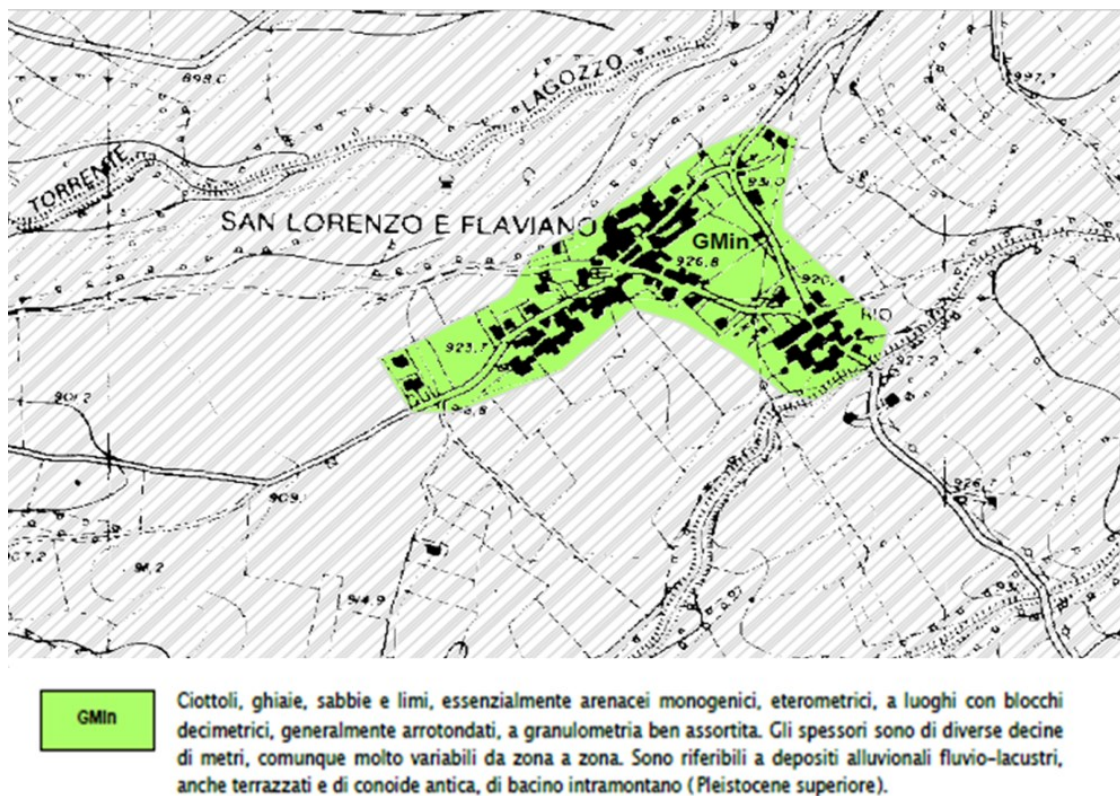
**Figure 5.71.** Geological map of San Lorenzo e Flaviano hamlet retrieved from the Level 1 Microzonation map of Amatrice (Regione Lazio, 2016).

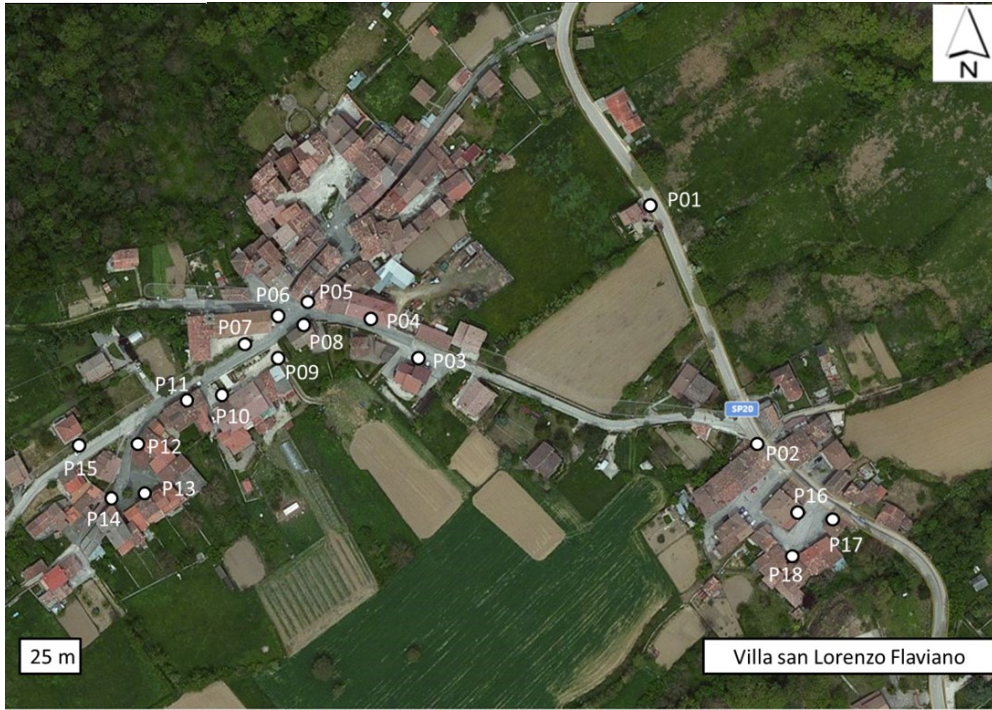
**Figure 5.72.** Locations of the representative structures inspected in San Lorenzo e Flaviano (see Table 5.19 for details).

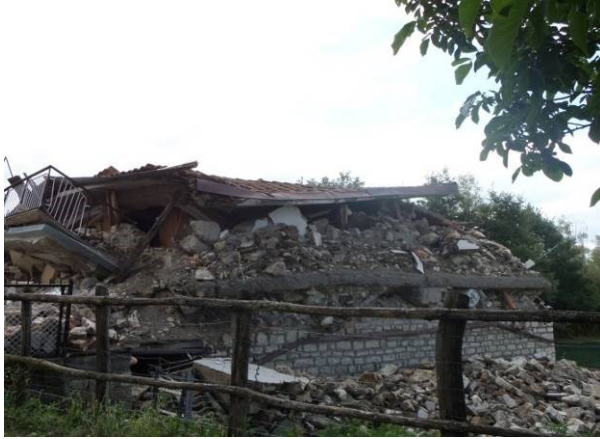
Picture	DATUM	Location		Damage Level	Notes
		Lat.	Long.		
P01	WBG-84	42.665401	13.288931	D5	
P02	WBG-84	42.664418	13.289463	D4	
P03	WBG-84	42.664803	13.287449	D5	
P04	WBG-84	42.664831	13.287356	D3	
P05	WBG-84	42.664912	13.286910	D5	
P06	WBG-84	42.664897	13.286813	D4	
P07	WBG-84	42.664794	13.286675	D4	
P08	WBG-84	42.664897	13.286813	D3	
P09	WBG-84	42.664738	13.286589	D4	
P10	WBG-84	42.664724	13.286543	D4	
P11	WBG-84	42.664555	13.286144	D3	
P12	WBG-84	42.664167	13.285836	D0	
P13	WBG-84	42.664167	13.285836	D3	
P14	WBG-84	42.664066	13.285641	D5	
P15	WBG-84	42.664259	13.285575	D4	
P16	WBG-84	42.663913	13.289765	D4	
P17	WBG-84	42.664034	13.289765	D4	
P18	WBG-84	42.663913	13.289765	D5

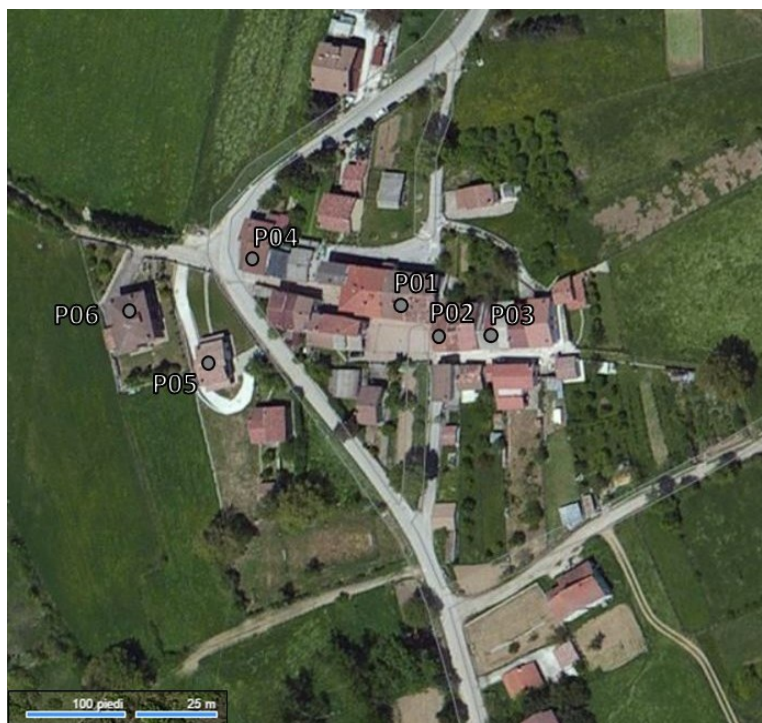
**Figure 5.74.** Locations of the representative structures inspected in Collecreta (Table 5.20 for details).

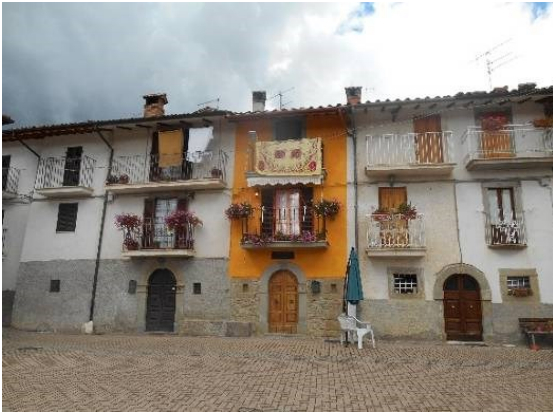
Picture	DATUM	longitude	latitude	Damage level	Note
P01	WGS- 84	13.324494	42.630019	D0	Traditional buildings facing the small square, all undamaged
P02	WGS- 84	13.324644	42.629939	D1	Only slight cracking visible
P03	WGS- 84	13.324978	42.629897	D1	Maybe the most ‘damaged’ building
P04	WGS- 84	13.323975	42.630127	D0	New houses close to the main road, totally undamaged
P05	WGS- 84	13.323884	42.629816	D0	
P06	WGS- 84	13.323549	42.630106	D0

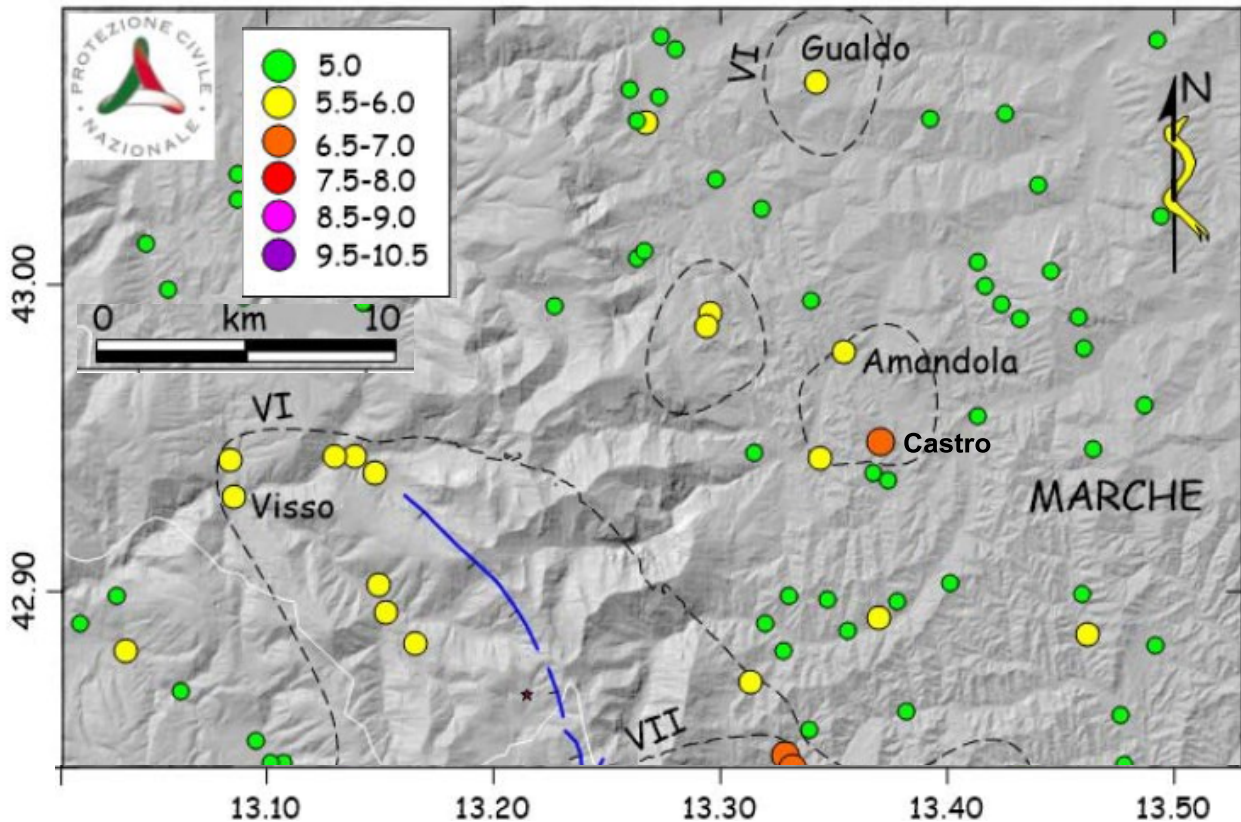
Figure 5.80. Macroseismic intensity map north of the epicentral area not visible in the figure (modified from Galli et al., 2016).

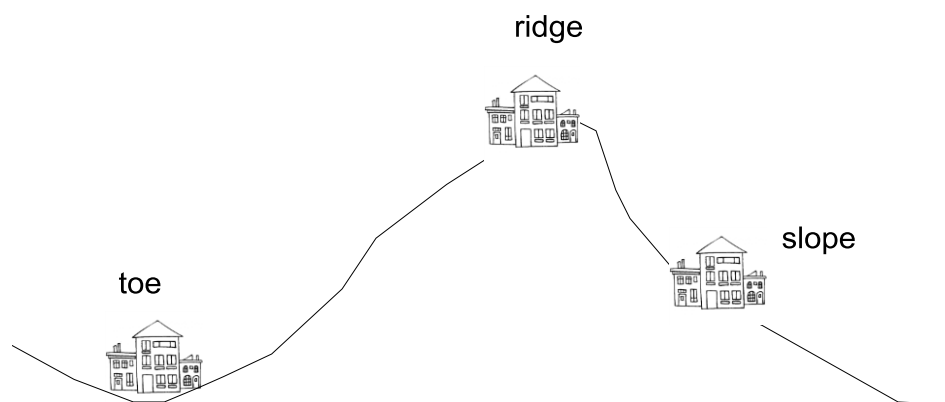
**Figure 5.81.** Schematic representation of the morphological categories identified from the surveyed hamlets within the Montegallos municipality.

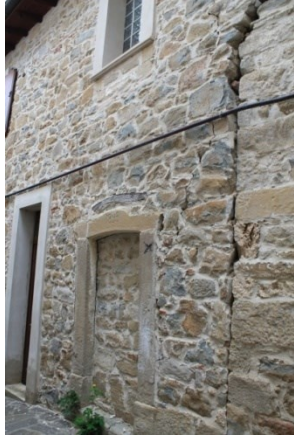
P20	Collefratte	WBG-84	42.839388°	13.319004°	D3
P21	Colleluce	WBG-84	42.838439°	13.308071°	D1-D2
P22	Colleluce	WBG-84	42.838439°	13.308071°	D1-D2

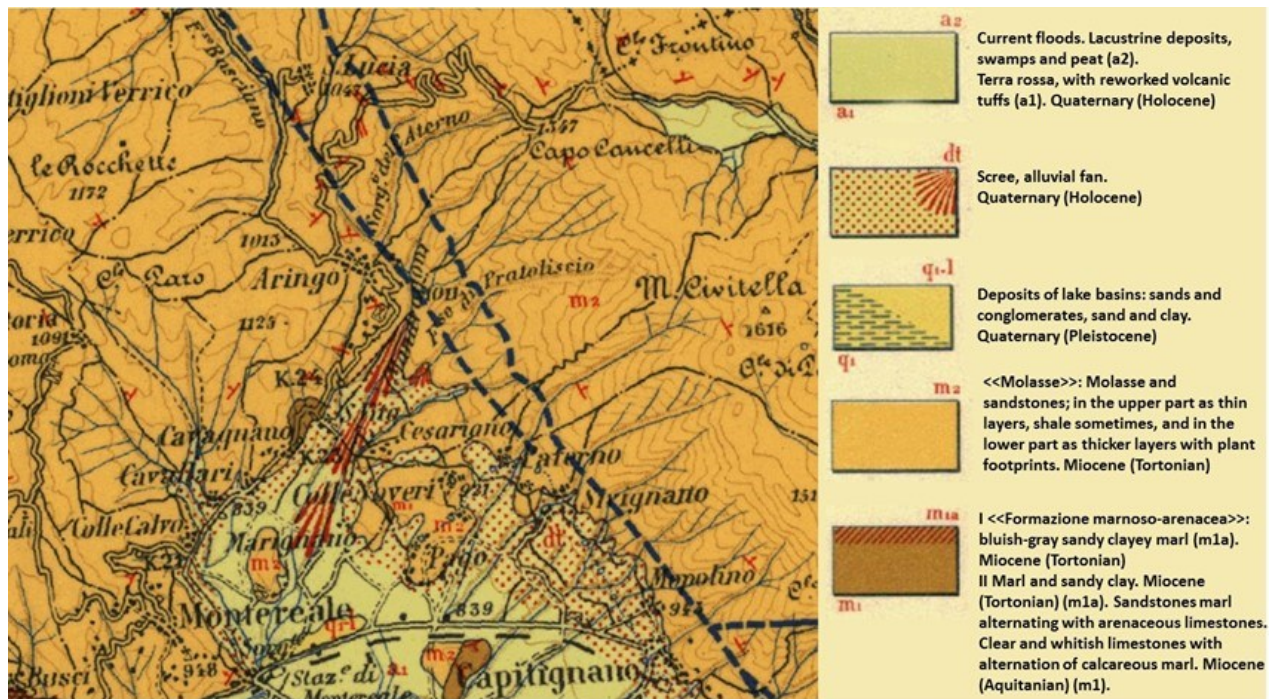
Figure 5.83. Geological map 1: 25000 (Carta Geologica d’Italia – f. 139- from ISPRA, 2016).

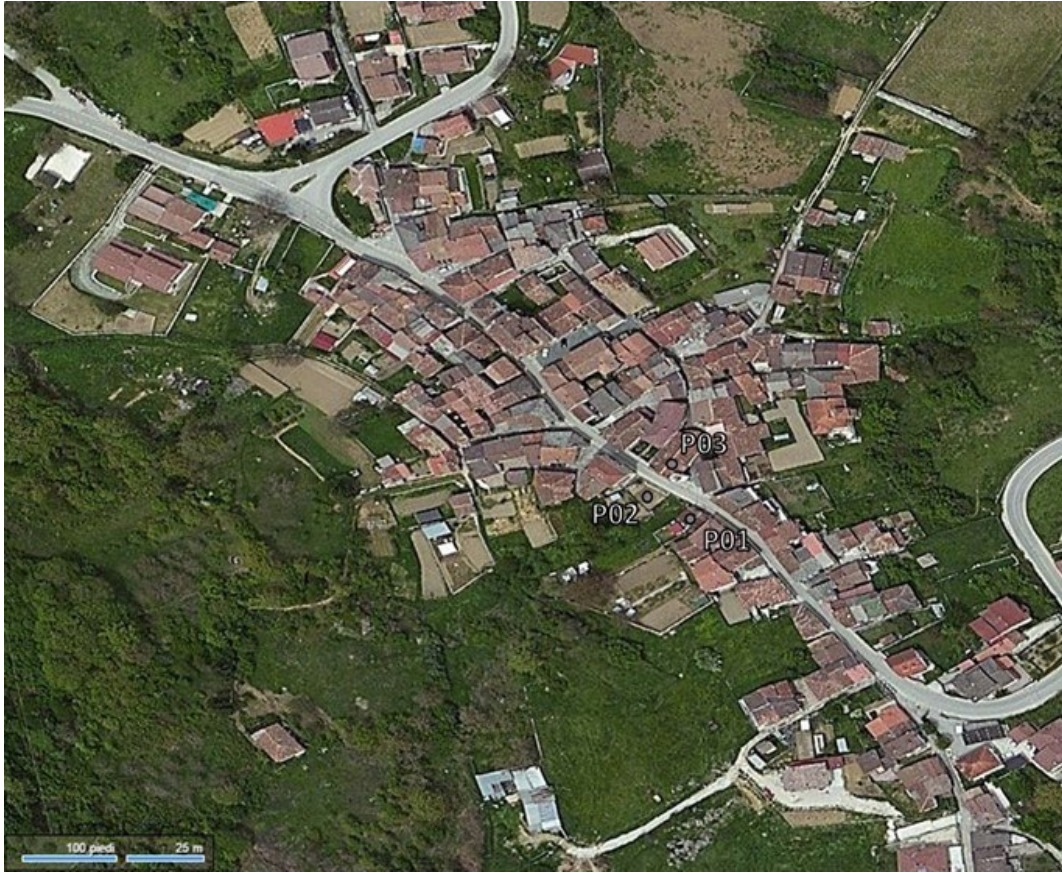
Figure 5.86. Location of representative picture taken in the village of Aringo (see Table 5.23 for details).

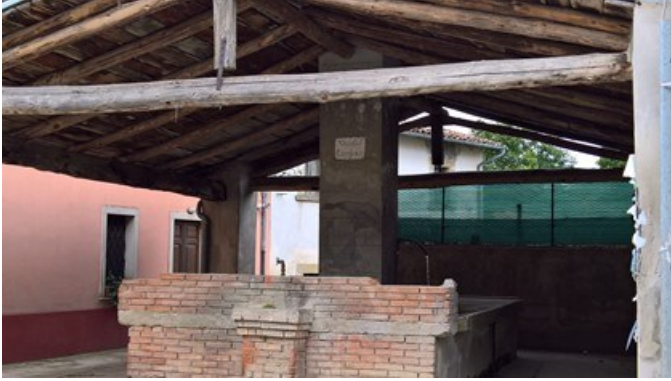
Picture	DATUM	longitude	latitude	Damage level
P01	WGS- 84	13.26763	42.55525	D0
P02	WGS- 84	13.26752	42.55489	D0
P03	WGS- 84	13.26760	42.55502	D0

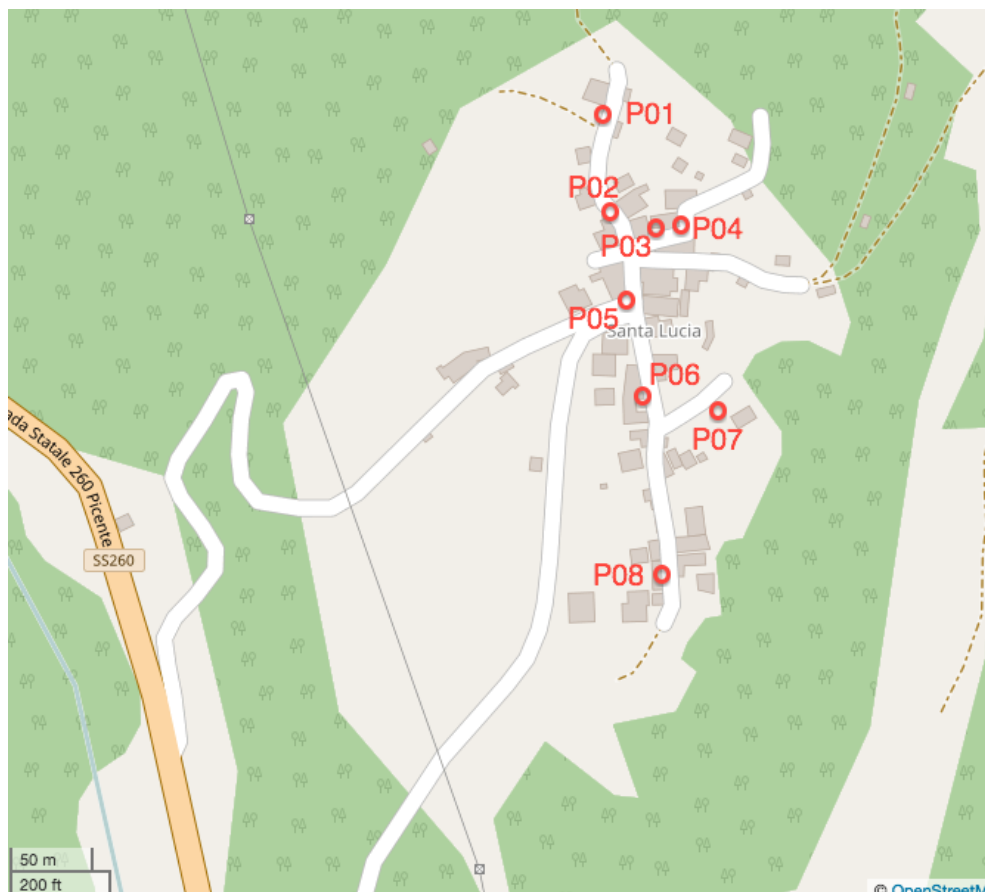
**Figure 5.88.** Locations of representative structures inspected in Santa Lucia (see Table 5.24 for details).

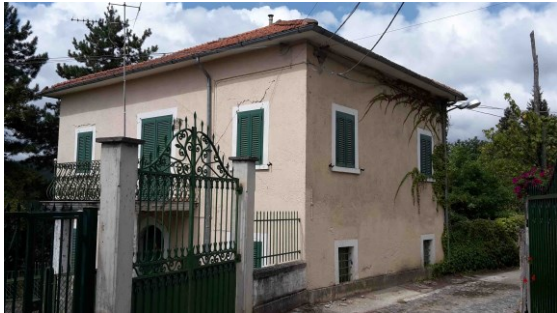
Picture	DATUM	Location		Damage Level
		Lat.	Long.	
P01	WGS-84	42° 34' 18" N	13° 15' 42" E	D1
P02	WGS-85	42° 34' 18" N	13° 15' 43,998" E	D0
P03	WGS-86	42° 34' 18" N	13° 15' 43,998" E	D1
P04	WGS-87	42° 34' 18" N	13° 15' 42" E	D1
P05	WGS-88	42° 34' 16,998" N	13° 15' 43,002" E	D5
P06	WGS-89	42° 34' 16,998" N	13° 15' 43,002" E	D2
P07	WGS-90	42° 34' 15" N	13° 15' 46,002" E	D3
P08	WGS-91	42° 34' 16,002" N	13° 15' 43,002" E	D2

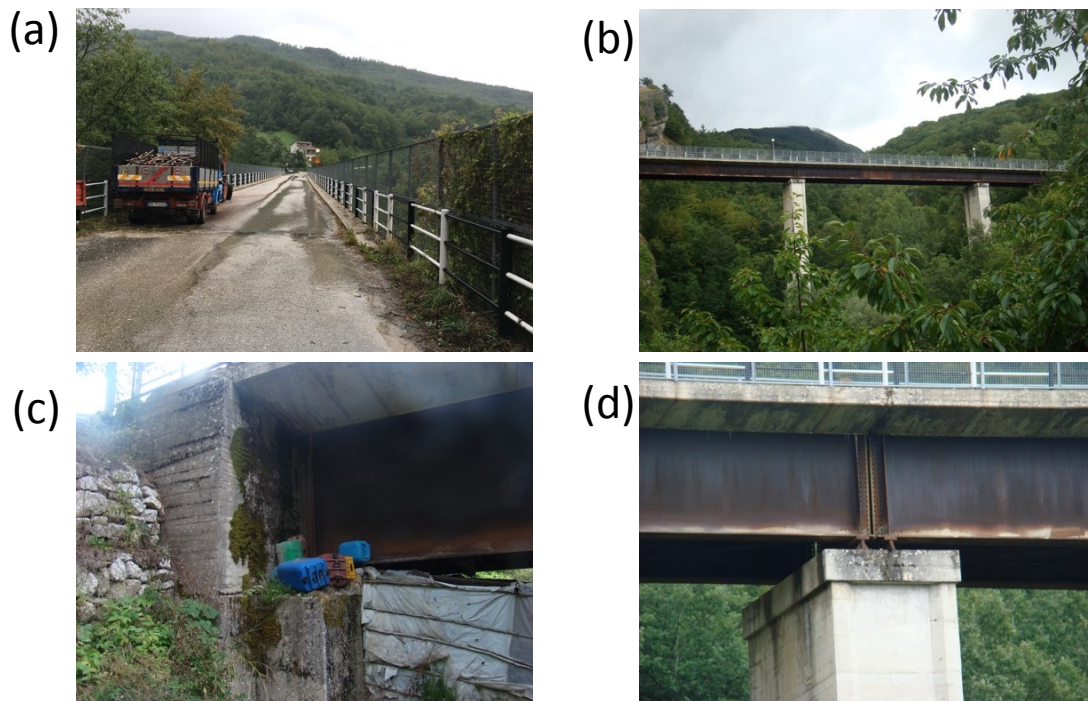
**Figure 6.2.** Ponte Ramazzotti - Composite steel and concrete bridge along the SP20 in Colle (42.7276 deg, 13.311 deg): overview of the bridge (a,b), abutment (c) and bridge support (d) details.

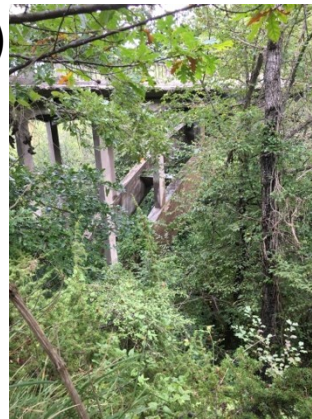
Figure 6.4. RC bridge along the SR577 Torrente Rionero (42.6172 deg, 13.3233 deg): overview of the bridge (a), rupture of the water pipeline on the bridge side (b) and view of the structure (c, d).

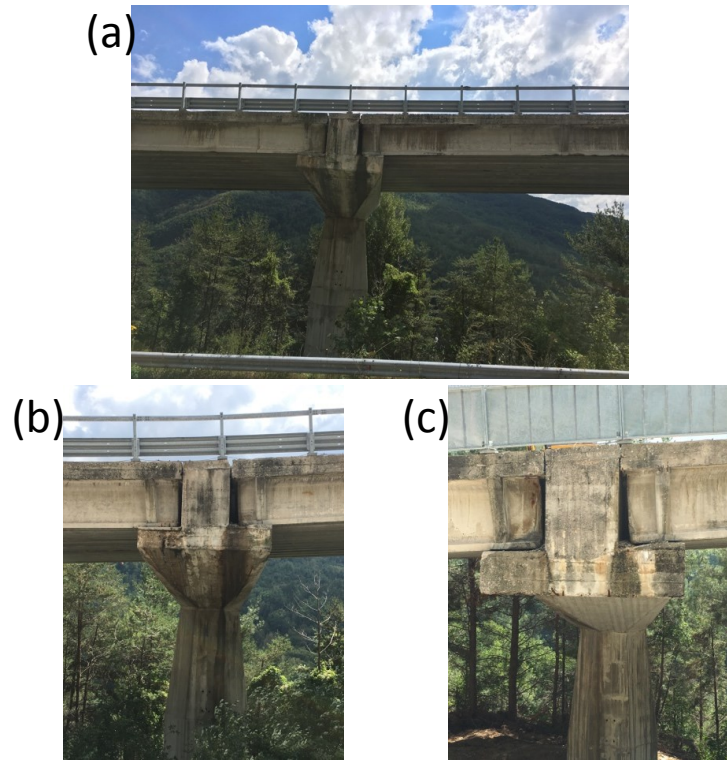
Figure 6.5. RC bridge along the SS685 Tre Valli Umbre (42.75625 deg, 13.277 deg): overview of the bridge (a), details of the hammering evidences (b and c).

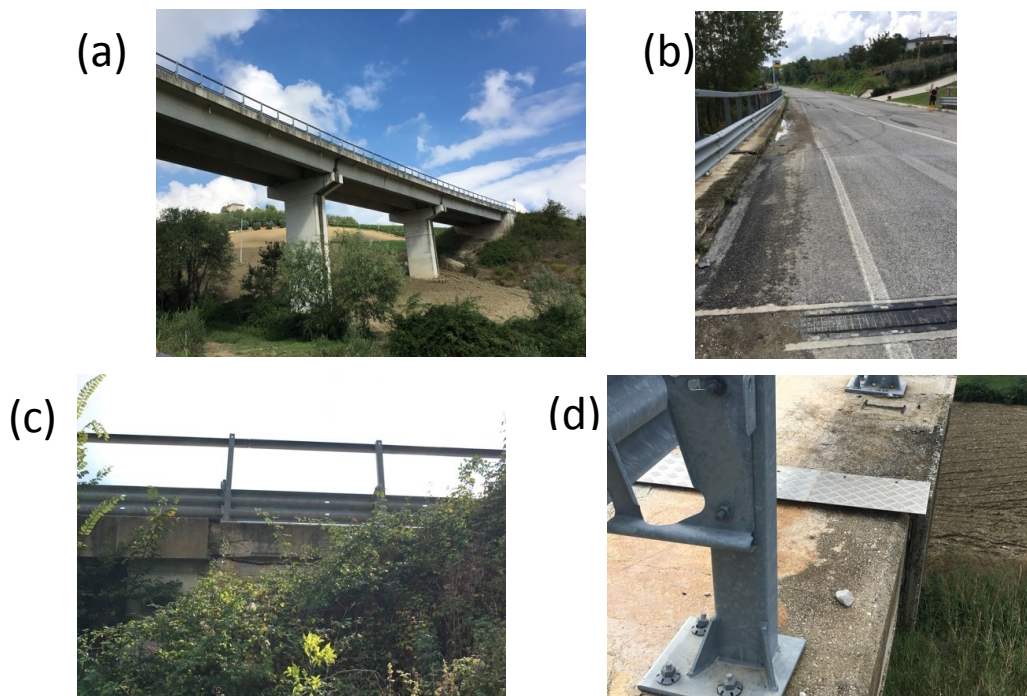
Figure 6.6. RC bridge along the SP173 in Offida (42.941687 deg, 13.702294 deg): overview of the bridge (a), settlement of the road (b) crack (c) and relative displacement of the abutment (d).

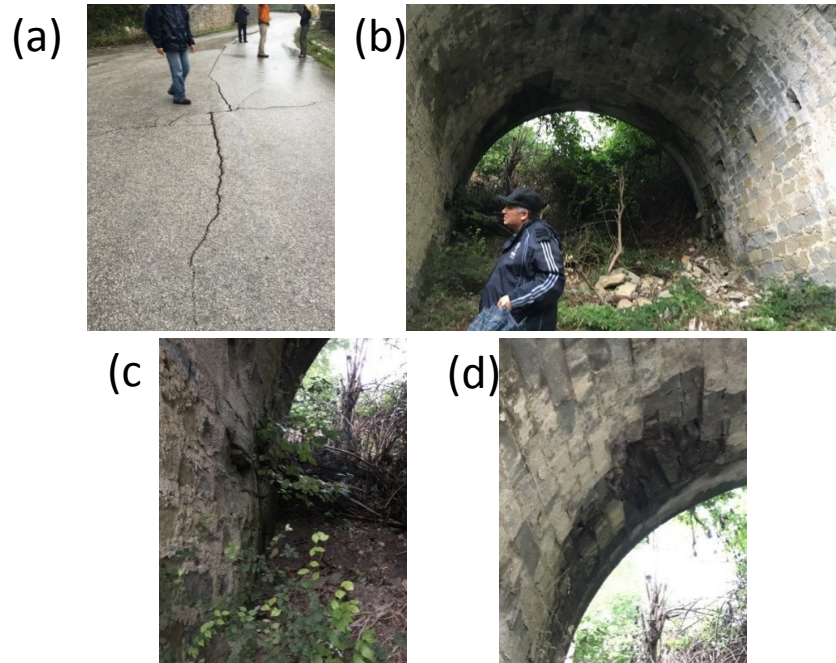
**Figure 6.7.** Masonry bridge along the Trisugo route (42.735981 deg, 13.254862 deg): damages on the road (a), overview of the bridge (b), abutment (c) and partial collapse of the interior part of the arch (d).

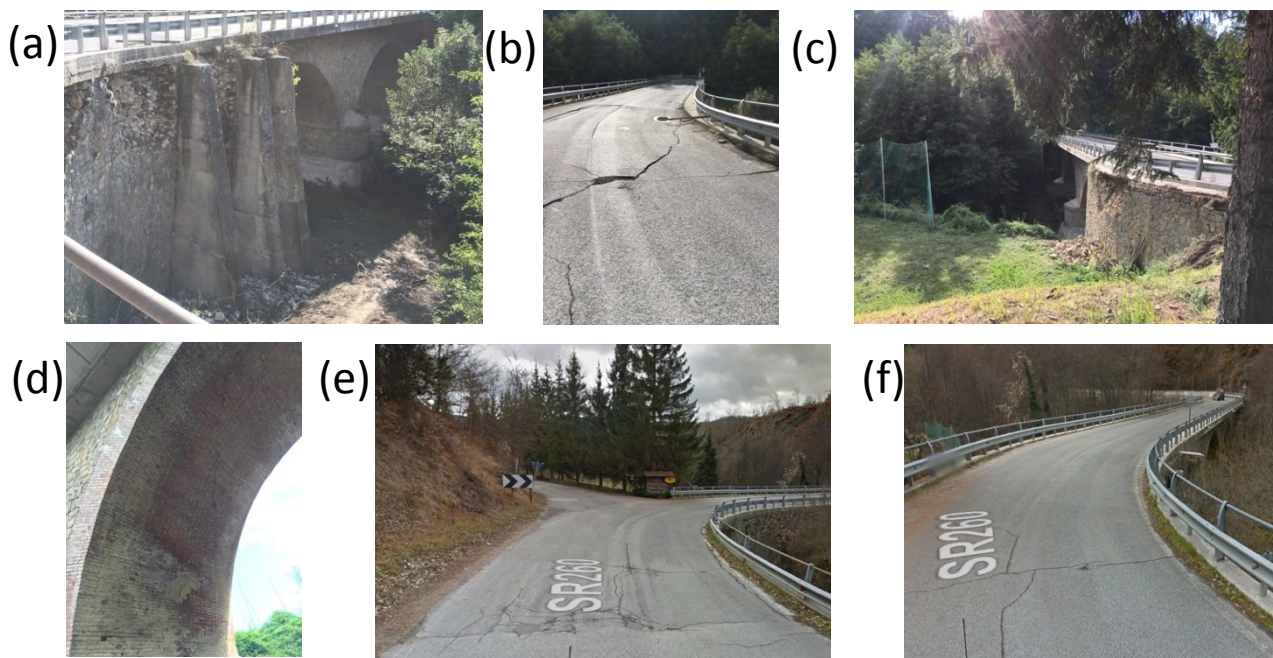
**Figure 6.9.** Ponte a Tre Occhi - Masonry bridge along the SR260 in Amatrice (42.620668 deg, 13.290176 deg): partial collapse of two side of the bridge (a, c), road settlement (b), cracks on the arch (d), pre-event cracks along the SR260 (e) and bridge-abutment connection (f) (source (e) and (f): Google maps).

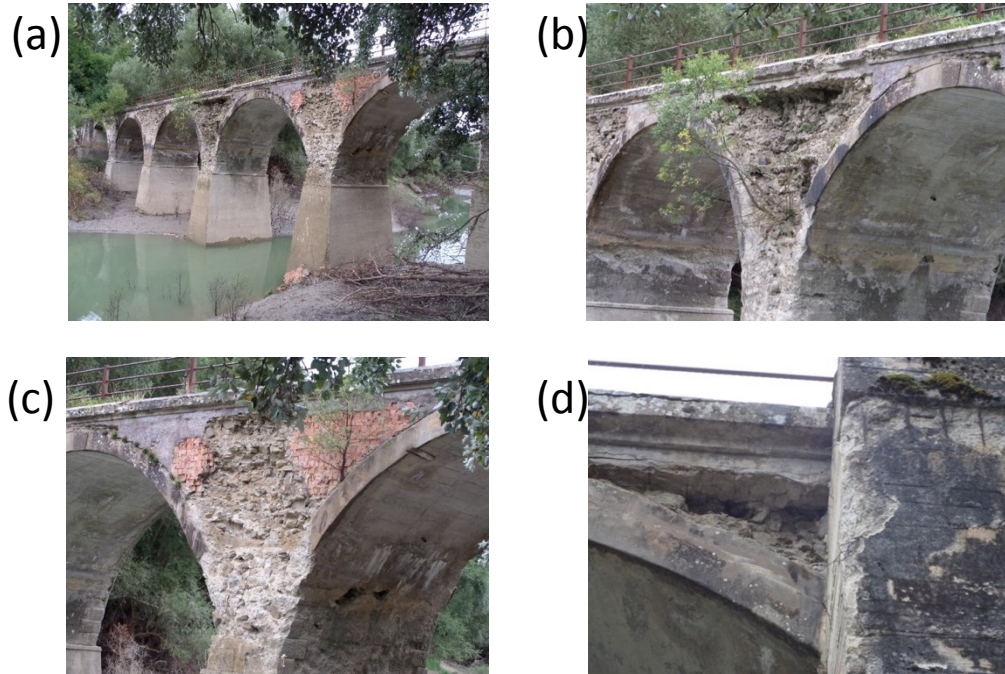
**Figure 6.10.** Ponte a Cinque Occhi - Masonry bridge (42.623178 deg, 13.250428 deg): (a) view of the 5 bridge arches, (b, c) partial collapse of the bridge masonry with evidence of previous structural interventions, (d) detail of the bridge-abutment connection.

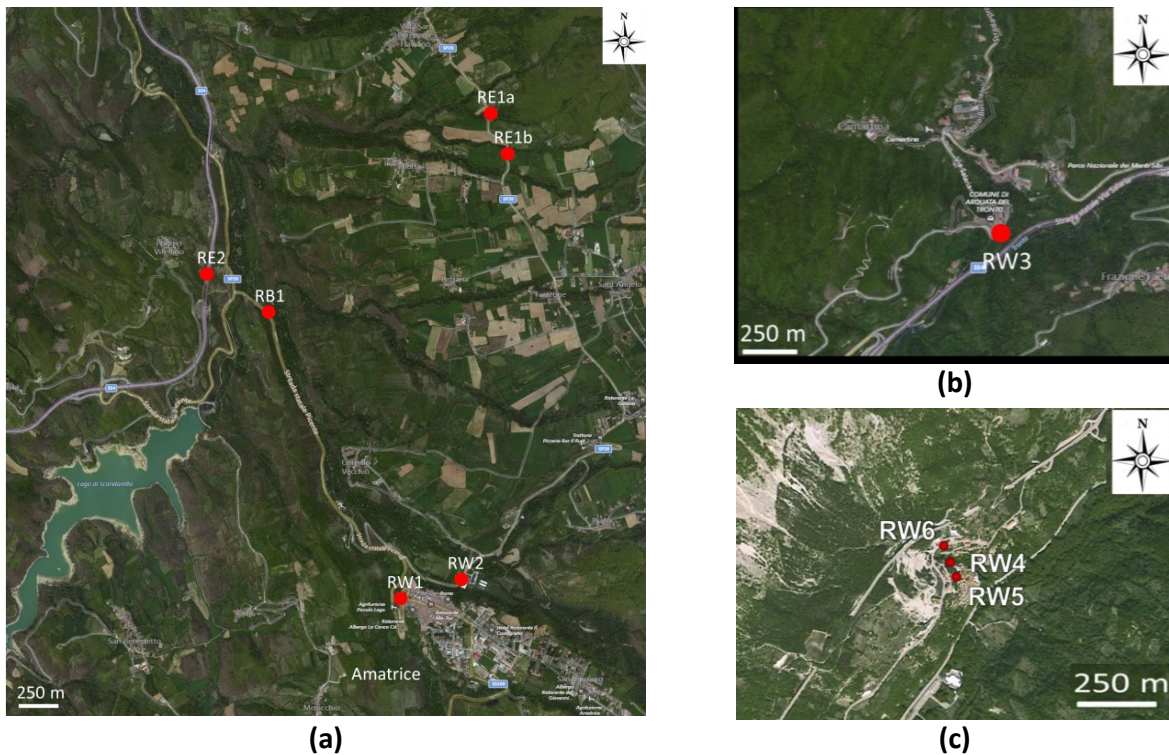
**Figure 7.1.** Locations of Retaining Walls (RW), Rockfall Barriers (RB) and Road Embankments (RE) observed in the municipalities of Amatrice (a), Arquata del Tronto (b) and Pescara del Tronto (c).

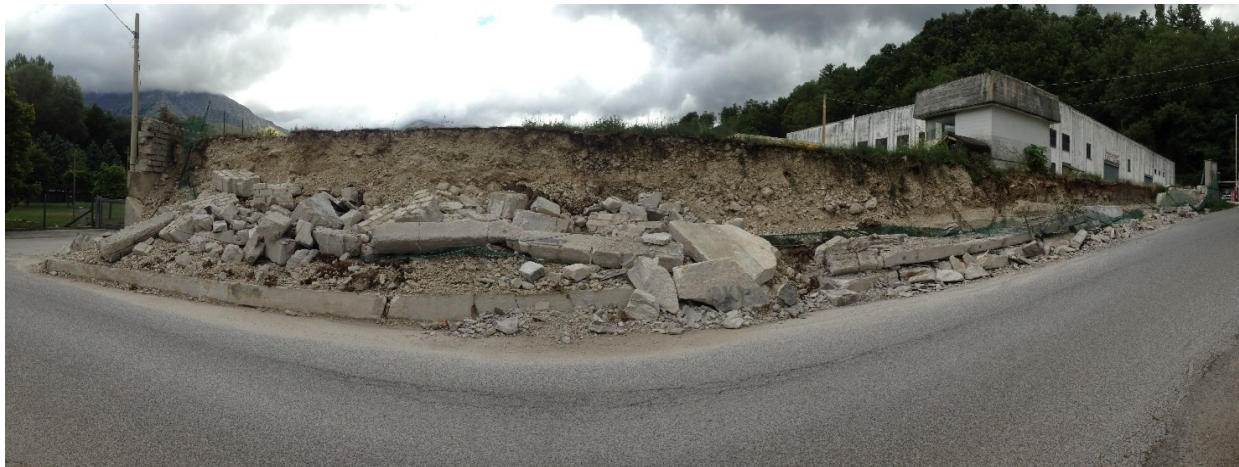
Figure 7.3a shows a collapsed retaining wall supporting a parking lot in the hamlet called “Ponte Sommati”, near Amatrice. The lower part of the wall was made of poorly reinforced concrete and the upper part was built with concrete blocks. The images in Figure 7.3b-c indicate the poor quality of the wall, including poor connections between the upper and lower parts.

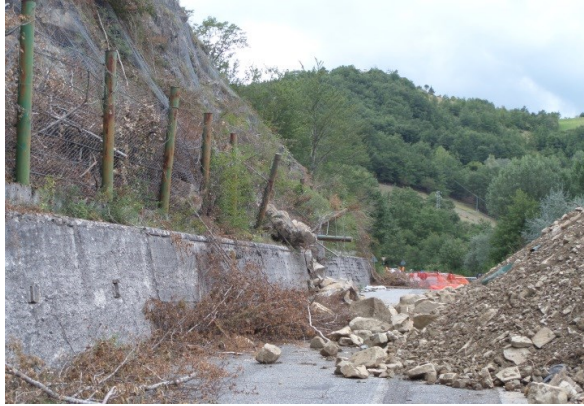
Figure 7.6a shows damage to a rockfall barrier along the SS260 road branch that connects Amatrice to the main road SS4 (Salaria). At the time of the reconnaissance, a protection embankment was placed at the toe of the slope (Figure 7.6b). The slope behind the barrier is covered with a hexagonal mesh, which along the failed slope is simply draped with no evidence of reinforcement (Figure 7.6c), while along the stable slope it appears connected to the arenaceous flysch formation by ropes and nails (Figure 7.6d).

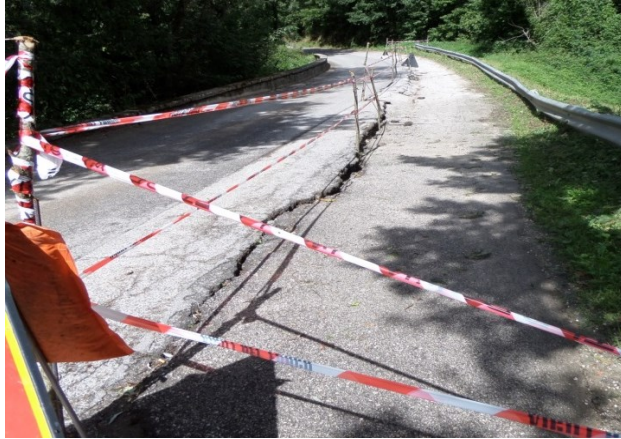
We observed longitudinal cracks (Figure 7.8a-b) at km 133 of main road SS4 (Salaria). Maximum crack widths in the asphalt surface are around 3 cm (Figure 7.8c) and cracking was also observed at the edge of the road pavement (Figure 7.8d). Adjacent to this section of road is a nearly vertical cut. Nearby areas with gentler slopes had no pavement cracking.

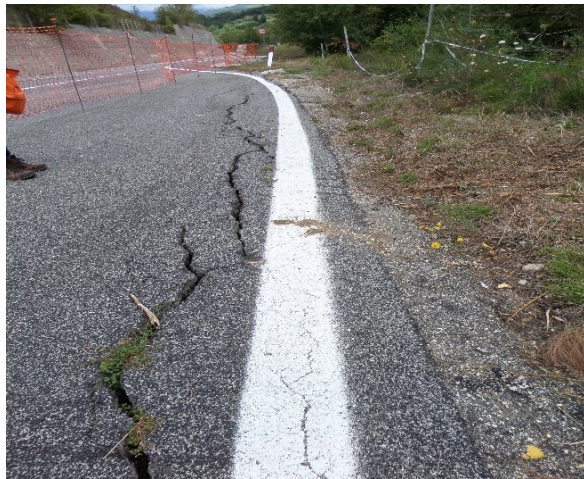
**Figure 7.7.** Embankment instability along the SP20 road between the villages of San Lorenzo e Flaviano and Sommati (42.660061N, 13.293697E): (a) longitudinal crack along the road surface after the earthquake;(b) downstream view of the crossing section; (c) view of the Armco tube underneath the embankment; (d) maximum vertical settlement at the bridge-embankment connection; (e) longitudinal crack at the border of the pavement surface; (f) previous conditions of the road branch before the earthquake (Google image dated July 2011).

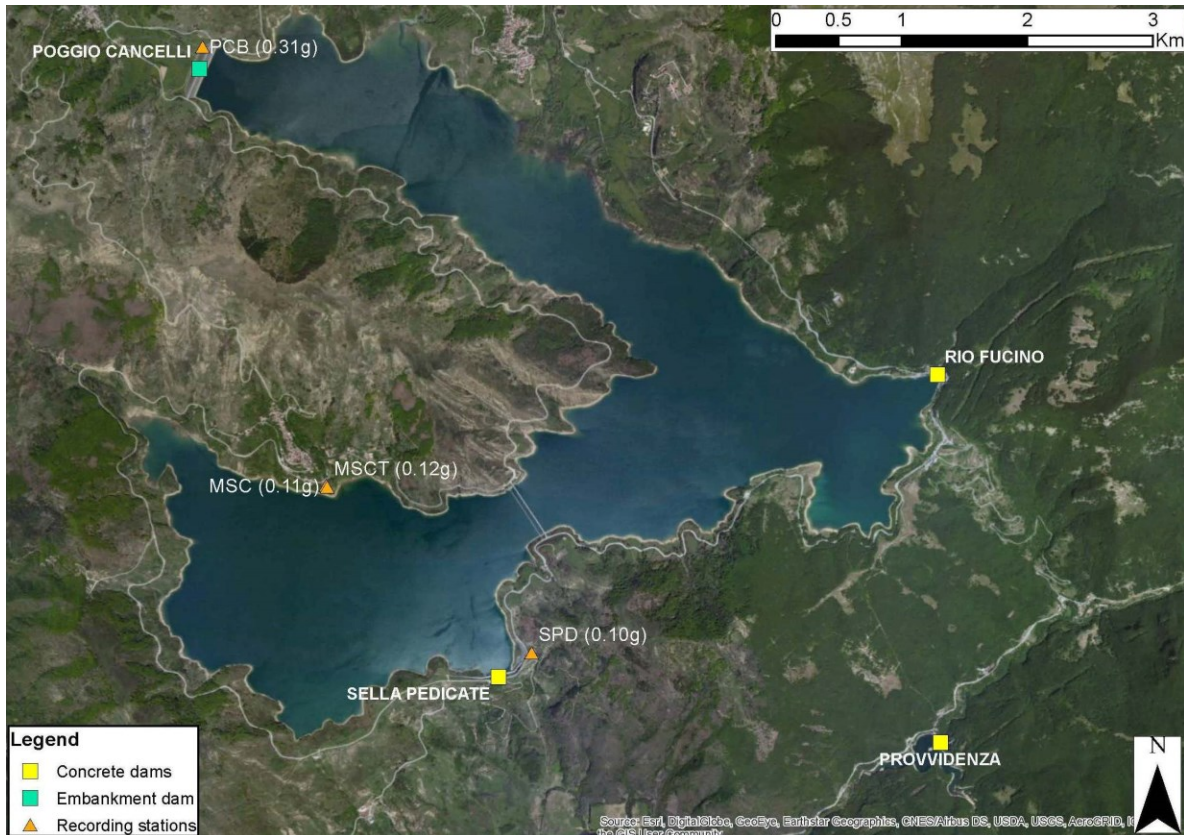
**Figure 7.10.** Map showing the Campotosto reservoir, dams located in the region (squares), and seismic stations (triangles) with the recorded values of peak ground acceleration in brackets.

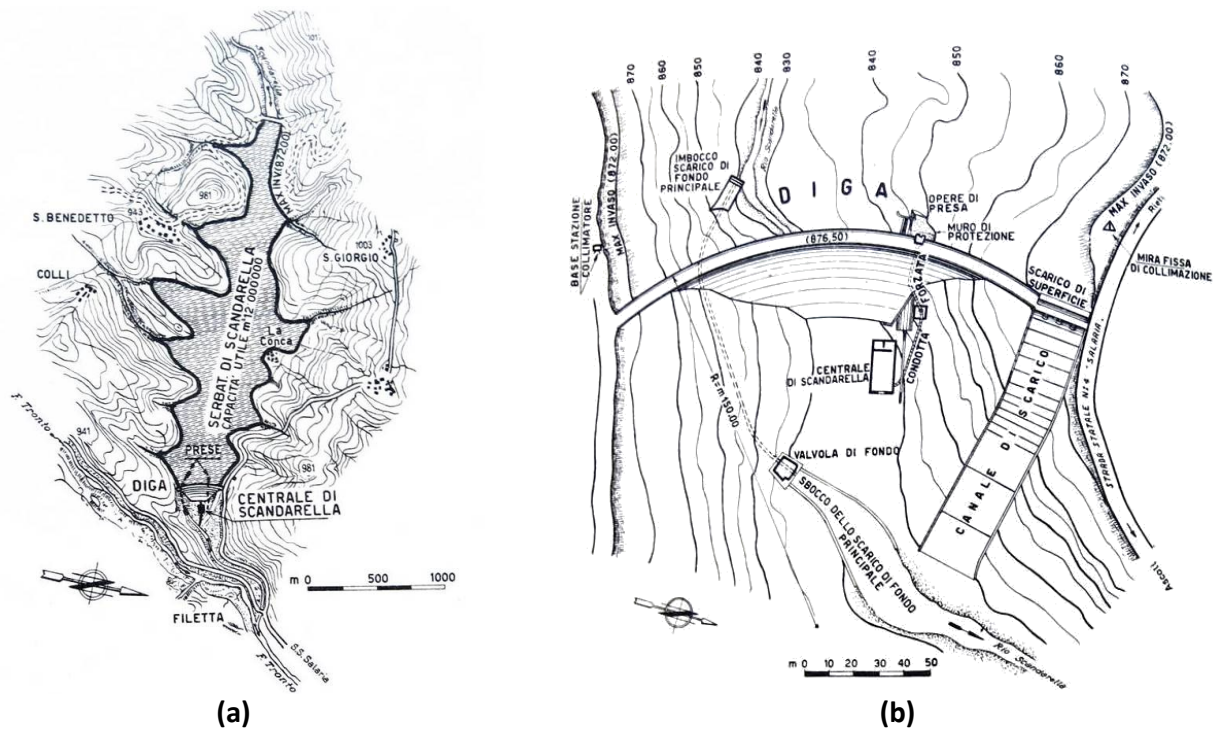
**Figure 7.11.** Plan view of the reservoir (a) and of the dam of Scandarello (b), located in the Municipality of Amatrice (after ANIDEL, 1951).

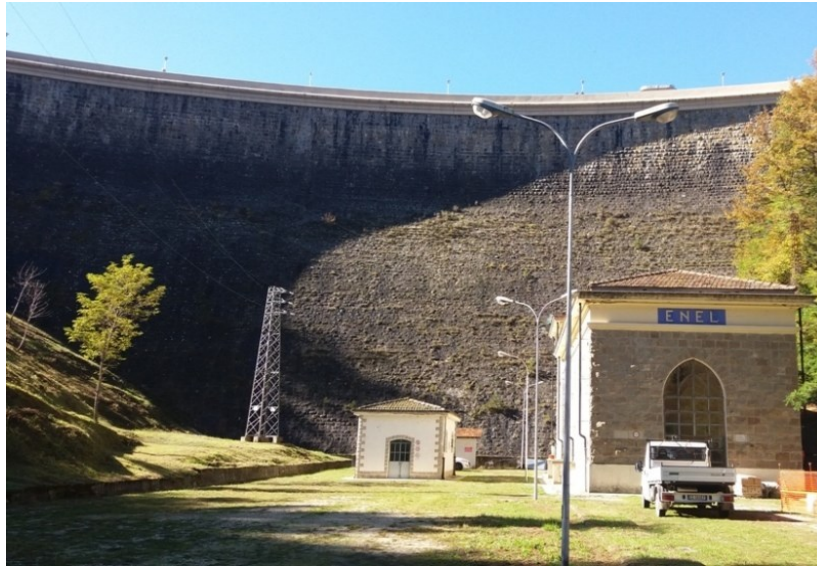
Figure 7.12. Downstream face of Scandarello dam, with the homonymous station for hydroelectric power generation located at the foot of the dam (October 19, 2016).

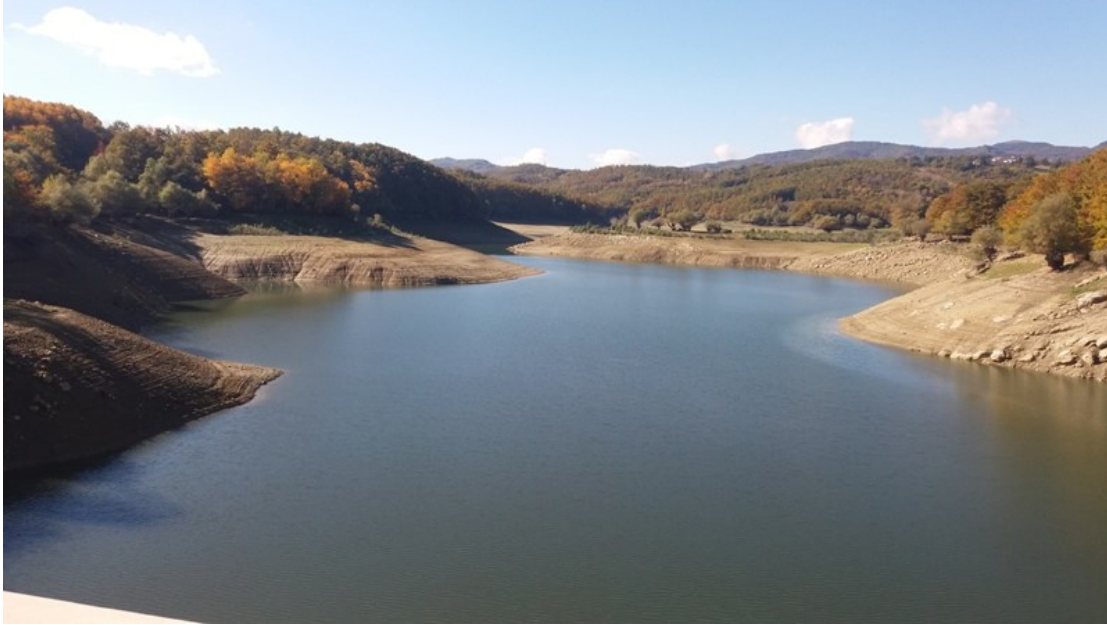
**Figure 7.14.** View of the reservoir from Scandarello dam viewpoint (October 19, 2016): no phenomena of bank instability were observed after the earthquake.

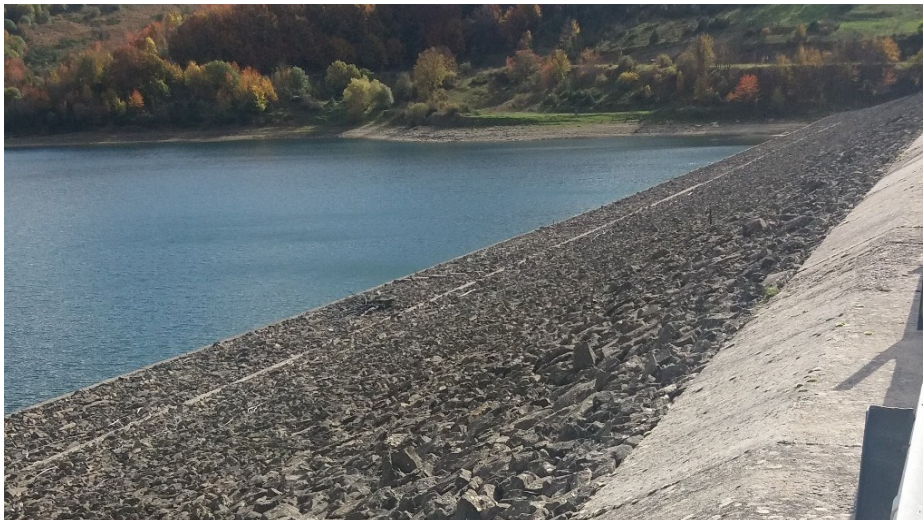
**Figure 7.15.** Poggio Cancelli embankment dam on the Campotosto reservoir (L'Aquila): photo of the upstream face taken on October 19, 2016 (42.557106°N, 13.338342°E).
