Engineering Reconnaissance of the 24 August 2016 Central Italy Earthquake. Version 2

*Original*

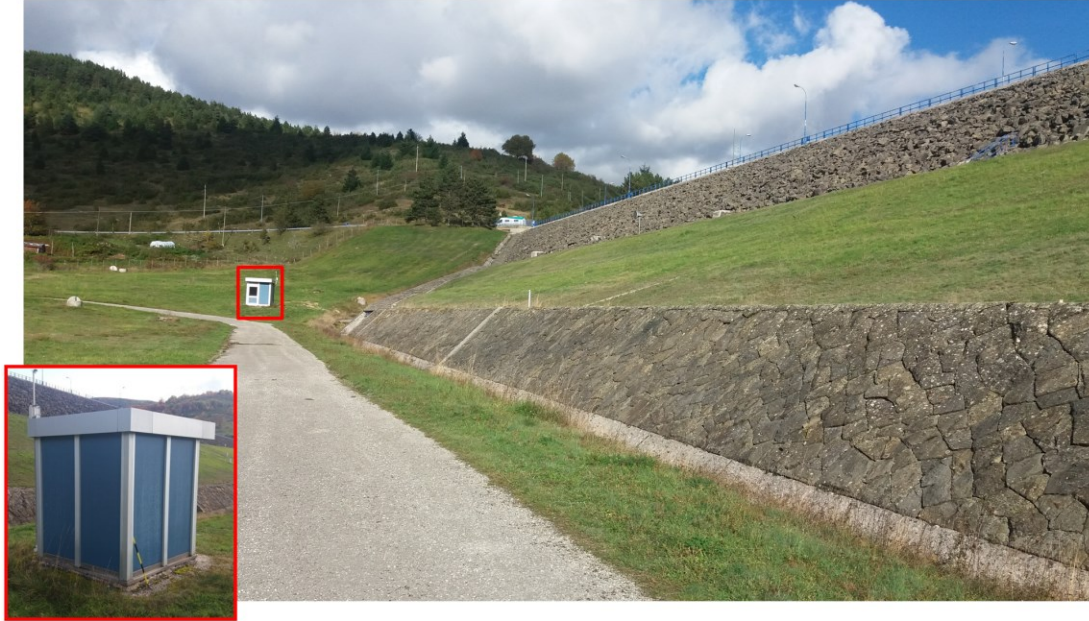
**Figure 7.17.** Downstream face of the Poggio Cancelli dam (October 19, 2016) with a close-up view of the light blue box hosting the PCB station (42.558022°N, 13.337990°E), which, during the August 24 earthquake, recorded a peak ground acceleration of about 0.31 g.

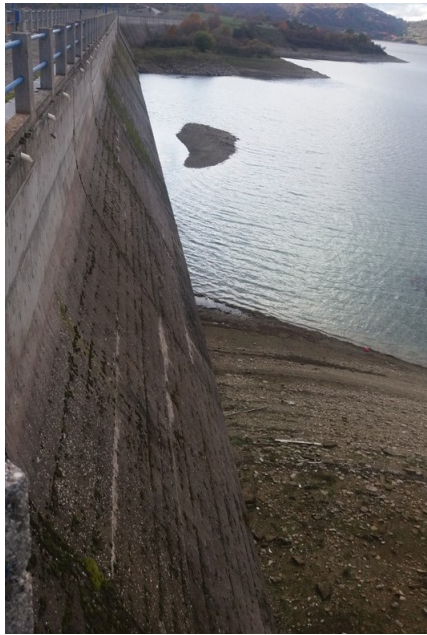
The inspections carried out by ENEL staff after the August 24, 2016 earthquake revealed that no damage to Rio Fucino dam was observed.

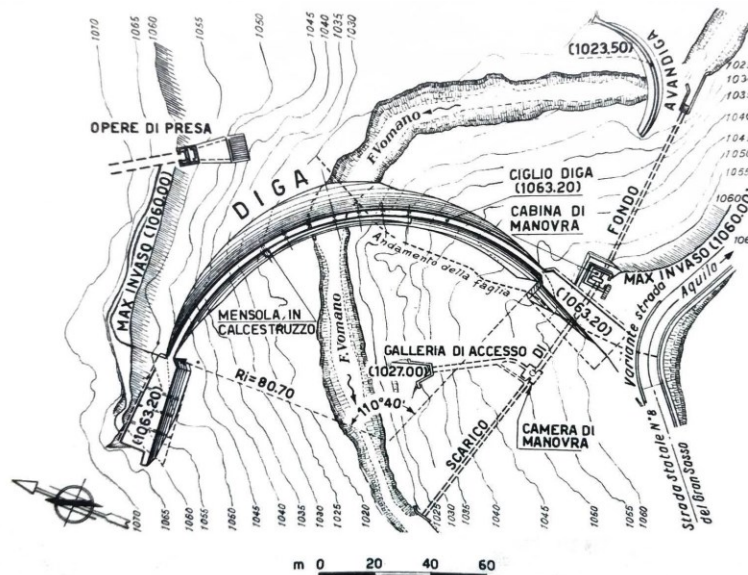
Figure 7.21. Plan view of the Provvidenza dam (from ANIDEL, 1952).

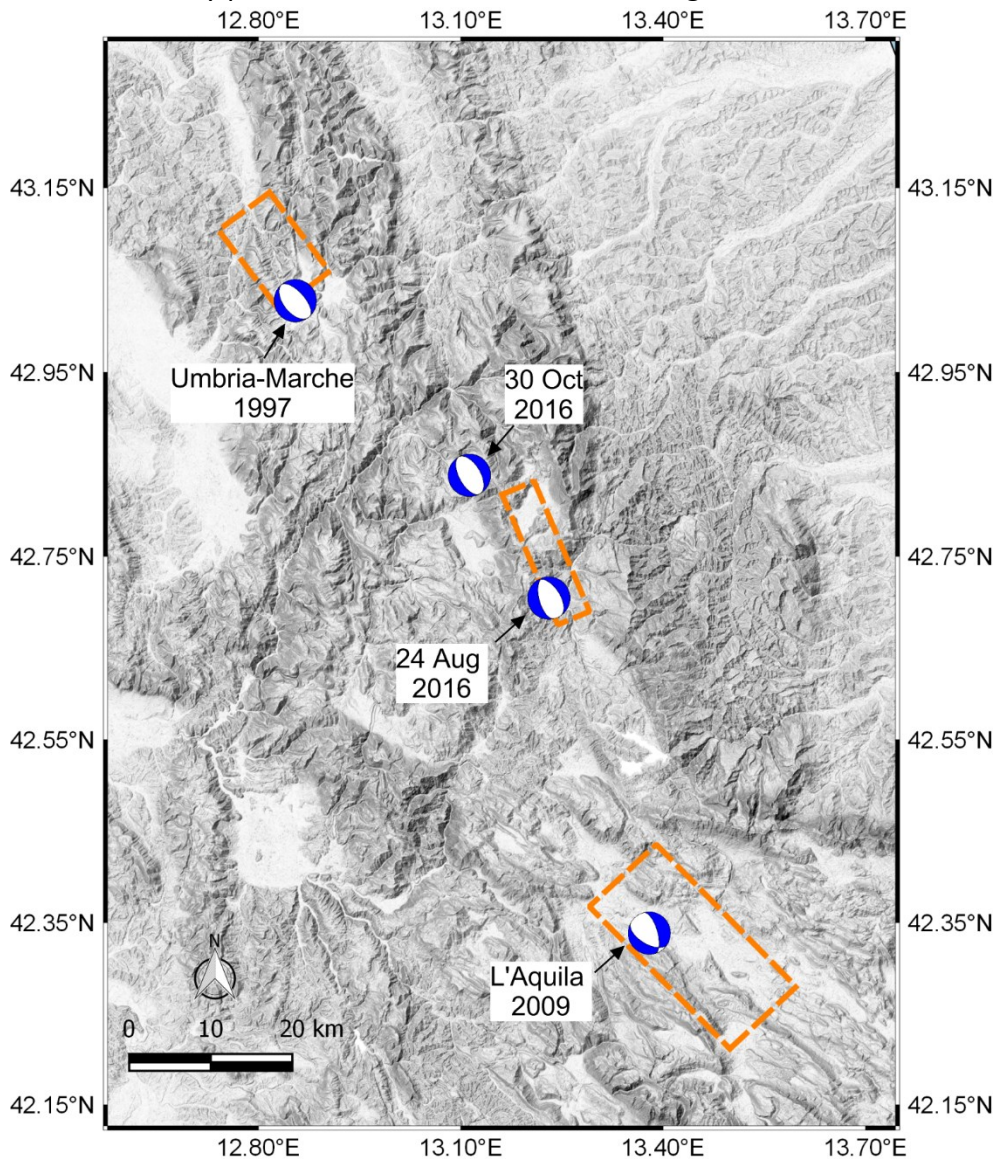
**Figure 8.1.** Map of central Italy showing moment tensors of major earthquakes since 1997 and the intermediate gap areas. Finite fault models from Chiaraluce et al. (2004; 1997 Umbria-Marche event), Piatanesi and Cirella (2009; 2009 L'Aquila event), and Tinti et al. (2016, 24 August mainshock). Moment tensor for 30 October 2016 earthquake is also shown.
