Detachment analysis of dehumidified repair mortars applied to historical masonry walls

# DETACHMENT ANALYSIS OF DEHUMIDIFIED REPAIR MORTARS APPLIED TO HISTORICAL MASONRY WALLS

An innovative laboratory procedure for the pre-qualification of repair mortars is described. The tested mortars are suitable for use with new dehumidified plasters applied to historical masonry walls. Long-term plaster detachment frequently occurs because of the mechanical incompatibility of mortar. The procedure consists of the application of static loads to mixed stone block-mortar specimens with particular characteristics, in terms of geometry and adhesion at the interface. A numerical simulation based on the cohesive crack model was used to follow the experimental data, in order to describe the evolutionary phenomenon of detachment as a function of a small number of parameters. The methodology is currently being used at Sacro Monte di Varallo Special Natural Reserve (UNESCO heritage site) in Piedmont (Italy).

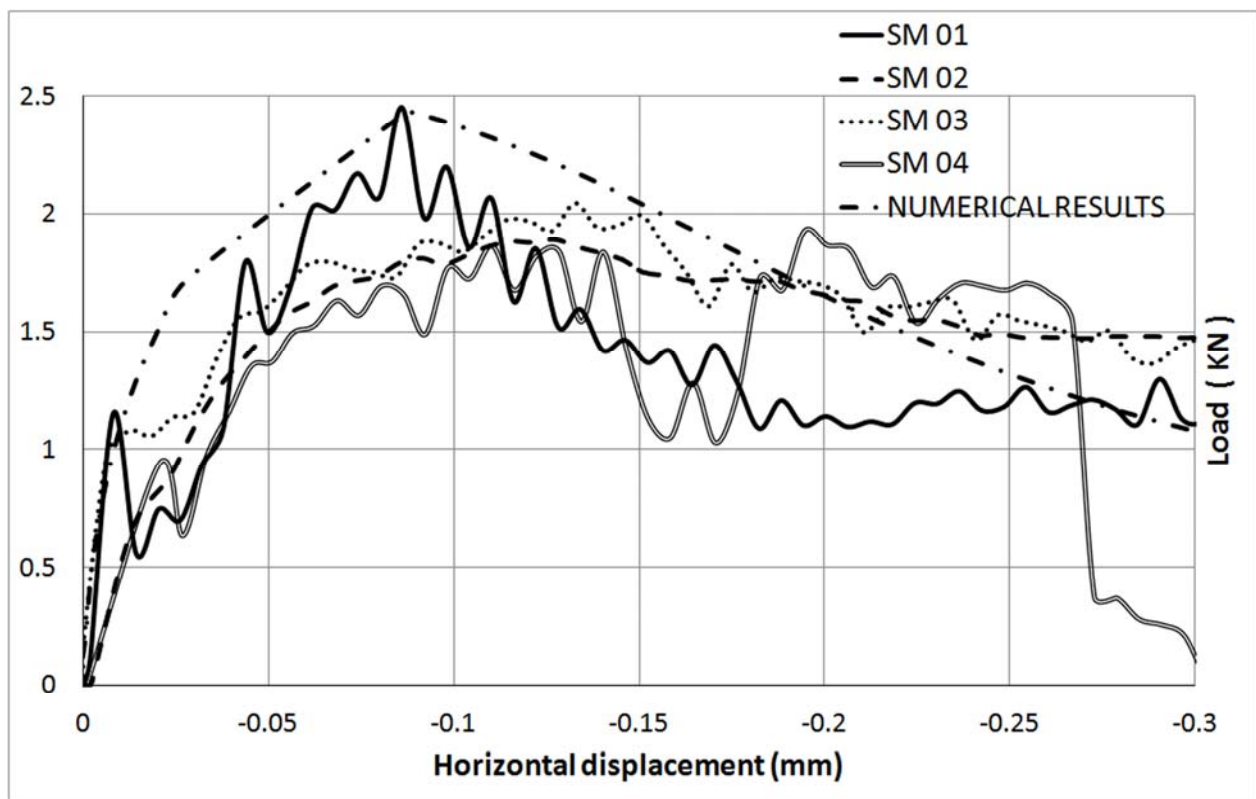
As far as the horizontal displacement is smaller than 0.2 mm, Figure 10 shows a good agreement between numerical and experimental results.

**Figure 10.** Comparison between numerical and experimental results.
