The Dynamic Behavior of the Basilica of San Francesco in Assisi Using Simplified Analytical Models

V. Arcidiacono, G.P. Cimellaro, E. Piermarini & J. Ochsendorf

KEYWORDS: Basilica of San Francesco in Assisi, Historic Masonry Structures, Monumental Structures, Seismic Vulnerability, Seismic Retrofitting

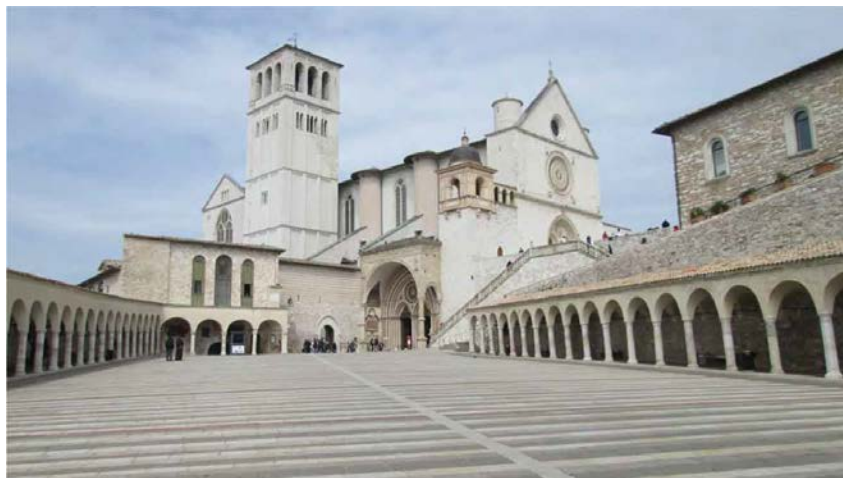
Figure 1- Basilica of San Francesco in Assisi.

The construction of the Monastery began two years after St. Francis of Assisi's death in 1226 and was completed in 1253 (Destinations, 2009). The Basilica (Figure 1) consists of two churches placed one on top of the other. The Lower Basilica was completed in 1230 and includes San Francesco's remains, while the Upper Basilica was completed in 1253 and consecrated by Pope Innocent IV. Both parts of the Basilica have similar architectural features: a one-aisle nave with four bays (Gothic vaults), a transept, and an apse. The interiors of both Basilicas are immediately striking due to the marvelous frescoes that were painted shortly after the completion of the Basilica. The paintings of the Upper Basilica began in the nave with a master Florentine painter Cenni di Pepi, known as Cimabue, in 1275. Cimabue was responsible for painting the apse, the walls and the vaults of the transept with important characters from the New Testament. The nave of the Basilica is decorated around the lower perimeter with frescoes depicting the life of San Francesco as well as stories of the life of Christ on the southern wall and other stories from the bible on the northern wall. The paintings of the nave are attributed to a variety of Roman master painters and another master Florentine painter Giotto di Bondone (Bonsanti et al., 1998).

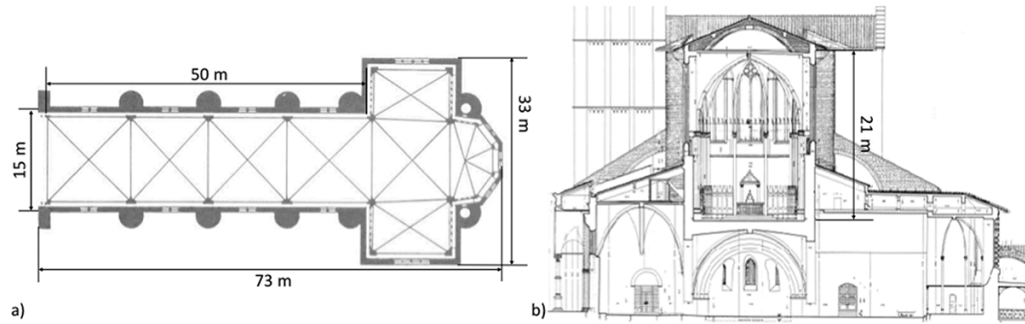
Figure 2- Dimensions of the Basilica of San Francesco in Assisi (Rocchi, 1982).

The dimensions of the Upper Basilica are about 73 m in the longitudinal direction, 33 m in the transverse direction, and approximately 21 m in height from the floor of the Upper Basilica to the roof (Figure 2). The nave is 50 m long and 15 m wide. The thicknesses of the masonry walls vary between 0.8 m to 3.2 m, near the cylindrical buttresses which in the XIV century were strengthened with arched flying buttresses (Bonsanti et al., 1998; Castex, 2008).

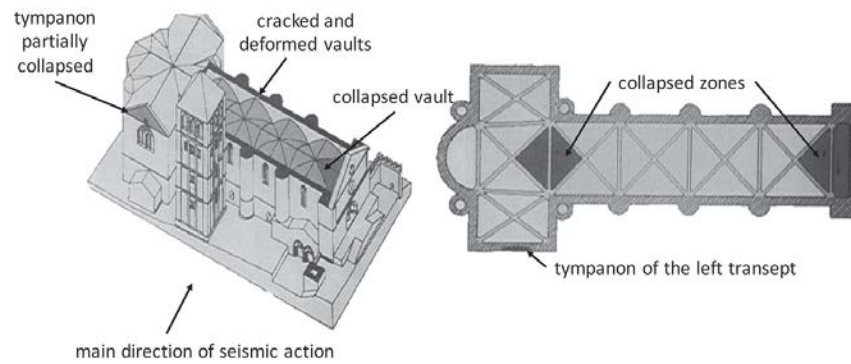
Figure 3- Damage incurred during 1997 earthquake (Croci, 2001).

The damaged areas of the Basilica are highlighted in Figure 3. The largest loss incurred due to the earthquake was the destruction of the precious frescoes that were painted on the portions of the vaults that collapsed, which included famous works by Cimabue and Giotto. Such works include Cimabue's fresco of San Matteo and Judea above the central nave and Giotto's vault of the Dottori della Chiesa near the facade, as seen in Figure 5. Immediate actions were taken after the earthquake to stabilize the surviving vaults and tympanum against other aftershocks. The ensuing restoration project involved preservation of the historic paintings as well as restoring structural integrity to the vaults and tympanum. Historians and preservationists sifted through the rubble in the nave looking for any surviving pieces of the vault rib or chips of fresco paint in order to rebuild the vaults with as much original material as possible. The restored works of San Matteo and Judea and Dottori della Chiesa can be seen in Figure 5.

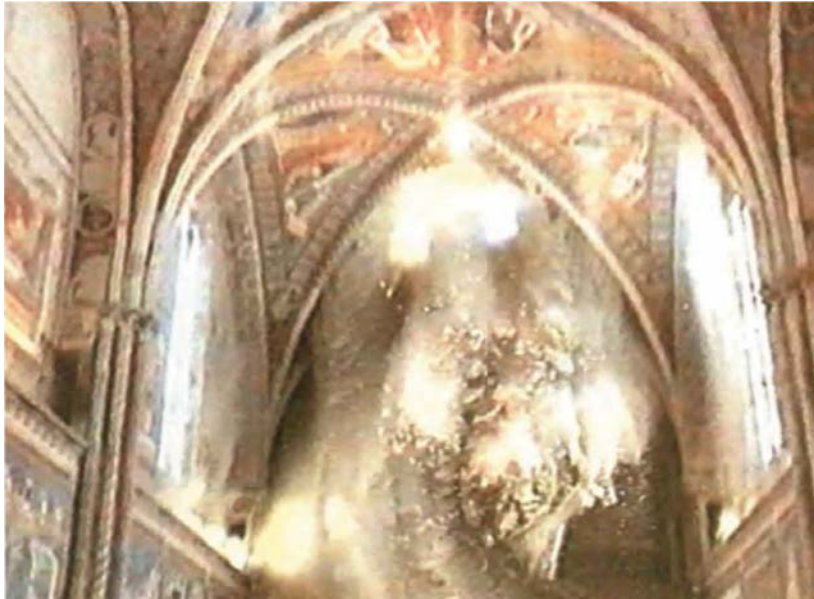
Figure 4- Collapse of the vault of the Doctors of the Church (Bonsanti, 1998).

The next morning at about 11:42 AM, a second tremor of magnitude 5.8 hit the Basilica. This time, Roli was just outside the doors of the Basilica and a camera crew from Umbria TV was at the front of the nave videotaping. Roli reports that “the jambs of the Basilica's doors rose, then fell while \lurching first forward then back...”. As seen in Figure 4, Umbria TV cameramen were

able to capture the collapse of the easternmost quadrant of the Gothic vault adjacent to the facade, which fell on individuals fleeing for the door and resulted in 4 deaths (Bonsanti, 1998). In addition to the vaults collapsing near the facade, those adjacent to the triumphal arch also collapsed.

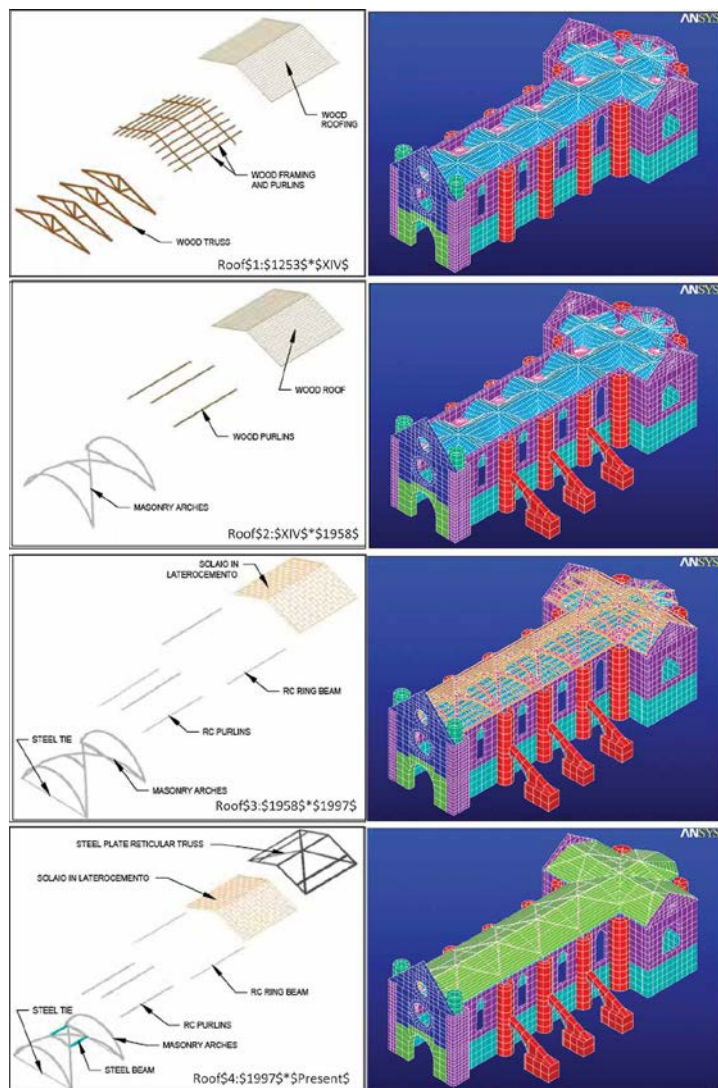
Figure 6- Schemes of the nave roof.

roofs of the Basilica of San Francesco compiled in one source is not available. Thus, it is necessary to first summarize each of the different roofs the Basilica has had. Figure 6 shows the roof interventions (Crocì, 2001; Crocì et al., 2007; Rocchi, 2002).

The structure of the roof has changed three times since its completion in 1253, with the most recent intervention being after the 1997 earthquake. It is known that solely wood materials made the original roof of the Basilica; however, a scheme of the original roof design does not exist. For unknown reasons, the original roof was replaced in the 1475 by a new system of wood purlins and sheathing supported by large masonry arches above the vaults. This system remained in place for over 400 years until the 1958, when it was decided by the Genio Civile di Perugia to replace the wooden parts of the roof to protect against fire hazards (Rocchi, 2002). Thus, the wood purlins were replaced with new ones made of reinforced concrete and the wood sheathing was replaced with a concrete and masonry flooring system. This new roof was placed on top of a reinforced concrete ring beam that was installed along the perimeter of the nave and transept. Furthermore, during the 1958 intervention the builders also added ties between the masonry arches that run perpendicular to the nave above the ceiling to compensate for the added thrust loads, as seen in Figure 7. The ties were not applied at the nave opening of the transept and at the façade (Figure 8), which are the two locations where the vaults collapse during 1997 earthquake. The final modification to the roof occurred during the restoration of the Basilica after 1997 earthquake. In the last intervention, the original ties between the masonry arches, since they were making contact with the top of the vaults, were raised of about 0.6 m (Rocchi, 2002). The tympanum was rebuilt using the original stones that had fallen during the 1997 earthquake and grouted with a new mortar. The connection between the tympanum and the roof was modified

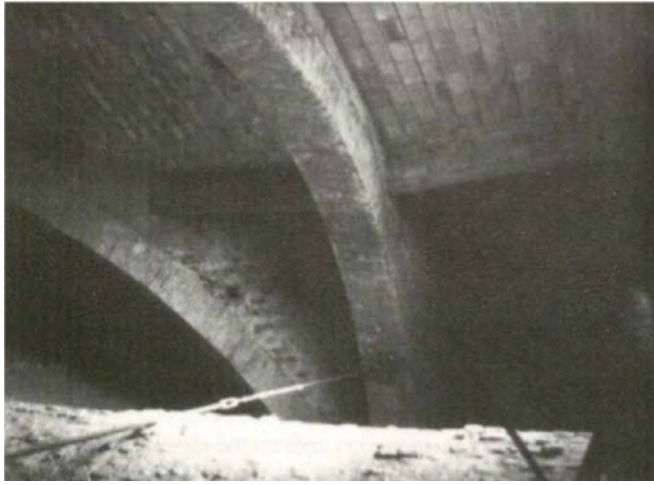
Figure 7- Tie installed during the 1958 (Rocchi, 2002).

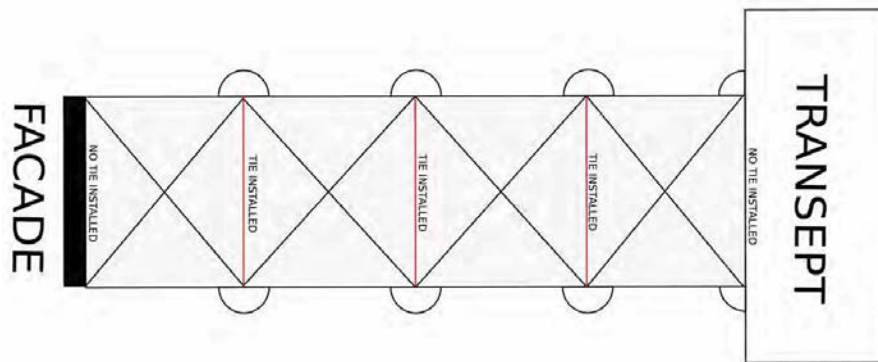
Figure 8- Location of the installed tie.

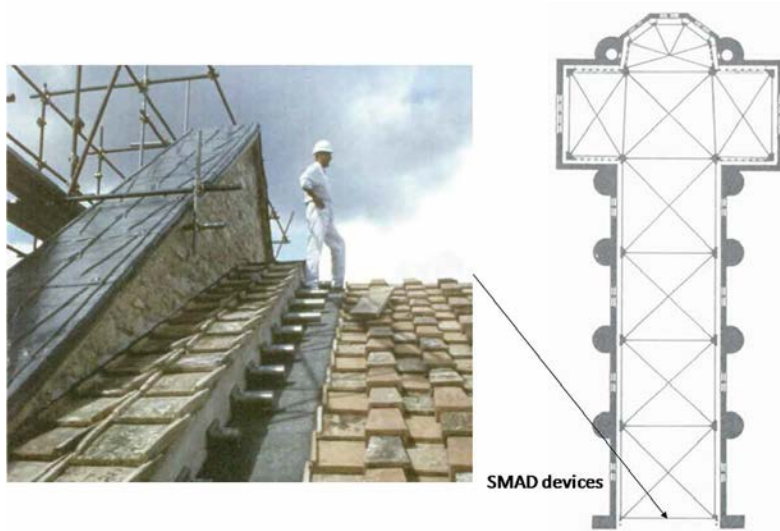
Figure 9- Installation of SMADs at the Tympanum-roof interface (Crocì et al., 2007).

from a rigid connection by inserting shape memory alloy devices (SMAD) to reduce the out of plane seismic loadings on the tympanum (Figure 9). The Gothic vaults were strengthened putting aramid fibers to the extrados of the ribs of the vaults using an epoxy. These ribs were then connected to the reinforced concrete roof purlins via a system of tie rods, springs, and steel beams as shown in Figure 10. These were connected to steel beams installed between diagonal arches. Finally, the vaults themselves, which had been severely cracked during the earthquake, were strengthened using a special type of mortar. The masonry walls were strengthened with a steel truss that runs around the perimeter of the nave and transept (Figure 11) at about 7 m above the floor, i.e. where the flying arch buttresses intersect the cylindrical buttresses.

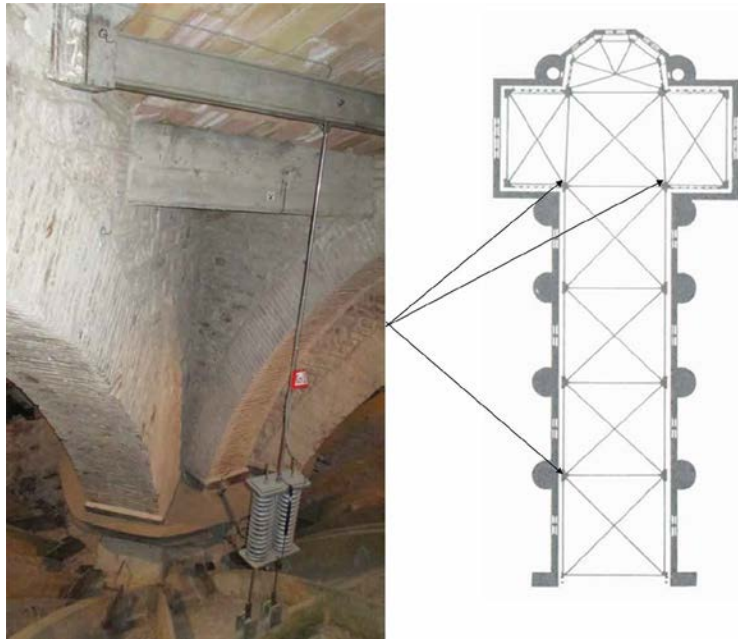
Figure 10- Steel beam and spring/damper system installed throughout the entire roof.

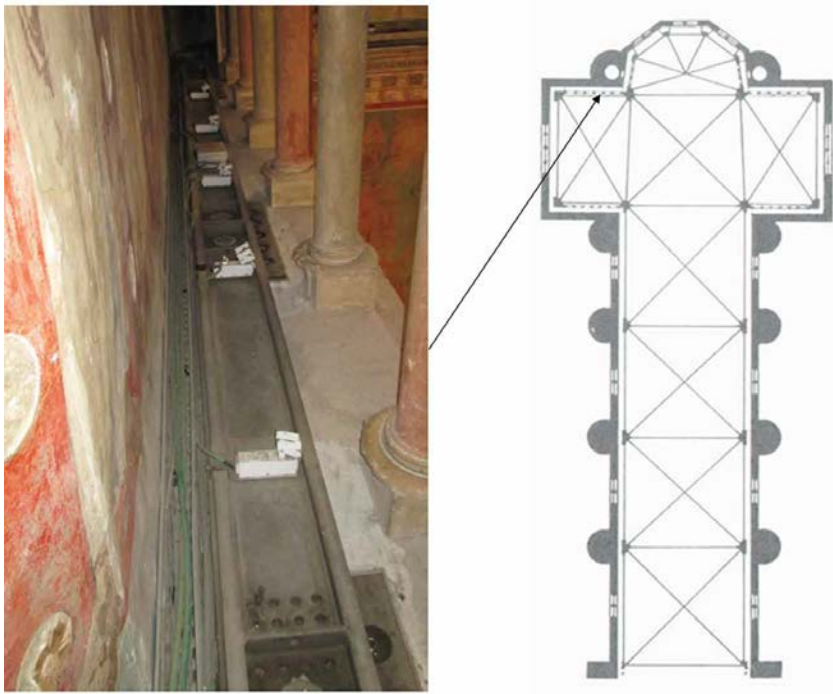
Figure 11- Ring beam installed along the cornice.

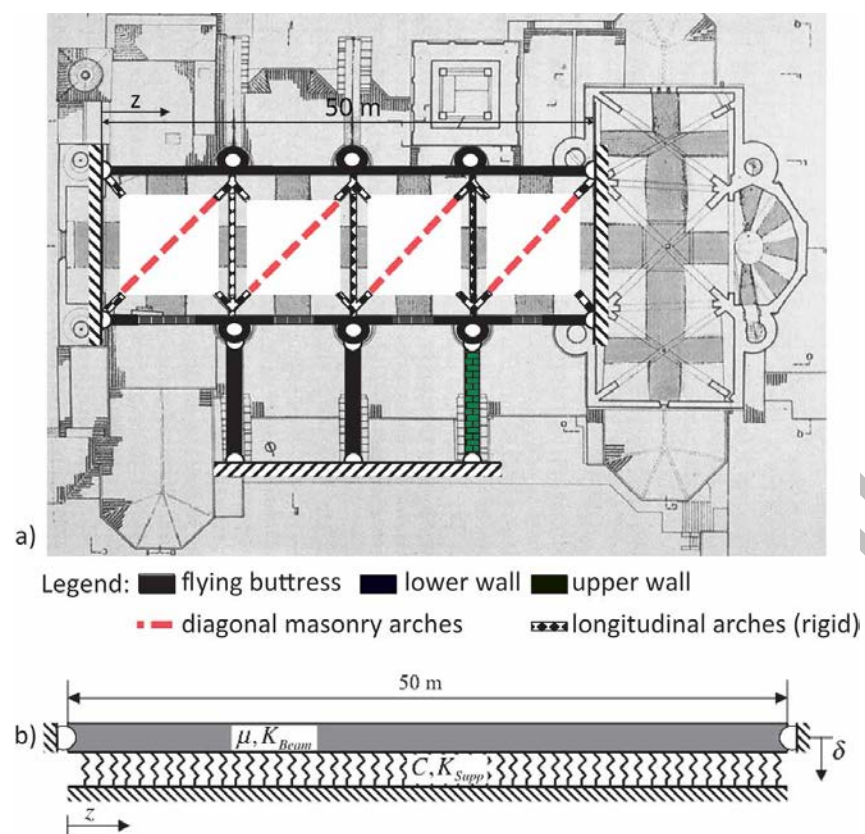
Figure 12- Schematic view of: a) elements involved in the analytical model, and b) the analytical model.

This model assumes that the façade and the transept are infinitely rigid in their planes. Hence, they are considered as rigid supports of the beam in the horizontal direction. The nave's windows are modeled assuming two section types of the nave's walls (1: bottom and 2: top). The stiffness

of the nave roof, the nave walls, and the cylindrical buttresses are consistent and symmetrical. The stiffnesses of the flying buttresses in the horizontal direction are not symmetrical because they react only in compression. With this assumption, it is possible to model each roof as shear beam with constant stiffness K_{Beam} and to assume that each adjacent section of nave wall, cylindrical buttress, and flying buttress will provide together the stiffness K_{Supp} . The participant mass μ is uniformly distributed on the beam length L . The natural frequencies and the effective modal masses of the *analytical model* can be expressed in a closed-form solution given by:

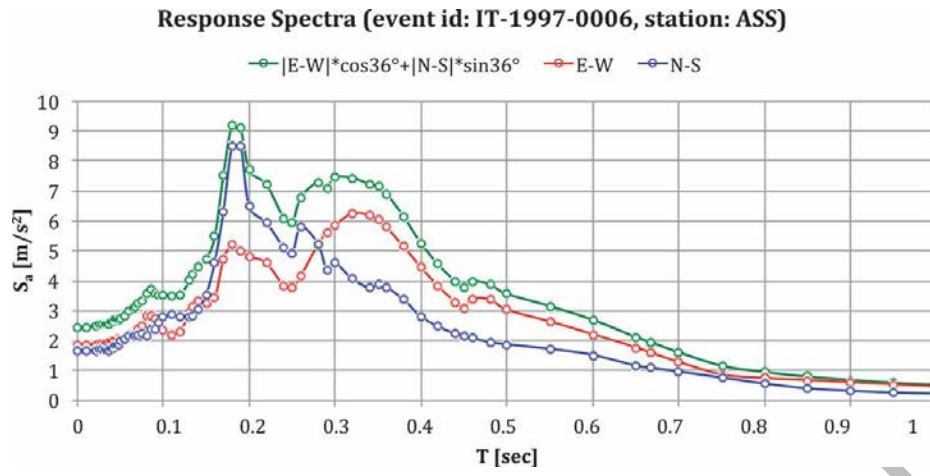
Figure 14-Response spectra of the 1997 Umbria-Marche earthquake.

The 1997 Umbria Marche 2nd shock seismic record related to the R.A.N. (Rete Accelerometrica Nazionale) station “ASS” has been used in the response spectrum analyses. Horizontal response spectra in the North-South and East-West directions and the worst-case combination, which considers the inclination (36°) of the Basilica with respect to the North-South direction, are shown in Figure 14. Response spectrum analyses were performed using the first 19 modes and applying the worst-case response spectrum. The analyses (Figure 15) predict that the maximum absolute displacement of the nave is at the middle point of the beam. This is 0.4 and 0.6 lower, respectively with *roof 3* and *roof 4*, with respect to that predicted with *roof 1* or *roof 2*. The shear envelope of the beam and the horizontal seismic loads applied on the nave section defined in Equation 7 are shown in Figure 16 and Figure 17. The analyses indicate that the maximum nave load is located at the middle point of the beam, while the maximum shear is located at the rigid supports (i.e., transept and façade). In Table 4 are listed the normalized results of the worst-case response spectrum analyses. The increase in the element stiffness and the participant mass explains the massive increase of 35 and 25 times, respectively, in the maximum beam shear and in the ratio between the maximum shear and the maximum nave load from *roof 1* to *roof 3*. The spectral acceleration of the analytical model with roof 4 model is lower with respect to that with

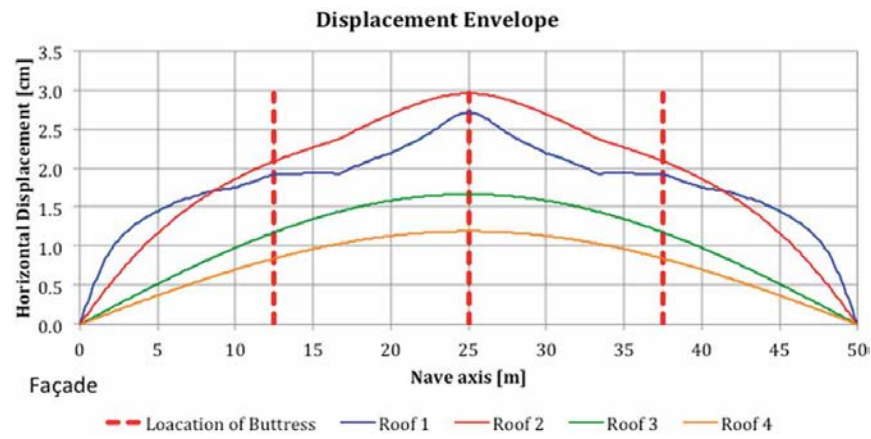
Figure 15- Results of the response spectrum analyses: horizontal displacement of the nave's axis.

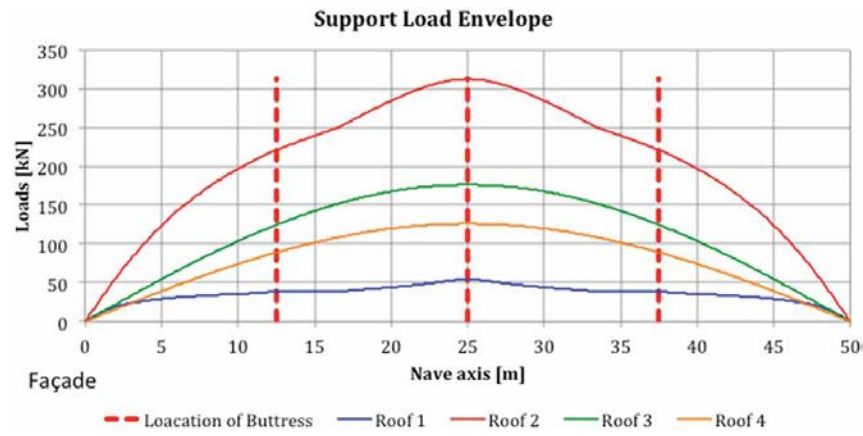
Figure 16- Results of the response spectrum analyses: load acting on the supports.

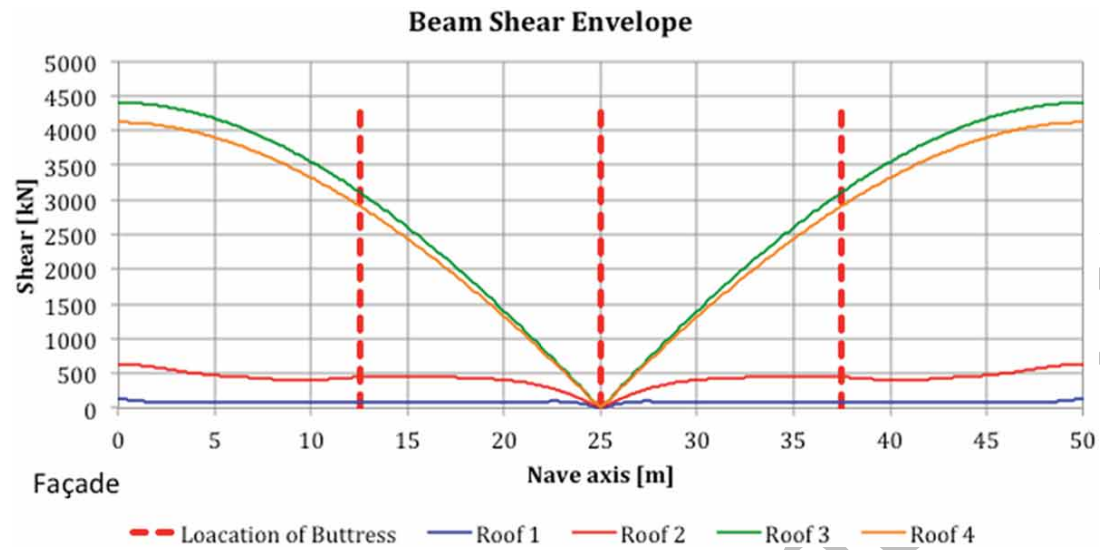
Figure 17- Results of the response spectrum analyses: shear acting on the beam.

roof 3 model. This justifies the reduction of the maximum shear from roof 3 to roof 4. The response spectrum analysis gives an approximation of the initial load distribution, but it does not provide any information about the dynamic nonlinearities.
