MULTITEMPORAL 3D MODELLING FOR CULTURAL HERITAGE EMERGENCY DURING SEISMIC EVENTS: DAMAGE ASSESMENT OF S. AGOSTINO CHURCH IN AMATRICE (RI)

F. Chiabrando^a, A. Di Lolli^b, G. Patrucco^a, A. Spanò^a, G. Sammartano^{a*}, L. Teppati Losè^a

KEY WORDS: UAV photogrammetry, multi-temporal model, structural assessment, seismic emergency, Cultural Heritage

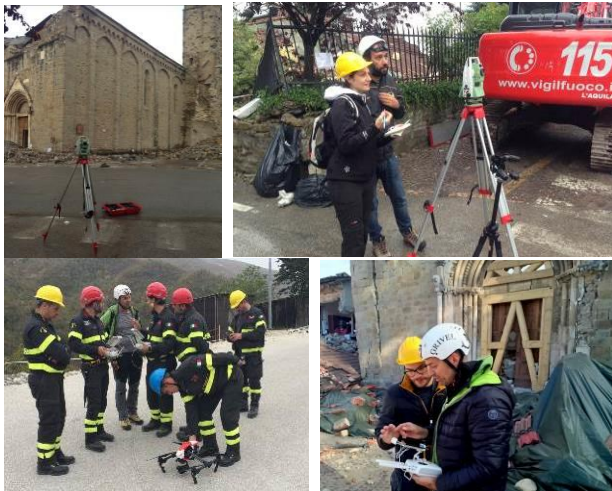
Figure 4. Survey operation in the area of Sant'Agostino; The RPAS group of the Firefighters with the INSPIRE 1; Remote control of the UAV during the image acquisition phase.

Furthermore, according to the usual data acquisition workflow several Ground Control Points were measured. The survey was performed with a traditional total station (Figure 4) in a local reference system, n°16 natural GCPs were measured in the two visible façades (it was not possible to use artificial marker, due to the structural problems of the church).

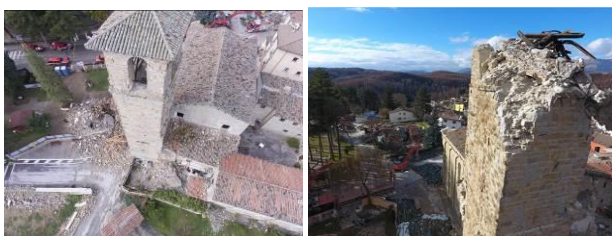
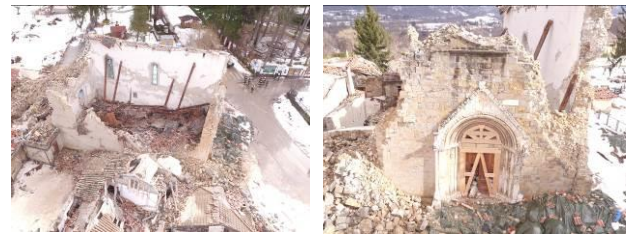
Figure 5. Oblique image of the Sant'Agostino Church; the top of the bell tower and the collapse after the Norcia earthquake; the structure after the January seismic events

As one can clearly deduce from the previous paragraph, the extremely poor balance situation was definitively exceeded after the sequence of three earthquakes occurred at 9:25 (M5.1), 10:14 (M5.5) and 10:25 (M5.4) on the 18th of January 2017. This new seismic swarm produced the collapse of the belt tower, the east and south façades and an important increasing of the damages on the main façade. The west part of the church is still preserve although very important damages are clearly recognizable on the structure.

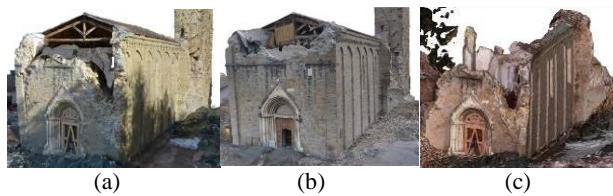
Figure 6. A view of the achieved models: September (a), December (b), January (c)

The achieved accuracy (Table1) allow considering the products suitable for a representation at a scale 1:100. In Figure 6 the achieved 3D models according to the different acquired dataset are reported.

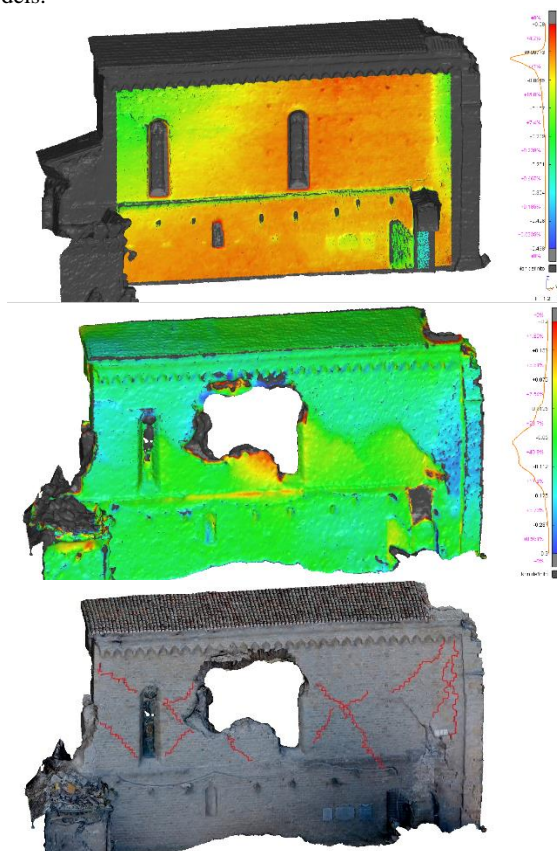
Figure 11. 3D analysis on West wall. a) Fitting plane analysis. b) t1-t2 comparison and mapping c) cracks mapping.

Another focus on the geometric evaluation by multi-temporal comparison that we chose to explore to support masonries stability assessment and contribute to the metric basis for structural diagnosis, is the West wall that, despite the East one, in T3 is not left standing after the subsequent seismic events. On the t1 model it can be traced a widespread lack of planarity of masonry surface (Figure 11a) on the basis on a mean plane fit at the basis on wall. 75% of the surface differs from the vertical plan of about $-0.06\text{m} < v < +0.08\text{m}$. In Figure 11b comparison of t2 on t1 after another seismic event and the collapse of the central area of the wall, in correspondence with the window opening. A series of shear stress traces can be observed, identified and measured with high scale detail on the 3D mesh. A preliminary evaluation of the collapsed volume can be performed too on these kind of models.

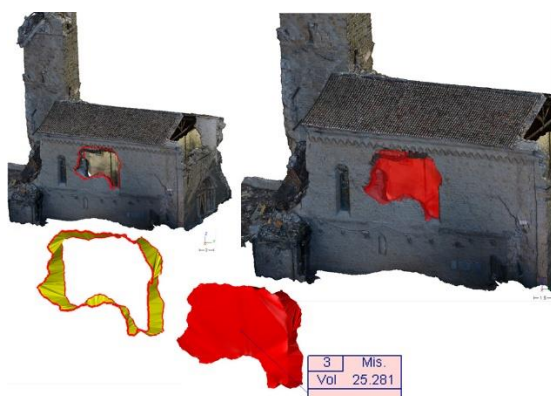
Figure 12. Analysis on West wall where the damage mechanisms caused the collapse of the central part of the masonry by shear failures.

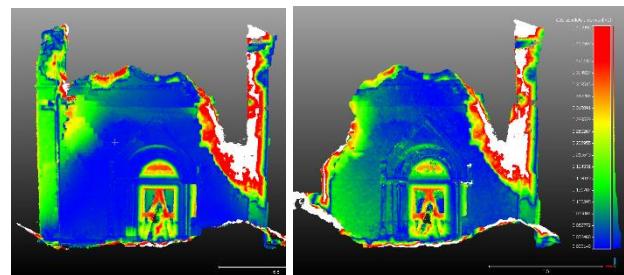
Figure 13. The main façade collapse comparison in 2 steps: a) t1-t2; b) t1-t3. The represented range values are $0 < v < 0.2\text{m}$ (white values $> 0.2\text{m}$).

Damages are consistent on the main façade and are well easy to read, detectable, and quantifiable too on multi-temporal 3D models. With t2 model the collapses occurred in t3 were easily maybe predictable and can be located and measured in relation to the global structural assessment. The key point of the dynamic behavior of the façade can be clearly identified in the lateral connection with transversal walls surrounding the church nave.

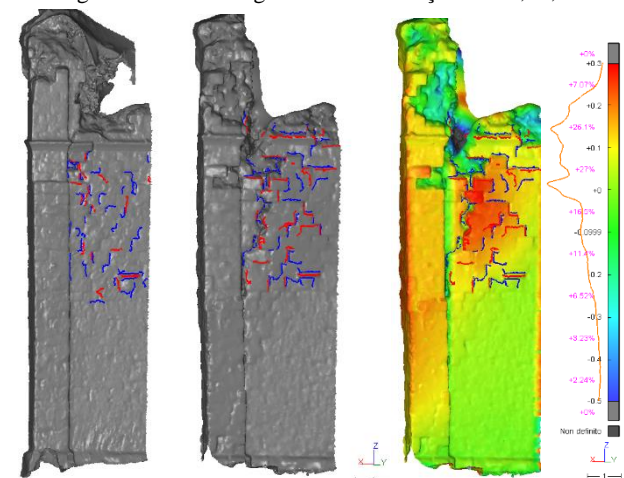
Figure 15. 3D model breaklines detection on t1 and t2; the surface comparison between t1-t2 with appreciable differences of about 0.1-0.3m (more or less 55% on the surface)

In this specific focus on the left connection with the West wall (Figure 14) the progressive evolution of collapse a series of break lines traces were detected in t1 in relation to the ones identified in t2 before the decisive collapse.
