Structural health monitoring of historical heritage in Italy: some relevant experiences

Alessandro De Stefano¹, Emiliano Matta¹, Paolo Clemente²

Abstract. The architectural heritage in the world represents a fundamental resource and a sign of the national cultural background. Its maintenance and preservation require a balance between the structural safety needs and the respect for their architectural and cultural value. Structural health monitoring (SHM) is increasingly emerging as a unique tool to achieve such a balance, through a proper combination of traditional and innovative techniques. This paper presents some recent experiences of SHM applied to the historical heritage in Italy, discussing relevant tools and reporting some of the most significant case studies.

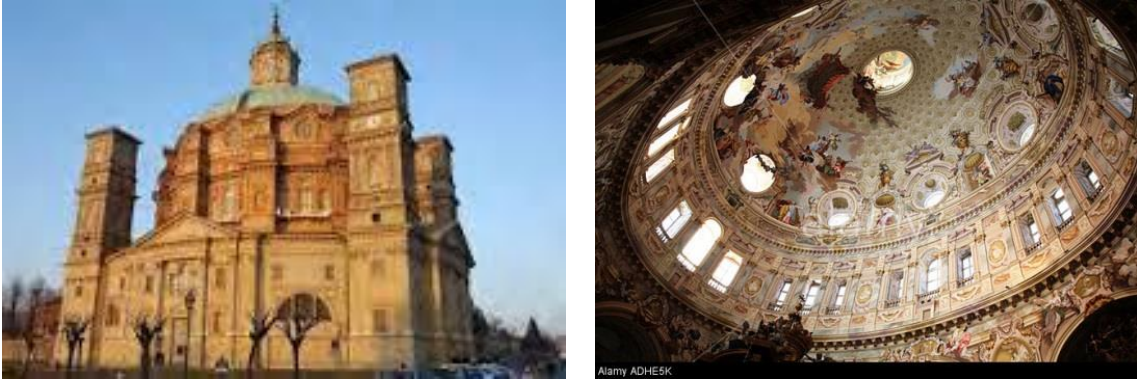
Fig. 4 The Sanctuary of Vicoforte: (a) exterior view; (b) interior view of the elliptic dome

The Sanctuary, a bold, highly prestigious, structure, underwent retrofits and modifications during all of its life and suffered significant damages. Recently, a nonlinear model was used to simulate the whole structure-foundation-soil system behaviour, accounting for the presence of deep layers of soft soil under the building, allowing significant settlements over the years and potentially causing serious damages in case of strong seismic actions [34]. The monument has been recently chosen as a case study for the evaluation and application of the Directive PCM 2008, describing the procedures to be followed in assessing the safety of an existing building [2]. For architectural heritage, this must be done in several steps: a) identification of the structure; b) geometric data gathering; c) historical analysis; d) survey of the materials and their state of preservation; e) mechanical characterization of the materials; f) soil and foundation analysis; g) monitoring. The first basic steps, including NDT, characterization of masonry and foundation soil and description of the geometric data and crack patterns, had already be concluded previously together with a general plan of future investigations [34]. Further studies were dedicated to the vibrational response and modal characterization. Due to the complexity and large size of the building, the experimental campaign focused on the dome, whereas for a seismic assessment the main interest rests in global modes, especially those falling in a low frequency range [35], and in the long-time measure of the deformation stability of the metal ties fastening the base of the dome [36].

The data acquisition campaign at the Sanctuary of Vicoforte was performed in June 2008 using four triaxial geophones with a sensitivity of 400 V/m/s and 5 accelerometers with 10 V/g sensitivity, relocated according to different setups so as to obtain a reliable global identification of the structure. The accelerometric signals were sampled at 128 Hz. All recorded signals were conditioned using filters, de-trending and subsampling. Signals were segmented in overlapping time windows and statistically treated. Computational modes were systematically discarded by using modal assurance criteria [37]. In more detail, all signals coming from different acquisitions were segmented and a great number of stochastic subspace identification (SSI) [38] sessions were performed. Stabilization processes were used to exclude apparent modes with too low energy to be surely recognized as true modes and probably due to exogenous components. Three real modes were finally identified, having frequencies equal to, respectively, 1.99 Hz (along-y, 1st bending mode), 2.08 Hz (along-x, 2nd bending mode), 3.42 Hz (torsional mode).

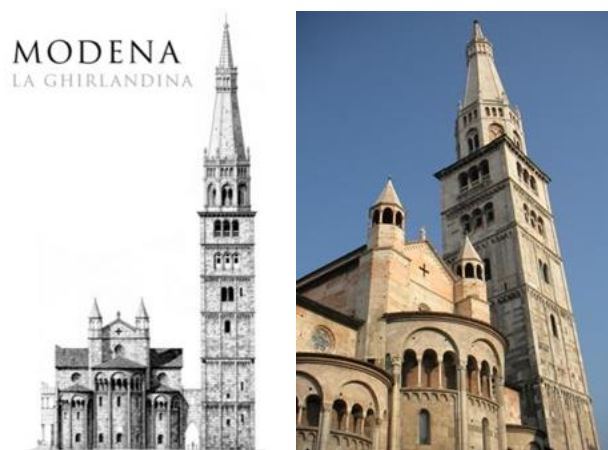
Fig. 6 The Ghirlandina Tower in Modena

The case study of the Ghirlandina bell-tower is important for its general implications [39]. The wonderful Cathedral of Modena (central-northern Italy) and its bell-tower Ghirlandina are part of the UNESCO site Piazza Grande (Fig. 6). The construction of the tower began in 1099 together with the cathedral and ended in 1319. The arches connecting the southern side of the tower to the cathedral were set in place in 1338, because there was evidence that a tilt, later corrected, occurred during the construction. Measurements of the tilt and studies on the foundation depth and consistency started at the end of the nineteenth century. In 2007 a scientific committee found that the brick-made foundation had a thickness of 3 m and was conceived as a spread foundation without supporting piles. It was possible to define the settlement suffered by the tower (~ 2 m) and the compressibility of the foundation soil. Over the last decade, there has been a growing interest in the potential seismic vulnerability of the tower and its interaction with the cathedral. This interest was further increased by the recent earthquake in the Emilia Romagna region in May 2012 because many historical masonry bell towers collapsed despite the moderate magnitude ($M = 5.9$) of the seismic event.
