# Structural health monitoring of historical heritage in Italy: some relevant experiences

**Abstract.** The architectural heritage in the world represents a fundamental resource and a sign of the national cultural background. Its maintenance and preservation require a balance between the structural safety needs and the respect for their architectural and cultural value. Structural health monitoring (SHM) is increasingly emerging as a unique tool to achieve such a balance, through a proper combination of traditional and innovative techniques. This paper presents some recent experiences of SHM applied to the historical heritage in Italy, discussing relevant tools and reporting some of the most significant case studies.

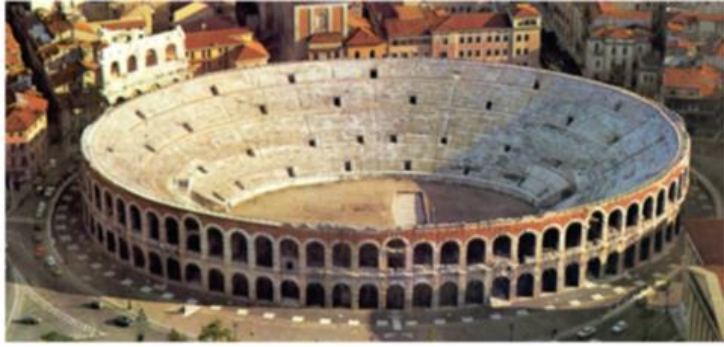
**Fig. 1** The Roman Arena in Verona

1 The Roman Arena in Verona, Italy, built in the first century A.D., is still standing in the historical city  
2 center (Fig. 1). It is open to public use for visits but also for operas, concerts and relevant shows (audience of  
3 20.000 people). It suffered damages due to aging as well as natural and man-induced events, such as  
4 earthquakes, floods, wars and sieges and, for centuries, continuative stealing of stones and material for reuse in  
5 other constructions. Past seismic events are the cause of the almost complete collapse of the third (external) ring  
6 of the monument, today only remaining in the so-called “ala” (wing) of the Arena, an isolated portion of stone  
7 blocks curved wall characterized by arches and massive pillars. Post-tensioned tendons were placed vertically  
8 along the entire height of the massive pillars in 1956.

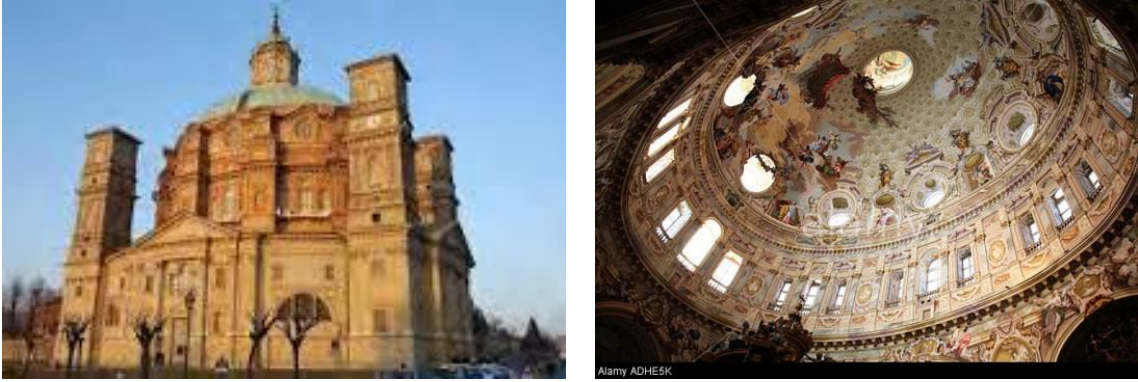
**Fig. 4** The Sanctuary of Vicoforte: (a) exterior view; (b) interior view of the elliptic dome

The Sanctuary, a bold, highly prestigious, structure, underwent retrofits and modifications during all of its life and suffered significant damages. Recently, a nonlinear model was used to simulate the whole structure-foundation-soil system behaviour, accounting for the presence of deep layers of soft soil under the building, allowing significant settlements over the years and potentially causing serious damages in case of strong seismic actions [34]. The monument has been recently chosen as a case study for the evaluation and application of the Directive PCM 2008, describing the procedures to be followed in assessing the safety of an existing building [2]. For architectural heritage, this must be done in several steps: a) identification of the structure; b) geometric data gathering; c) historical analysis; d) survey of the materials and their state of preservation; e) mechanical characterization of the materials; f) soil and foundation analysis; g) monitoring. The first basic steps, including NDT, characterization of masonry and foundation soil and description of the geometric data and crack patterns, had already be concluded previously together with a general plan of future investigations [34]. Further studies were dedicated to the vibrational response and modal characterization. Due to the complexity and large size of the building, the experimental campaign focused on the dome, whereas for a seismic assessment the main interest rests in global modes, especially those falling in a low frequency range [35], and in the long-time measure of the deformation stability of the metal ties fastening the base of the dome [36].

The data acquisition campaign at the Sanctuary of Vicoforte was performed in June 2008 using four triaxial geophones with a sensitivity of 400 V/m/s and 5 accelerometers with 10 V/g sensitivity, relocated according to different setups so as to obtain a reliable global identification of the structure. The accelerometric signals were sampled at 128 Hz. All recorded signals were conditioned using filters, de-trending and subsampling. Signals were segmented in overlapping time windows and statistically treated. Computational modes were systematically discarded by using modal assurance criteria [37]. In more detail, all signals coming from different acquisitions were segmented and a great number of stochastic subspace identification (SSI) [38] sessions were performed. Stabilization processes were used to exclude apparent modes with too low energy to be surely recognized as true modes and probably due to exogenous components. Three real modes were finally identified, having frequencies equal to, respectively, 1.99 Hz (along-y, 1<sup>st</sup> bending mode), 2.08 Hz (along-x, 2<sup>nd</sup> bending mode), 3.42 Hz (torsional mode).

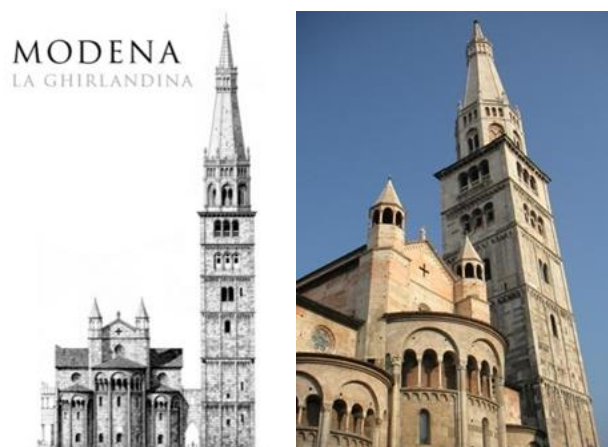
**Fig. 6** The Ghirlandina Tower in Modena

The case study of the Ghirlandina bell-tower is important for its general implications [39]. The wonderful Cathedral of Modena (central-northern Italy) and its bell-tower Ghirlandina are part of the UNESCO site Piazza Grande (Fig. 6). The construction of the tower began in 1099 together with the cathedral and ended in 1319. The arches connecting the southern side of the tower to the cathedral were set in place in 1338, because there was evidence that a tilt, later corrected, occurred during the construction. Measurements of the tilt and studies on the foundation depth and consistency started at the end of the nineteenth century. In 2007 a scientific committee found that the brick-made foundation had a thickness of 3 m and was conceived as a spread foundation without supporting piles. It was possible to define the settlement suffered by the tower ( $\sim 2$  m) and the compressibility of the foundation soil. Over the last decade, there has been a growing interest in the potential seismic vulnerability of the tower and its interaction with the cathedral. This interest was further increased by the recent earthquake in the Emilia Romagna region in May 2012 because many historical masonry bell towers collapsed despite the moderate magnitude ( $M = 5.9$ ) of the seismic event.

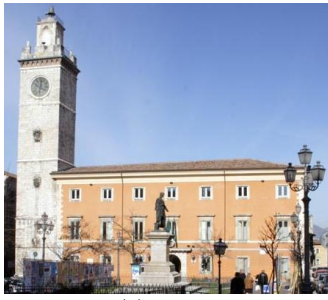
**Fig. 12** Palazzo Margherita and Civic Tower: (a) front; (b) plan; (c) underground isolation (Patent PCT d.n. PCT/IB2011/000716, april 02, 2011 Politecnico di Torino-ENEA)

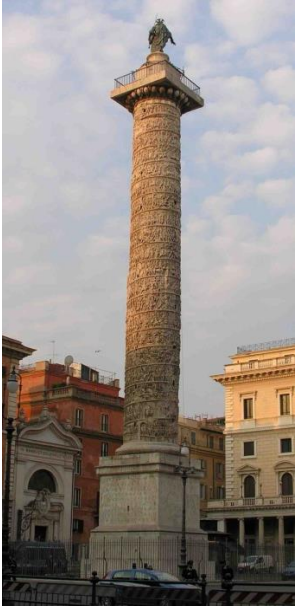
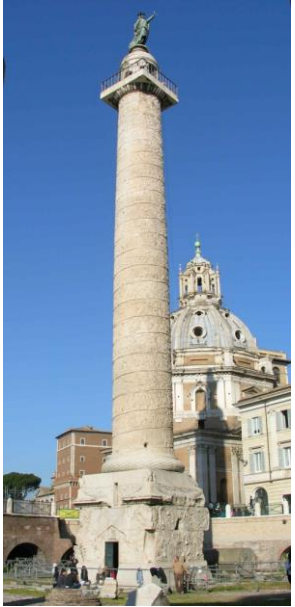
**Fig. 16** (a) The Aurelian Column and (b) the Trajan's Column

40  
41 Among the best-known vestiges of ancient Rome monumental architecture, the Aurelian and Trajan’s  
42 Columns (also called the Cochlid Columns), are both composed by 19 marble blocks carved to obtain a spiral  
43 staircase, the so called cochlea, connecting the central core to the outer ring (Fig. 16). Each block is about 1.5 m  
44 tall, for a total height of the column of about 30 m. The external diameter varies from 3.7 to 3.2 m, while the  
45 diameter of the internal core varies from 1.0 to 0.5 m. Both columns rest on square pedestals. The extent and the  
46 consistency of the underground soil and of the foundations are unknown for both columns [69, 70].

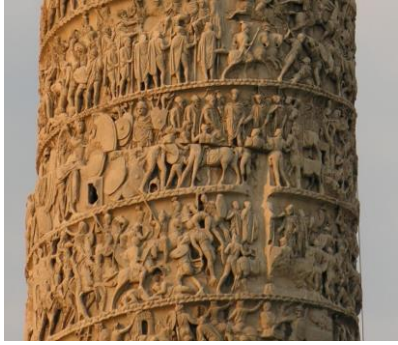
**Fig. 17** The Aurelian Column: relative dislocation between two adjacent blocks
