Structural health monitoring of historical heritage in Italy: some relevant experiences

Alessandro De Stefano¹, Emiliano Matta¹, Paolo Clemente²

Keywords: architectural heritage; historical constructions; structural health monitoring; masonry buildings; real case studies; damage symptoms.

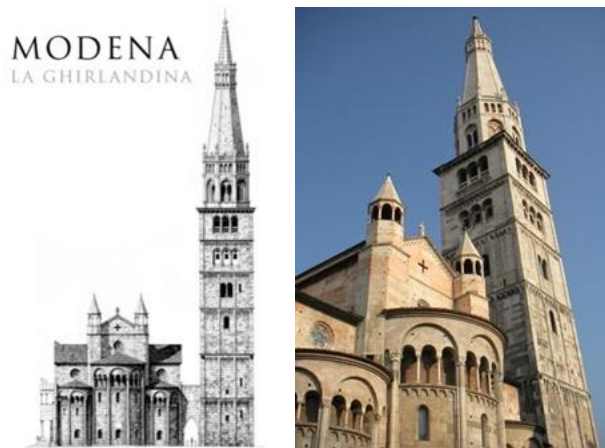
Fig. 6 The Ghirlandina Tower in Modena

The case study of the Ghirlandina bell-tower is important for its general implications [39]. The wonderful Cathedral of Modena (central-northern Italy) and its bell-tower Ghirlandina are part of the UNESCO site Piazza Grande (Fig. 6). The construction of the tower began in 1099 together with the cathedral and ended in 1319. The arches connecting the southern side of the tower to the cathedral were set in place in 1338, because there was evidence that a tilt, later corrected, occurred during the construction. Measurements of the tilt and studies on the foundation depth and consistency started at the end of the nineteenth century. In 2007 a scientific committee found that the brick-made foundation had a thickness of 3 m and was conceived as a spread foundation without supporting piles. It was possible to define the settlement suffered by the tower (~ 2 m) and the compressibility of the foundation soil. Over the last decade, there has been a growing interest in the potential seismic vulnerability of the tower and its interaction with the cathedral. This interest was further increased by the recent earthquake in the Emilia Romagna region in May 2012 because many historical masonry bell towers collapsed despite the moderate magnitude ($M = 5.9$) of the seismic event.

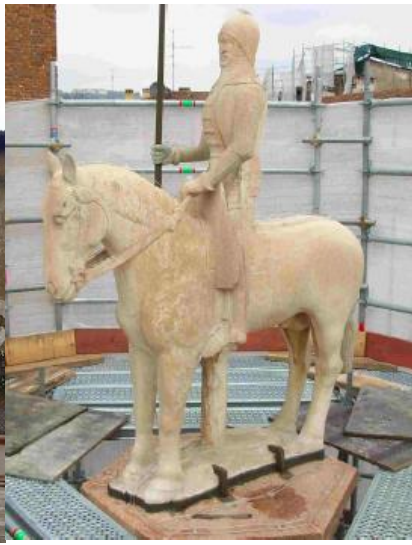
Fig. 9 Cansignorio stone tomb: (a) overall view; (b) the equestrian statue; (c) sensors layout (left: static transducers on cracks; right: mono-axial accelerometers)

The Scaliger Tombs is a group of five Gothic funerary monuments in Verona, Italy, celebrating the Scaligeri family, who ruled Verona from the 13th to the late 14th century. Throughout the centuries, several repair interventions were necessary to preserve the delicate structure of the stone tomb, such as those carried out in the XVII, XIX and XX centuries (Fig. 9a and 9b).
