Specific Energy Absorption Evaluation on GFRP Laminate Plate by Optical, Thermographic and Tomographic Analysis

Specific Energy Absorption Evaluation on GFRP Laminate Plate by Optical, Thermographic and Tomographic Analysis / Virgillito, Enrico; Airale, A. G.; Ferraris, A.; Sisca, L.; Carello, M.. - In: EXPERIMENTAL TECHNIQUES. - ISSN 0732-8818. - ELETTRONICO. - 43:1(2019), pp. 15-24. [10.1007/s40799-018-0257-y]

E. Virgillito, A. G. Airale, A. Ferraris, L. Sisca, M. Carello

Department of Mechanical and Aerospace Engineering - Politecnico di Torino

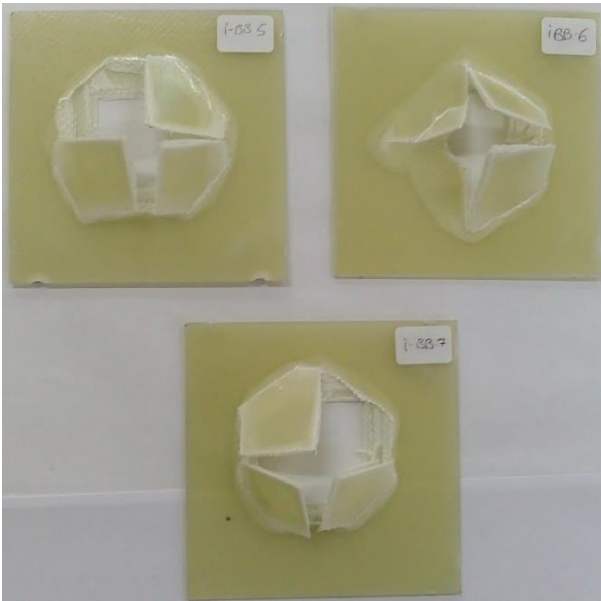
Figure 3: iBB 1.5 m/s

Data shows below in Table 1 have been filtered because the rapid variation of the kinematic energy excites vibrations, which depends on the stiffness and mass of both the specimen and the impactor. The acquisition rate was 1 MHz, which is appropriate for sufficient number of sampled points for a phenomenon normally lasts less than 100 milliseconds. E-Glass Epoxy (iBB) specimens are tested with impact speeds of 1.5m/s and 6 m/s, and their curves Energy-Displacement and Force-Displacement are shown in Figure 4 and Figure 5. It could be seen that specimens are more brittle at lower impact speeds.

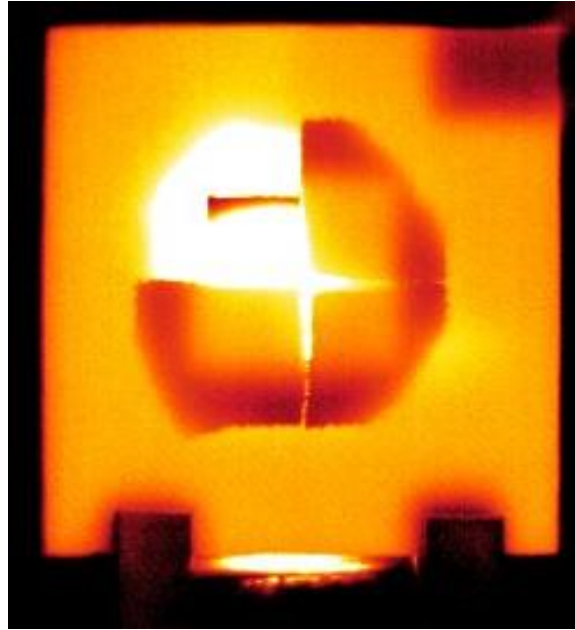
Since delaminated area has interspace between the layers, transmission of heat is differently than the non-damaged part, which can be observed by using IR camera. The Thermal graphic method provides more detailed information for failure phenomenon than the optical method. Through software TImage®, it is possible to create a map of points (image correlation), where each pixel and has an associated temperature. Comparing all the frames taken during the measurement, a temperature different between the first frame to the last frame can be observed with a value at least $\Delta T > 2^\circ \text{C}$. The results were obtained from 2D images of the surface of the specimens, and same assumption of constant damage along the is made to evaluate the effective volume. However, this technique can be applied to any type of material. The effective volume calculated is shown with SEA in **Errore. L'origine riferimento non è stata trovata.**:

Figure 8: SEA Thermographic analysis

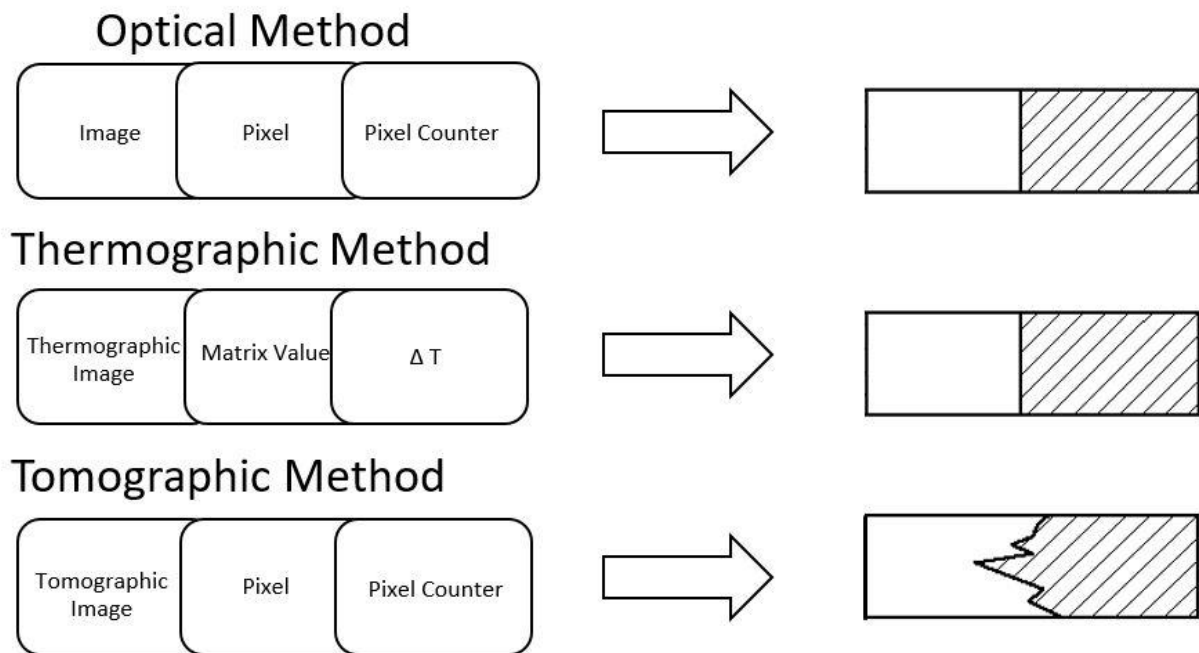
A fast, easy and effective way to obtain this property has been defined as using tomographic method. This is obtained through comparison of three different commonly used analysis method (Optical, Thermographic and Tomographic) as shown in Figure 11:

Figure 11: Measurement methods.

- The optical method for the evaluation of the SEA greatly underestimate the effective volume of the material, such consequentially effects of the evaluation of SEA. This technique is proved to be inaccurate and unreliable. It is also limited that can be applied exclusively for transparent material (at least in the interested zone).
- Both the Thermographic method and Tomographic method does not have limitations for material transparency. The result obtained by both methods are very similar to each other. They are both suitable for the evaluation of SEA.
- As shown in Table 6, the $\Delta\%$ referred to Tomographic method could be up to 20% in Optical method, meanwhile it's below the 5% in Thermographic case.
