Acoustic emission and numerical analysis of the delamination process in repair plasters applied to historical walls

Acoustic emission and numerical analysis of the delamination process in repair plasters applied to historical walls / Grazzini, Alessandro; Accornero, Federico; Lacidogna, Giuseppe; Valente, Silvio. - In: CONSTRUCTION AND BUILDING MATERIALS. - ISSN 0950-0618. - STAMPA. - 236:(2020). [10.1016/j.conbuildmat.2019.117798]

Alessandro Grazzini, Federico Accornero, Giuseppe Lacidogna, Silvio Valente  
Politecnico di Torino (Italy)

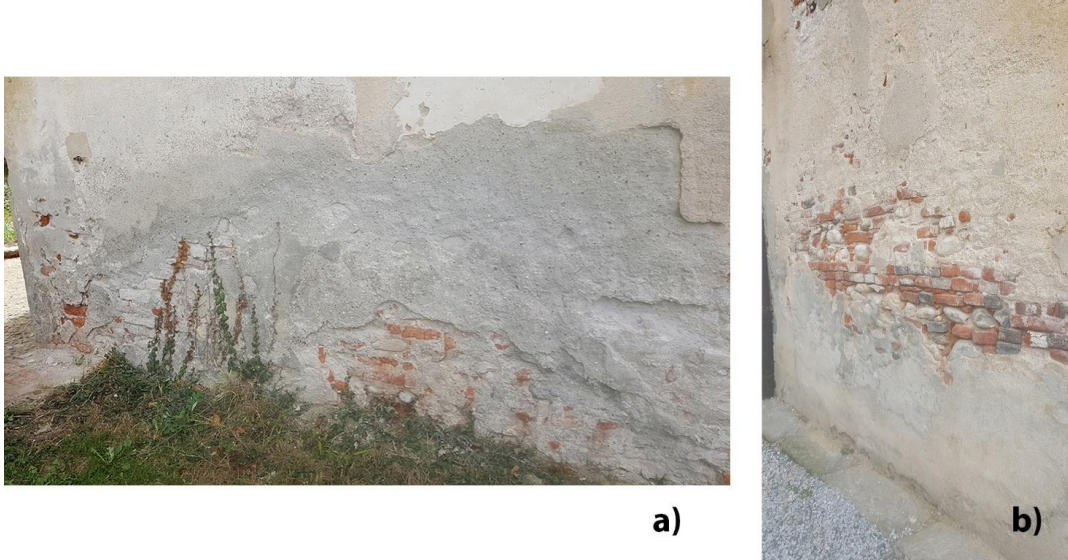
**Fig. 1.** Some examples of plaster detachment on historical walls due to: a) damp action from capillary rising,  
b) the action of freezing-thawing freeze-thaw cycles.

41 The detachment of the repair plasters applied to historical walls represents a serious problem of  
42 durability in the restoration work. The walls of historic buildings are often subject to degradation  
43 due to damp action from capillary rising or due to the action of freeze-thaw cycles [1, 2] (Fig. 1).  
44 These thermo-hygrometric cycles become mechanical stresses in the mortar-masonry interface,  
45 which intensity are often not compatible with mechanical strength of the materials leading to  
46 delamination. Many times the stresses are also caused by mechanical incompatibility between the  
47 plaster and the masonry layer. It can often happen that the application of repair mortars that are too  
48 rigid, when stressed by thermo-mechanical stress (~~freezing-thawing~~ freeze-thaw cycles,  
49 environmental vibrations etc...) undergo a detachment due to the great difference in stiffness with

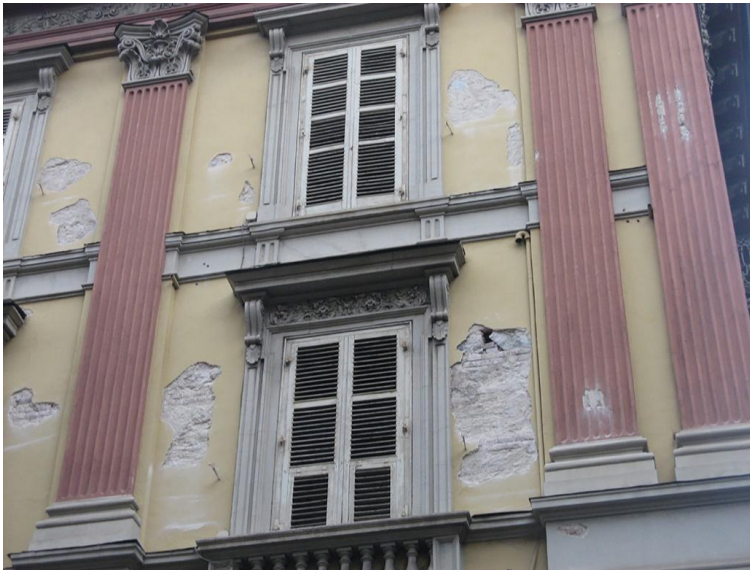
**Fig. 2.** Example of the mechanical incompatibility of patches made by cement mortar in a historical plaster based on lime mortar. The noticeable difference in stiffness of the concrete patch against the original lime-based plaster has favored the detachment under thermo-hygrometric stress.

1  
2  
3 supports and not durable compared to the thermo-hygro-mechanical stresses that the environment  
4 can induce (Fig. 2) [4-86-10].  
5  
6  
7

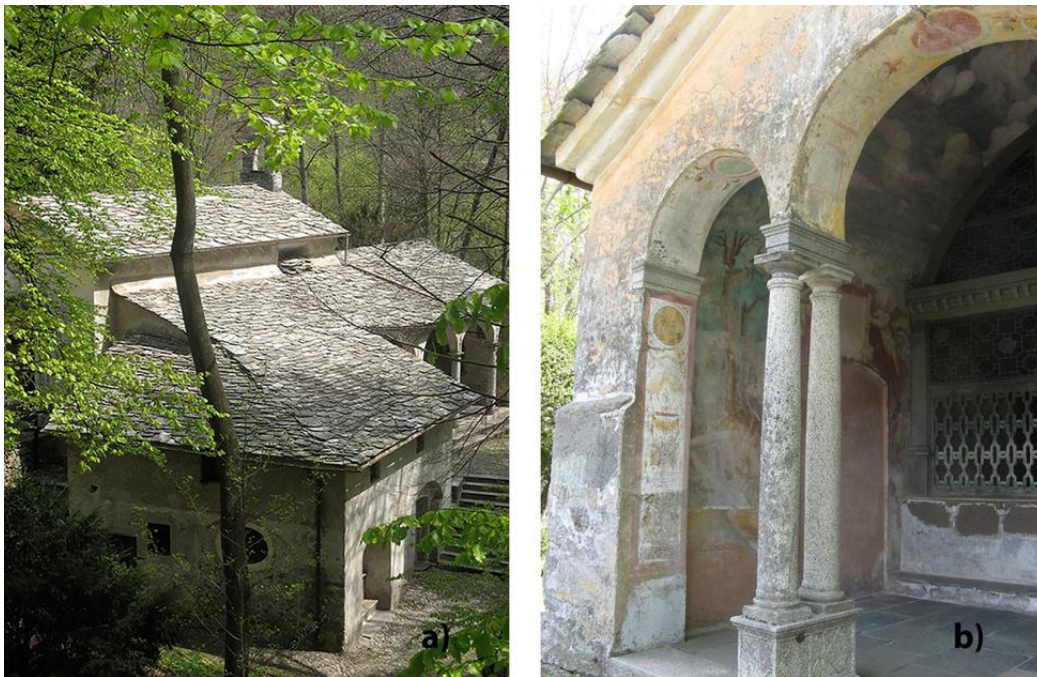
20  
21  
22  
23  
24  
25  
26  
27  
28  
29  
30  
31  
32  
33  
34  
35  
36  
37  
38  
39  
40  
41  
42  
43  
44 **Fig. 3.** Same example of religious stone building at the Sacro Monte di Varallo: a) Nazaret building; b)  
45 Chapel of the Temptations.  
46

13 the area. The Sacro Monte di Varallo is a UNESCO site featuring 45 chapels, built between the 15<sup>th</sup>  
14 and 18<sup>th</sup> centuries, which represent by stages the life of Christ (Fig 3). The chapels are built with  
15 stone masonry and their plasters, some also painted, highlight multiple detachments in large parts  
16 due to the abundance of rain and humidity that characterizes the mountain environment in which  
17 they are located (Fig. 3b) [4015].  
18  
19
