Post-collapse analysis of Morandi's Polcevera viaduct in Genoa Italy

Post Collapse Analysis of Morandi's Polcevera Viaduct in Genoa Italy

Maurizio Morgese ^a, Farhad Ansari ^b, Marco Domaneschi ^c, and Gian Paolo Cimellaro ^d

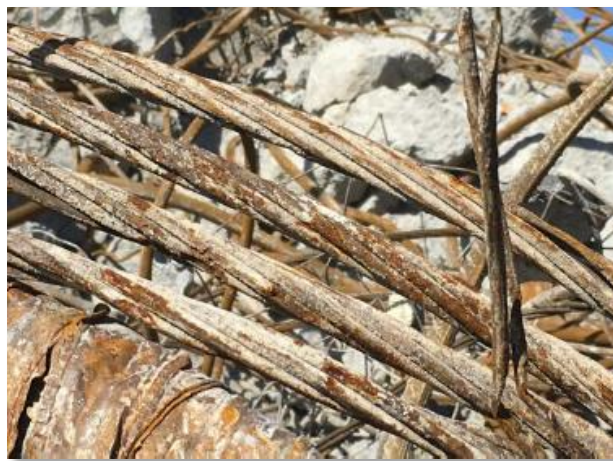
Figure 2. Pitting corrosion of prestressing tendons.

Transport (MIT) [16, 17]. Fig. 2 pertains to a photo of the corroded tendons, taken by Autostrade, which is the operating entity for the highway system that includes the Polcevera viaduct.

Following the failure of Polcevera viaduct, some considered the influence of bad weather and lightning on the collapse. However, degradation of the cables due to corrosion was confirmed by an investigation carried out by the inspection commission of the Ministry of Infrastructure and

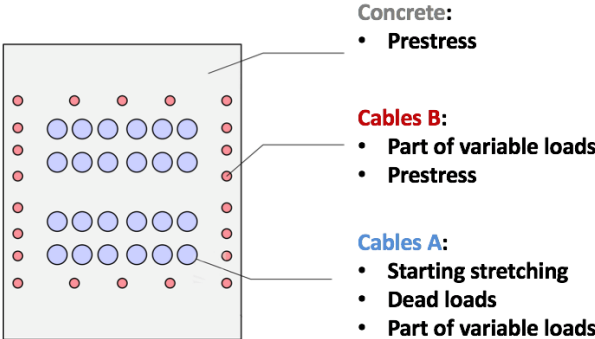
With reference to construction phases, the intent was to assure support for the main deck dead loads by Tendons A and compression of the concrete stay cover by Tendons B. Both cable types contributed in supporting the Gerber beams (Phase 5) and the live loads.

Figure 7. Load configuration per Morandi's design specifications for the stays
