Collapse analysis of the Polcevera Viaduct by the Applied Element Method

M. Domaneschi ^{a*}, C. Pellicchia ^b, E. De Iuliis ^b, G. P. Cimellaro ^a, M. Morgese ^d, A.A. Khalil ^c, F. Ansari ^d

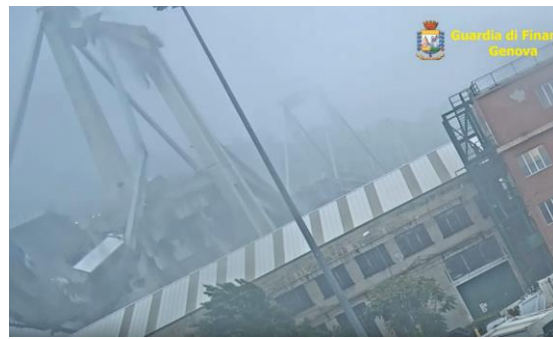
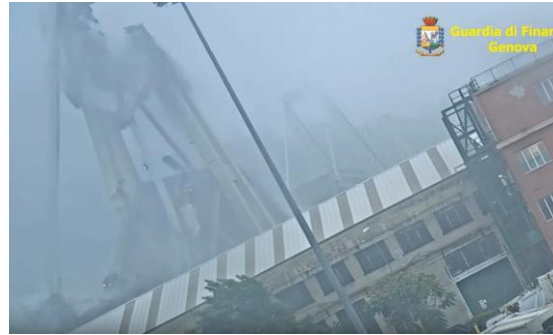
The first step at the 1-second time instant in Fig. shows the collapsing bridge deck that has lost its support at the South-East stay. The bridge starts to collapse, and the end of the deck at the east side undergoes relevant displacements in vertical direction. The southwest stay breaks the tower, and at the same time, the deck breaks in two points.

At the 2-second time instant, the deck twists around the longitudinal axis because of the pull from the standing support at the north side stay. By the 3-second time instant, the deck has already broken into a “V” shape. The south saddle at the top of the A-shaped tower has also collapsed during this time interval. It is also worth noticing that the western portion of the deck sticks vertically into the ground.

However, a discrepancy can be observed in the video footage from the 5 second time instant onwards, when the downstream (South) part of the tower is still standing up until the 9-second time instant, but in the model it collapses much earlier.

Correspondence between the computational model and the footage at the 3-second time instant can be also observed by the rotation of the western section of the deck with respect to the transvers axis of the bridge. In

Fig. 18 – Side by side comparison of the collapse mechanism of the bridge. Analysis results (left), actual collapse images (right) [9].
