Embedded fiber-optic sensors in reinforced concrete beams for post event structural assessment

## Distributed Measurements in Reinforced Concrete Beam

In this work, laboratory tests are described on reinforced concrete beams equipped with distributed fiber optics sensors to monitor the state of cracking and the propagation in the thickness.

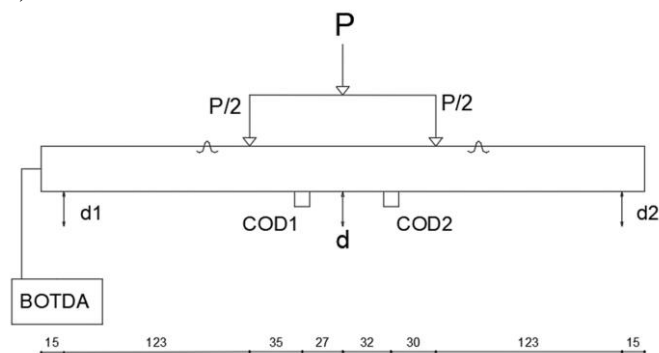
Comparing the results collected from FOS and FBG, according to the objectives of the test, it should be possible to get the performance of distributed sensors. Flexpatch system is glued on the frontal surface of the beam. This is a Monitoring Wireless System that is composed by strain sensor, thermometer, tilt sensor, seismographic sensor and transmission unit. Behind, on the opposite side there is another system to control strain and cracks: Digital Image Correlation. The beam is painted of white from the middle span to 500 mm on each side, there are dots drawn on the paint. A camera captures the distance changes between the dots at each loading step. Clip gauge extensometer and Linear Variable Differential Transformer are applied on the beam in order to measure the deflection and the crack opening at the notches locations (Fig. 5).

Figure 5. LVDT arrangement.

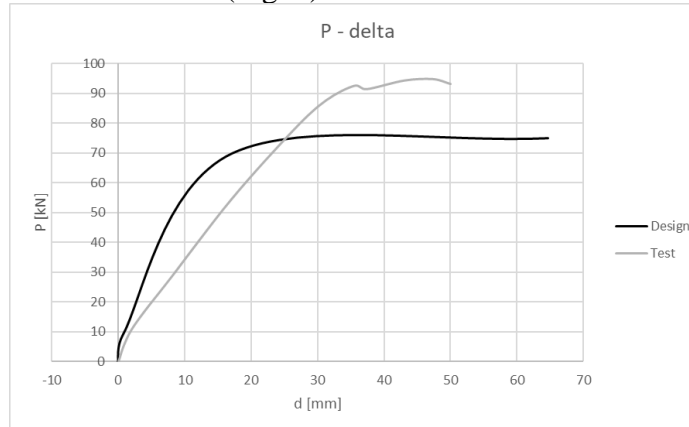
The cracking load is around 10 kN against the 7 kN of the design (Fig. 6), it sounds a good result because the design properties of materials are affected by the coefficient of the NTC 2018 (the Italian code for civil construction). The bending load and the ultimate load present differences between the design and the real value

Figure 6. Comparison between design and test force-displacement relationship.

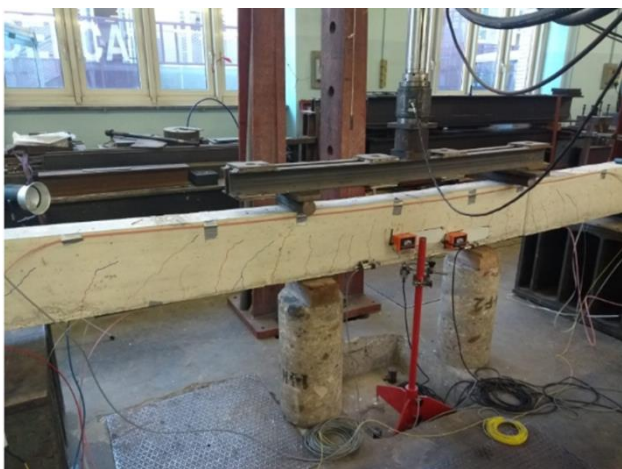
due to the same reason. It is important to know that for the design value, the confinement effect of the stirrups is taken into account. During the test, the behavior of the beam is extremely ductile, as predicted by the project, so that it is possible to capture the progressive growth of the cracks. At the end of the test there are two types of cracks: one due to bending moment and the other due to shear. It is possible to see vertical cracks between the two loading points where only the moment acts, while cracks at 45° between the support and the loading point, area in which the shear intervenes (Fig. 7).

Figure 7. Cracks on tested beam.

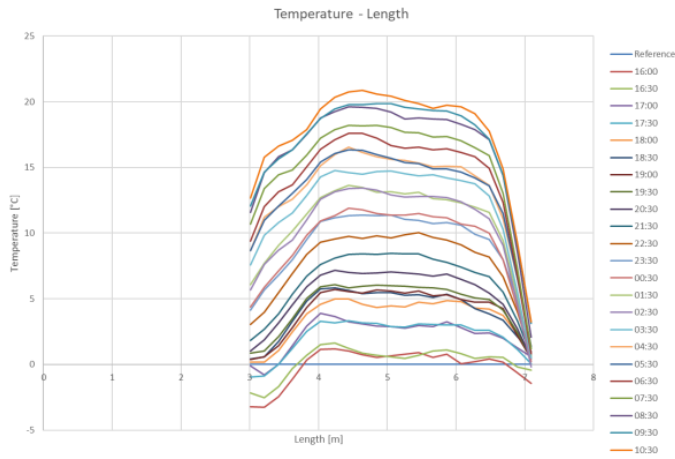
From the first and last measurements it is clear to note an increase in frequency due to the increase in temperature following the curing of the concrete. The Fig. 10 is the temperature change over the length of the temperature sensors over the span length of the beam.

Figure 10. Temperature change over beam length.

In the first 18 hours a temperature increase of about  $20^{\circ}$  is calculated. A local calculation of the middle span point is carried out, so the shift in frequency of this point during the first 18th hours due to the Brillouin frequency change of the temperature sensors and the growth temperature in the same point during the first 18th hours due to change frequency of temperature sensor are plotted in the Fig. 11.

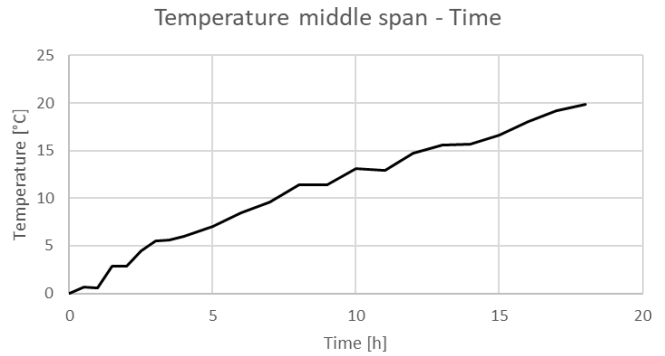
Figure 11. Frequency and temperature change over time.

This measurement could be more accurate with an initial measurement of room temperature, it is clear that it is not possible to start from  $0^{\circ}\text{C}$ .

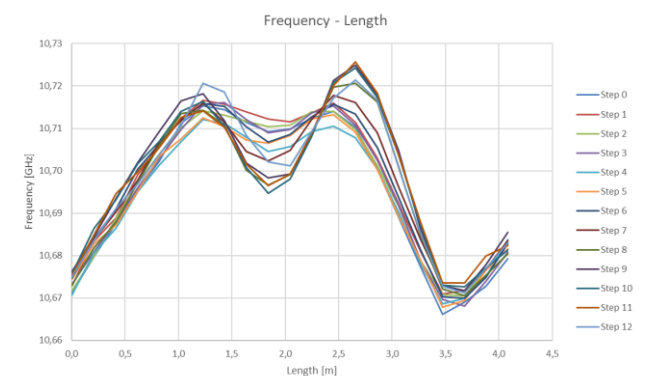
The Fig. 14 is a plot of the frequency change of the top sensor along the beam length during the test. The double humps in this sensor is due to the location of the two loads in the 4-point bend. However, they shift, indicating the effects of the multiple cracks within the SR measurements of the system.

Figure 14. Frequency change of the top sensor along the beam length.

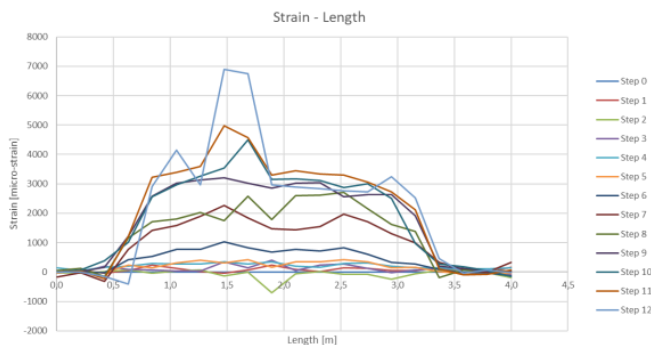
From Fig. 17 it is possible to see at different steps the onset of very high strains in some points. The SMART PROFILE sensor confirms the above and is considered to be the one with the greatest ability to pick up cracks.

Figure 17. Strain variation over beam length.

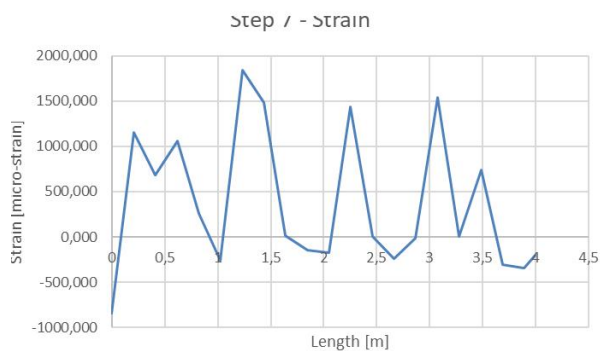
ones. A DIC computation is proposed in Fig. 18 that can help in locating the crack with FOS. The digital image correlation was performed in the central part of the beam, from 1,5m to 2,5m. It is possible to see as in the step number 7 of the test, the external SMART PROFILE sensor at 2,25 m shows an increase in frequency and in strain that matches the results obtained from the digital image correlation. Indeed, in this point at that step, a crack could be occurred and the variation in strain was so big.

Figure 18. Comparison between FOS and DIC.
