MA-XRF measurement for corrosion assessment on bronze artefacts / Lins, S.A.B., Di Francia, E., Grassini, S., Gigante, G.E., Ridolfi, S.. - ELETTRONICO. - (2019), pp. 538-542. (2019 IMEKO TC4 International Conference on Metrology for Archaeology and Cultural Heritage, MetroArchaeo 2019 Firenze, Italy 4-6 December 2019).

# MA-XRF measurement for corrosion assessment on bronze artefacts

**Abstract** – In this study, an innovative portable macro X-Ray Fluorescence (MA-XRF) scanner prototype has been employed in order to gain information on composition and distribution of corrosion products artificially grown on Cu-based coupons. First results have shown the importance of using artificially corroded reference samples before any assessment on archaeological artefacts. Moreover, the prototype used demonstrated to be a powerful tool for understanding complex corrosion processes which might occur on Cu-based alloys. The scanner was able to detect light elements as S and Cl, essential for studying the distribution of specific corrosion compounds. Using imaging techniques, it was possible to observe a gradient in Cu elemental maps intensity caused by the overlapping of a thicker corrosion

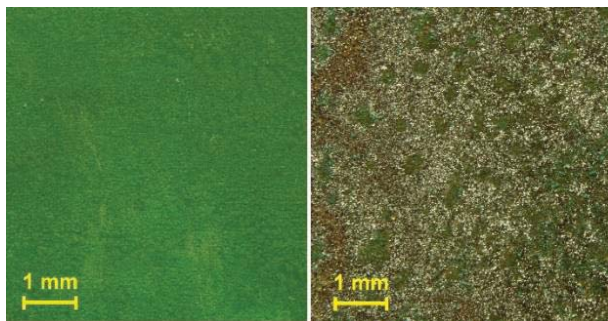
Fig. 1. Artificially corroded layers: CW (left) and sulphate (right) samples. High resolution images.

The study has been performed on Cu 99.96 wt%, reference coupons ( $45 \times 15 \times 5 \text{ mm}^3$ ). The specimens were polished with 500 to 4000 grid SiC paper, rinsed in ethanol in ultrasonic bath for 5 min, and well dried. Then, two kind of artificial corrosion layers have been produced by chemical synthesis (Fig. 1): a set of samples (*sulphate sample*) was created by immersion in a 0.1 M  $\text{Na}_2\text{SO}_4$  solution for three months at room temperature in order to obtain a sulphate corrosion layer. The other set of samples (*CW sample*) was created by immersion in a Corrosive Water solution (CW,  $2.8 \cdot 10^{-2}$  M NaCl, 0.01 M  $\text{Na}_2\text{SO}_4$ ,  $16.1 \cdot 10^{-2}$  M  $\text{NaHCO}_3$ ), that is an ASTM D1384 solution modified by Constantinides [2], for 7 months at room temperature in order to obtain a complex corroded layer. Both solutions were neither stirred nor aerated by bubbling.

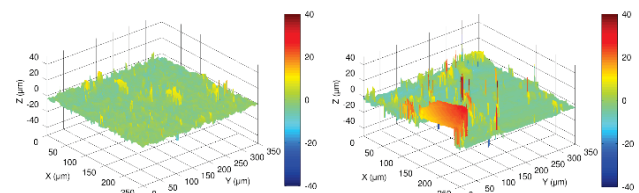
Fig. 2 shows, as an example, the confocal microscope images acquired on some of the copper reference samples. The *CW sample* presents a quite smooth surface structure with a standard deviation of about 2.7  $\mu\text{m}$ ; the *sulphate sample* instead presents a more heterogeneous morphology with surface roughness values of about 6.1  $\mu\text{m}$ .

Fig. 2. Confocal microscope images of the CW (left) and sulphate (right) corroded layers.

The roughness can be one of the major geometrical variables that affect the scanner performance, therefore a comparison of roughness and the sum map can show the presence of a geometrical factor that can create a sort of distortion on the scanner response. If the statistics are enough, one can hypothesize using an elemental map image as a mask to account for any roughness contribution to the final images.

The corrosion product layer thickness can vary greatly, and it depends on the nature of the products present and the alloy. As an approximation, its thickness can vary from 40 to 138  $\mu\text{m}$  in the case of tin bronzes and from 14 to 146  $\mu\text{m}$  in the case of quaternary bronzes [20]. Therefore, it is unlikely that, in this case, roughness would cause any significant distortion in the elemental distribution maps.

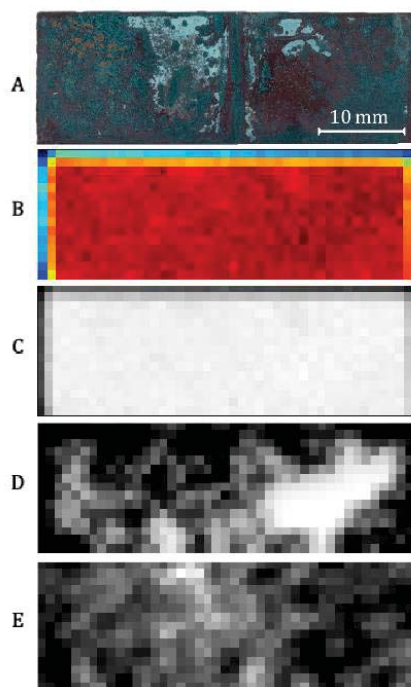
Fig. 3. Sulphate sample surface (A) and scans: (B) sum map, (C) copper map, (D) filtered copper map and (E) sulphur map.

In fact, when applying an average-threshold filter to the copper maps one can observe a certain gradient in the intensity values. The reasons can be three-fold: the formation of a variable-in thickness corrosion layer which attenuates (proportionally to its thickness) the signal from the copper atoms underneath or a selective/preferential corrosion of copper atoms or lastly a distortion caused merely by the surface's roughness. Carefully inspecting the elemental maps of copper and sulphur from the sulphate sample and the sample's aspect (Fig. 3), it is reasonable that what caused a gradient in the copper intensity values in this sample is the presence of a thicker corrosion product area (lighter area, Fig. 3A) in the upper part of the sample surface.

Nonetheless, sulphur was detected across the sulphate sample's surface (as expected) and formed a seemingly gradient that spreads from the upper-middle portion towards the lower region (Fig. 3E). Chlorine could not be detected due to its significantly lower counts and signal contamination from the sample holder (made of polyvinyl-chloride). Whereas for the CW sample, sulphur could not be detected, and chlorine could be mapped only when applying a low-pass filter to the elemental distribution map cutting off a portion of the contamination signal coming from the sample holder in the bottom right part (Fig. 5E).

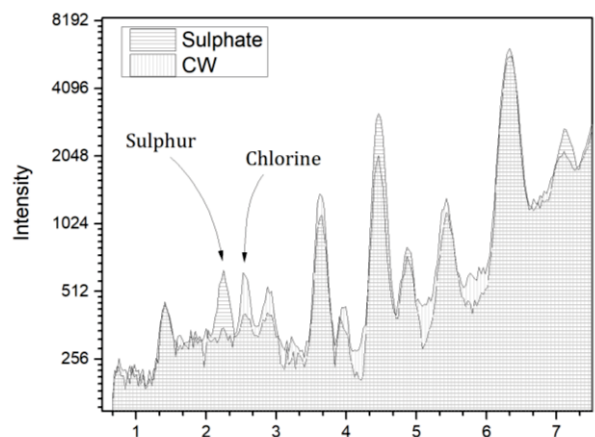
Fig. 4. Sum spectra comparison of samples sulphate and CW. Arrows point to S-K $\alpha$  and Cl-K $\alpha$  lines.

Concerning the corrosion components distribution across the sample surface, the chemical elements identified are either sulphur or chlorine (since carbon and oxygen cannot be detected by the instrument): being light (low Z) atoms, their counts statistics is considerably low (Fig. 4).

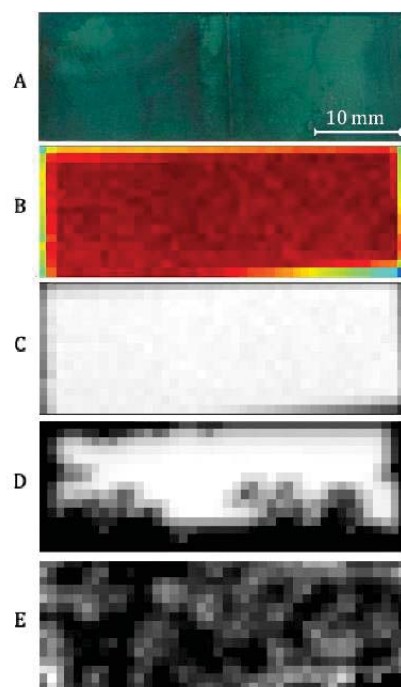
Fig. 5. CW sample surface (A) and scans: (B) sum map, (C) copper map, (D) filtered copper map and (E) chlorine map.

Differently from what was observed in the *sulphate sample*, the corrosion products distribution did not follow any specific “macro” pattern, nor did the copper distribution map shown any gradient (Fig. 5). The reason may be the distribution of chlorine and the corrosion products formation process. Constantinides et al. [2] demonstrated through artificially corroded Cu-alloys that chlorine is preferably deposited in an inner layer, in between the alloy’s bulk and the outer corrosion layer. This preferential deposition is created by a mechanism originating from mechanical stress or chemical reaction, where cracking occurs in the surface and promotes pitting corrosion. This process causes a further dissolution of the alloy, producing more  $\text{Cu}^+$  cations which reacts with  $\text{Cl}^-$  anions present in the solution, as a result  $\text{CuCl}$  and  $\text{CuCl}_2$  are formed and built up in an internal layer to the corrosion surface. Even though the formation of chlorine compounds is propelled in this mechanism, the net weight concentration of chlorine is still relatively low (when compared to the alloying elements concentration and the system detection limit), commonly about 2 wt%. Moreover, considering that chlorine is deposited underneath a Cu-oxide layer, its detection by the MA-XRF system is further hindered by attenuation effects.
