ARCHITECTURAL HERITAGE AT RISK: THE CASE OF THE MAGNANO HAMLET (PIEDMONT, ITALY)

2.1 Construction features and current state of conservation

2.2 Analysis of the interventions carried out in the Magnano hamlet

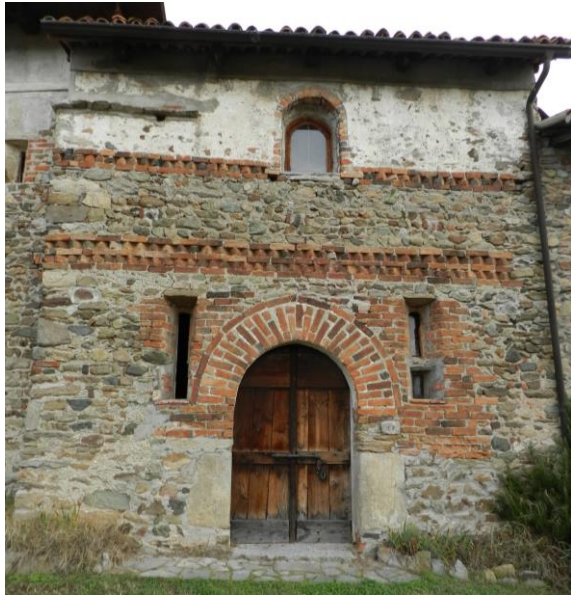
Figure 5. Brick decorative elements (credits Manuela Mattone).

The openings are mostly delimited by fired bricks to be referred to interventions carried out in the XVth century on the existing wall structure (Vigilino Davico, 1978). Sometimes, bricks are also used for decorative purposes: elements such as cornices and notches adorn some buildings' façade (Figure 5).

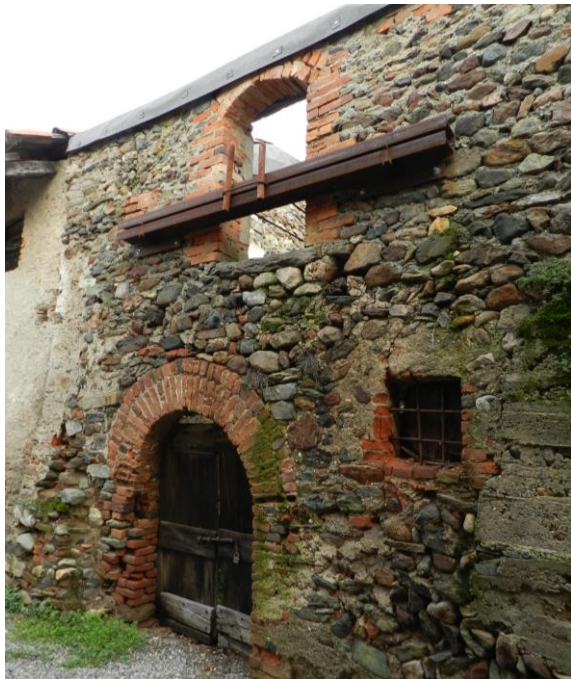
Abandoned for years, some buildings are without roof and their stability is guaranteed through temporary static aids, positioned by the municipal administration in order to avoid their collapse (Figure 6).

Figure 6. Building C - Temporary consolidation intervention carried out by the municipality (credits Manuela Mattone).

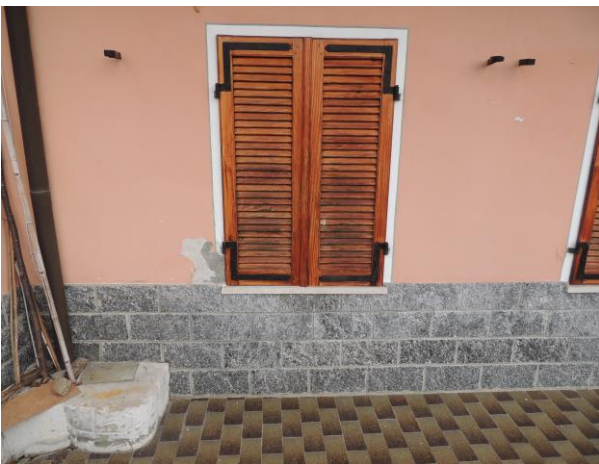
Figure 8. Building E - Baseboard in stone slabs and an external flooring in ceramic tiles, replacement of the windows and application of a new finishing layer (credits Fabio Fratini).

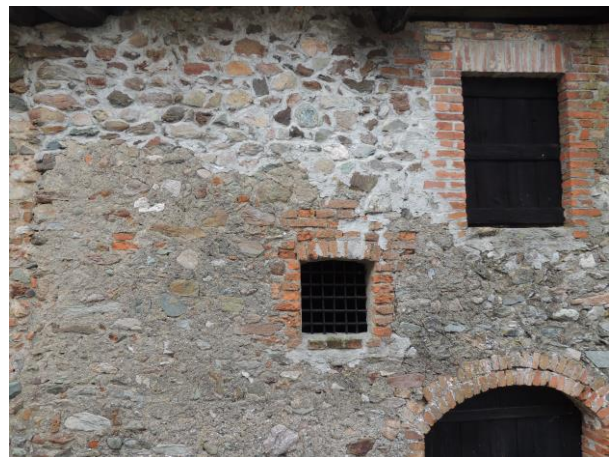
2.2.2 Incompatible materials and technique: Numerous inappropriate punctual interventions have also been done. Restoration of the walls has been often carried out using inadequate laying materials and methods. Particularly noteworthy is the widespread use of cement mortar not only for the bedding of bricks, but also for the reintegration of cracks and heavily eroded bricks (Figures 11 to 15).

Figure 11. Building B - Reintegration of the masonry adopting inappropriate materials (credits Fabio Fratini).

This intervention is incompatible not only from the mechanical point of view (elastic modulus of the whole), but also as regards the chemical (development of saline efflorescence) and physical compatibility (different behaviour towards water both in liquid and vapour form).

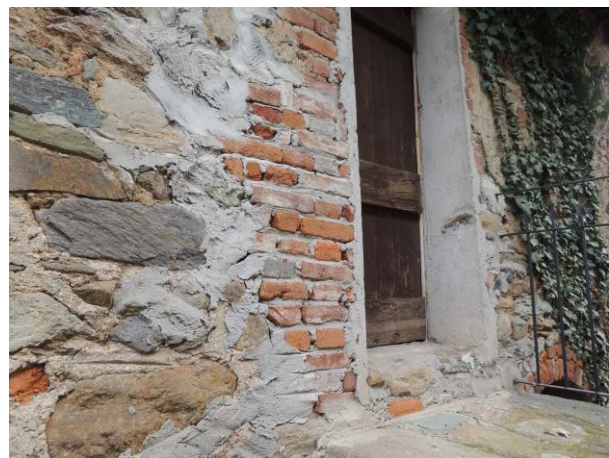
Figure 12. Building G - Improper intervention with cement mortar (credits Fabio Fratini).

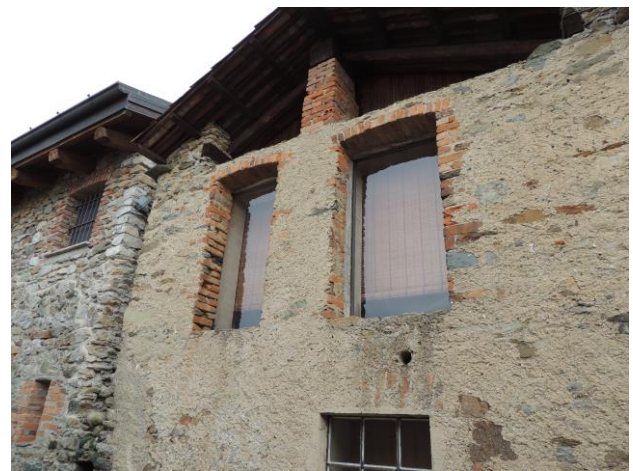
Interesting in this sense are the examples of Figures 16 and 17. In the first case, the intervention aimed at ensuring the re-use of the building was carried out without changing the characteristics of the masonry surface and of the roof, whose thickness was not altered.

In order to solve the problems due to the lack of light in the interior, windows were replaced adopting thin window frames (Figure 16).

Figure 16. Building F - Intervention preserving both the external masonry surfaces and the roof (credits Silvia Rescic).

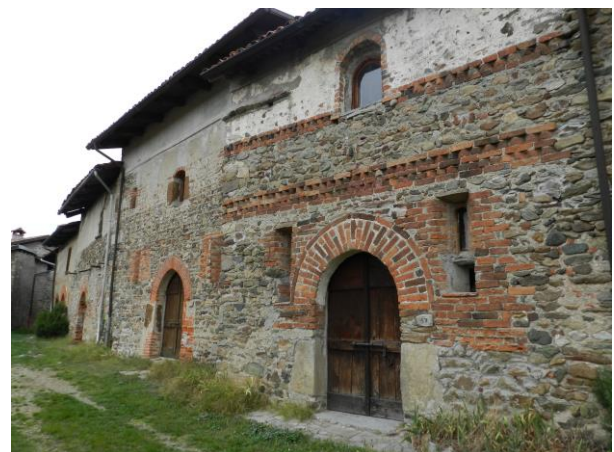
Preservation of the external wall surfaces and their stratifications, as well as of the finishing elements (such as the access portal) characterise also the intervention shown in Figure 17.

Figure 17. Building H - Preservation of the surface of the external wall and of the access portal (credits Silvia Rescic).
