TOWARDS A SUSTAINABLE AND CONTEXT-BASED APPROACH TO ANTI-SEISMIC RETROFITTING TECHNIQUES FOR VERNACULAR ADOBE BUILDINGS IN COLOMBIA.

F. De Filippi¹, R. Pennacchio^{1,*}, L. Restuccia², S. Torres¹

KEY WORDS: Colombia, Vernacular heritage, Earthen architecture, Adobe, Appropriate technologies, Seismic behaviour, Reinforcement techniques.

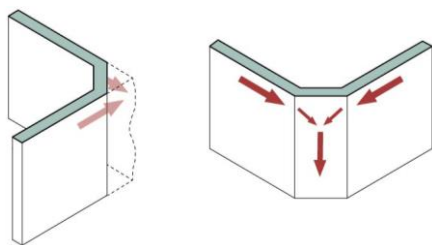
Corner chamfering helps to reduce the shear and bending stress concentration on the junction of perpendicular walls (Figure 2) (Minke, 2001; Pennacchio, Nicchia, 2013). Even if this strategy can increase by 9% the gravitational and horizontal collapse load (Angulo et al., 2011), can only be applied during new buildings design phase, and cannot be taken into consideration for retrofit interventions.

Figure 2. Rounded corners scheme. Figure from Minke, 2001.

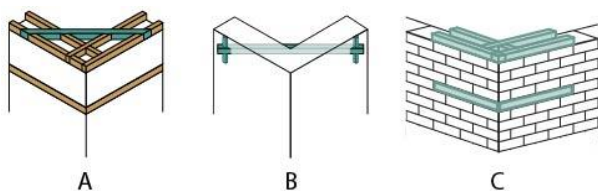
Corner braces or corner keys reinforcements otherwise, help strengthening wall-to-wall junction as shown on Figure 3 (Angulo et al. 2011; Ortega et al., 2017).

Corner timber bracing reduce tensile cracks failures, by sharing shear stress among adjacent walls, while helping the masonry to keep its box-like behaviour, by strengthening corner junctions. Additionally, timber is able to assume the bending stress before adobes are carried to failure. Furthermore, even if the adobe masonry would crack in the corners, the braces reinforcement should keep the walls together. This type of reinforcement allows to modify the seismic response of the structure: it acquires a dissipative behaviour and therefore a greater ductility, linked to the post-peak capacity to absorb energy before breaking (Ortega et al., 2017), avoiding a sudden collapse of the corner. Angulo et al. (2011), found that, under vertical and horizontal loads, in case of corner braces fixed to the ring beam, the collapse load increase in 118% (Figure 3a), in 64% using diagonal tie braces (b), while, bracing beams parallel to the walls, showed a collapse load increase of 48% (c).

Figure 3. Corner braces options. Image redraw from Ortega et al. (2017).

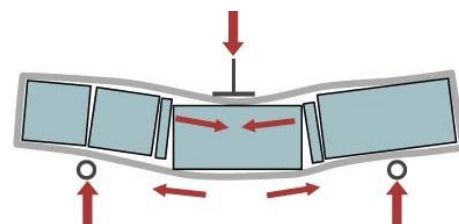
3.3.1 Plastic geogrids and synthetic ropes reinforcement: were studied for the first time in Latino America at 'Pontificia Universidad Catolica de Perú'. An interesting proposal, in this regard, is the use of a rope grid to reduce costs and make the technology accessible to poor population (Blondet et al., 2011). The behaviour of the wall compound, under horizontal non-axial loads, is schematized in Figure 4 (Invernizzi et al. 2017). Geogrid control flexural cracks caused by the maximum bending moment, thus reducing the associated failure mechanisms and, providing tensile strength to the adobe wall (Blondet et al., 2011). Considering a deflection increase of almost 750% for the geogrids reinforced walls under non-axial loads, Invernizzi et al. (2017) specified that the reinforcement is able to redistribute the stress, bracing the wall and keeping it together, as a single element. Moreover, shear capacity of geogrid reinforced elements is increased by 180% and shear deformation is 4 times larger than the unreinforced walls (Invernizzi et al. 2017). This suggests that failure mechanisms by shear cracking in walls and corners can be reduced by geogrid reinforcements.

Figure 4. Adobe bricks kinematics and geogrid bending effect. Redrew from Invernizzi et al., 2017.

- All wall surfaces, should be surrounded, by the geogrid, including openings indoor faces;
- Geogrids should be fixed by ropes passing through ring beams, basement courses and wall thickness;
- In order to control cracking and increase wall's ductility, the reinforcement should be covered with earthen plaster.
