TOWARDS A SUSTAINABLE AND CONTEXT-BASED APPROACH TO ANTI-SEISMIC
RETROFITTING TECHNIQUES FOR VERNACULAR ADOBE BUILDINGS IN COLOMBIA

Volume XLIV-M-1-2020, 2020 | HERITAGE2020 (3DPast | RISK-Terra) International Conference on Vernacular Architecture in World Heritage Sites. Risks and New Technologies (Volume XLIV-M-1- 2020)

TOWARDS A SUSTAINABLE AND CONTEXT-BASED APPROACH TO ANTI-SEISMIC RETROFITTING TECHNIQUES FOR VERNACULAR ADOBE BUILDINGS IN COLOMBIA.

F. De Filippi¹, R. Pennacchio^{1,*}, L. Restuccia², S. Torres¹

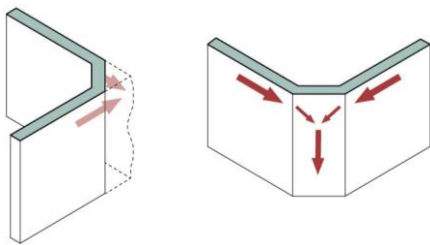
Corner chamfering helps to reduce the shear and bending stress concentration on the junction of perpendicular walls (Figure 2) (Minke, 2001; Pennacchio, Nicchia, 2013). Even if this strategy can increase by 9% the gravitational and horizontal collapse load (Angulo et al., 2011), can only be applied during new buildings design phase, and cannot be taken into consideration for retrofit interventions.

Figure 2. Rounded corners scheme. Figure from Minke, 2001.

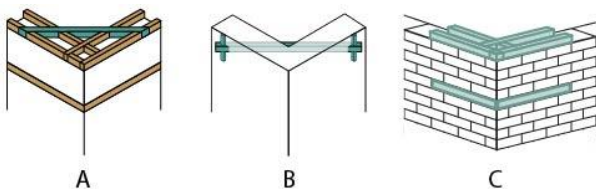
Corner braces or corner keys reinforcements otherwise, help strengthening wall-to-wall junction as shown on Figure 3 (Angulo et al. 2011; Ortega et al., 2017).

Corner timber bracing reduce tensile cracks failures, by sharing shear stress among adjacent walls, while helping the masonry to keep its box-like behaviour, by strengthening corner junctions. Additionally, timber is able to assume the bending stress before adobes are carried to failure. Furthermore, even if the adobe masonry would crack in the corners, the braces reinforcement should keep the walls together. This type of reinforcement allows to modify the seismic response of the structure: it acquires a dissipative behaviour and therefore a greater ductility, linked to the post-peak capacity to absorb energy before breaking (Ortega et al., 2017), avoiding a sudden collapse of the corner. Angulo et al. (2011), found that, under vertical and horizontal loads, in case of corner braces fixed to the ring beam, the collapse load increase in 118% (Figure 3a), in 64% using diagonal tie braces (b), while, bracing beams parallel to the walls, showed a collapse load increase of 48% (c).

Figure 3. Corner braces options. Image redraw from Ortega et al. (2017).

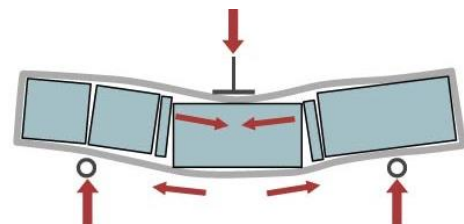
3.3.1 Plastic geogrids and synthetic ropes reinforcement: were studied for the first time in Latino America at ‘Pontificia Universidad Catolica de Perú’. An interesting proposal, in this regard, is the use of a rope grid to reduce costs and make the technology accessible to poor population (Blondet et al., 2011). The behaviour of the wall compound, under horizontal non-axial loads, is schematized in Figure 4 (Invernizzi et al. 2017). Geogrid control flexural cracks caused by the maximum bending moment, thus reducing the associated failure mechanisms and, providing tensile strength to the adobe wall (Blondet et al., 2011). Considering a deflection increase of almost 750% for the geogrids reinforced walls under non-axial loads, Invernizzi et al. (2017) specified that the reinforcement is able to redistribute the stress, bracing the wall and keeping it together, as a single element. Moreover, shear capacity of geogrid reinforced elements is increased by 180% and shear deformation is 4 times larger than the unreinforced walls (Invernizzi et al. 2017). This suggests that failure mechanisms by shear cracking in walls and corners can be reduced by geogrid reinforcements.

Figure 4. Adobe bricks kinematics and geogrid bending effect. Redrew from Invernizzi et al., 2017.
