## Addressing the need for standardization of test methods for self-healing concrete: an inter-laboratory study on concrete with macrocapsules

Development and commercialization of self-healing concrete is hampered due to a lack of standardized test methods. Six inter-laboratory testing programs are being executed by the EU COST action SARCOS, each focusing on test methods for a specific self-healing technique. This paper reports on the comparison of tests for mortar and concrete specimens with polyurethane encapsulated in glass macrocapsules. First, the pre-cracking method was analysed: mortar specimens were cracked in a three-point bending test followed by an active crack width control technique to restrain the crack width up to a predefined value, while the concrete specimens were cracked in a three-point bending setup with a displacement-controlled loading system. Microscopic measurements showed that with the application of the active control technique almost all crack widths were within a narrow predefined range. Conversely, for the concrete specimens the variation on the crack width was higher. After pre-cracking, the self-healing effect was characterized via durability tests

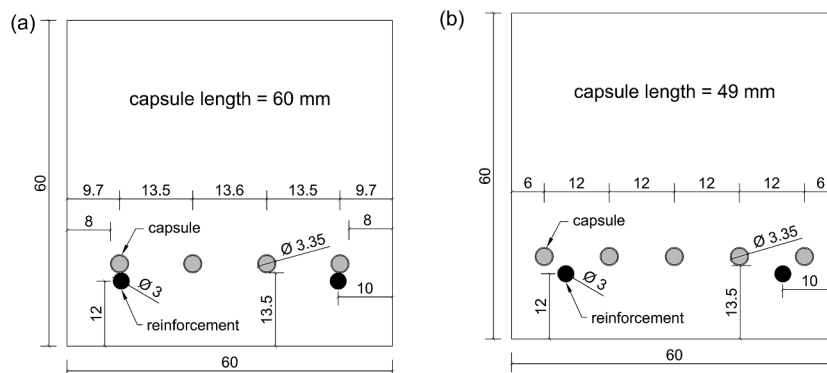
Figure 1. Cross-section of concrete specimens (a: layout with four capsules, b: layout with five capsules) (dimensions in mm).

agent to a slightly larger area of the crack in order to obtain perfect healing, see Figure 1 a. For the layout with five capsules, the requirement that the largest aggregates should be able to pass between the capsules and the side faces was not imposed as this would cause too much deviation from the identical circular outflow for the outermost capsules. Instead extra care was taken in filling and compacting these moulds. In both layouts, capsules were prepositioned in the moulds by gluing them on a nylon wire running just above the reinforcement, see Figure 2.

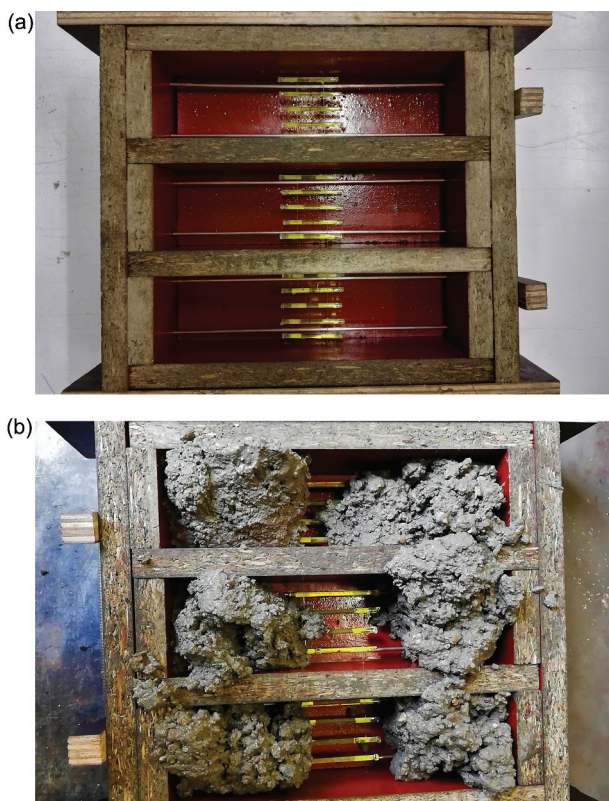
Figure 2. Moulds to make concrete specimens ( $60 \times 60 \times 220 \text{ mm}^3$ ) with capsules (a: mould with five capsules; b: casting of specimens with four capsules).

All specimens were compacted on a vibration table. For the specimens with capsules, concrete was first placed next to the capsules, see Figure 2. The vibration table was then activated allowing the concrete to flow under and between the capsules, after which the rest of the concrete was added. The specimens were stored in a curing room (20°C and >95% relative humidity RH) and the day after casting they were demoulded. No compaction defects were visible for the specimens with five capsules, despite the limited distance between the outer capsules and the walls of the mould. The specimens were sealed in plastic foil in groups of three to prepare them for shipping. Up until the moment of shipping the specimens remained in a climate room at 20°C.

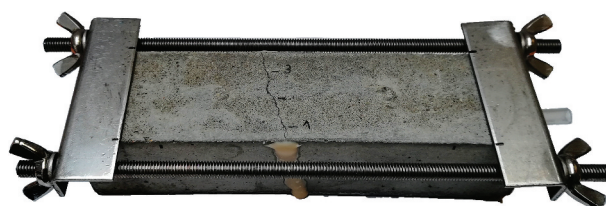
**Figure 4.** Screw jacks used for actively restraining the crack width of a mortar specimen.

After cracking the mortar specimens, they were restrained using screw jacks. The final mean crack width  $w$  measured by all labs after the active crack width restraining process is given in Figure 12. This figure shows the individual values, as well as the mean crack width of the series (horizontal lines) and the 95% confidence interval on this mean (error bars) for both REF and CAPS specimens. The green shaded band indicates the desired crack width range (290–310  $\mu\text{m}$ ). Lab 3 and lab 4 did a pre-test on a separately sent batch of specimens to familiarize themselves with the test technique, these are denoted by lab 3\* and lab 4\*. The crack width of many of these specimens fell outside of the intended range. Additionally, the screw jacks were not applying a significant pressure on the specimens, because the crack width of these specimens was rather limited after crack creation by three-point bending. In

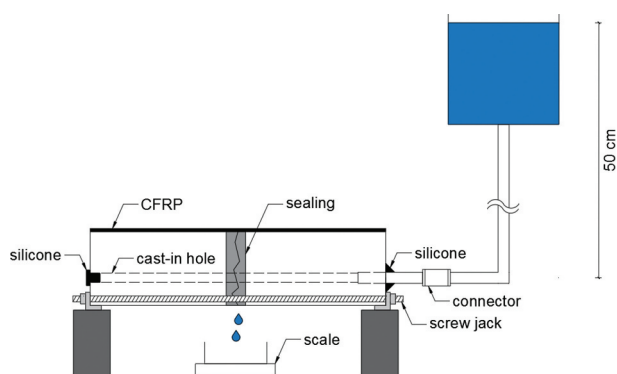
Figure 5. Water permeability measured by a constant head water flow test [33].

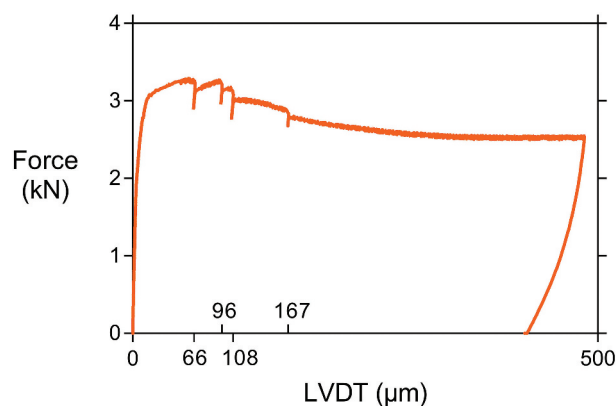
**Figure 6.** Load displacement graph of a CAPS specimen showing capsule rupture at 66, 96, 108, and 167  $\mu$ m.

From the data recorded during crack creation by three-point bending, controlled by using a displacement-controlled loading system, it was possible to plot load-displacement graphs. In the case of CAPS specimens, small drops in the load indicated the rupture of capsules. Figure 6 shows the load displacement graph of a representative concrete specimen with four capsules. In the represented case the four capsules broke at: 66, 96, 108 and 167  $\mu$ m of crack mouth opening. For some specimens, it was not possible to discern a discrete load drop for all of the contained capsules. The reason for this could be noise on the data or simultaneous breaking of multiple capsules. It has been reported for the type of capsules used in this study that the crack width at rupture at the location of the capsule is approximately 25  $\mu$ m [48]. This value was surpassed in all specimens; therefore, it can be assumed that all capsules inside of the concrete specimens ruptured.

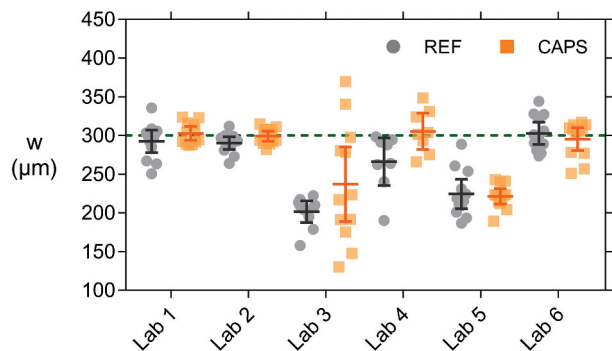
**Figure 7.** Crack width  $w$  of individual concrete specimens for which the mean of the series are indicated by horizontal lines and error bars give the 95% confidence interval on this mean. The horizontal dashed line indicates the target crack width of 300  $\mu\text{m}$ .

After cracking, the crack width  $w$  at the bottom side of the concrete specimens was measured. Figure 7 shows the individual mean crack width of each specimen, as well as the mean of the series (horizontal lines) and the 95% confidence interval on this mean (error bars) for both REF and CAPS specimens. The horizontal-dashed line indicates the target crack width of 300  $\mu$ m. It is evident that there was quite some variation on the results, even though two minimal outliers (one of lab 3 REF and one of lab 4 REF) and two maximal outliers (two of lab 4 CAPS) were discarded from the dataset prior to plotting this graph and performing the subsequent statistical analysis. Table 5 shows the number of specimens for each lab after removing the outliers (lab 3 and lab 4 also lost some specimens while calibrating the cracking procedure). For each lab it was statistically analysed if the mean crack width of the REF, respectively CAPS specimens, was equal to the target crack width of 300  $\mu$ m (level of significance = 5.0%). Table 6 indicates that this

hypothesis was not valid in the case of: the REF series of lab 2, both the REF and CAPS series of lab 3 and 5, and the REF series of lab 4. For the REF series of lab 2, the difference was rather moderate; the mean was practically equal to the target with a mean value of 290  $\mu\text{m}$ , but the statistical test indicated a significant difference from 300  $\mu\text{m}$  due to the low variation on the results, see also Figure 7. For each lab it was also analysed using independent sample t-tests (level of significance = 5.0%) if the mean crack width of the REF series was equal to the CAPS series. Table 6 indicates that only for lab 4 a moderately significant result was obtained (probability value  $p = 3.0\%$ ). Indeed, Figure 7 shows that the CAPS specimens of lab 4 had a slightly wider crack width than the REF specimens. To study if there was a significant difference for the crack widths obtained by the different labs the results of the REF and CAPS specimens were taken together – despite the difference between the REF and CAPS series of lab 4. Equal variances could not be assumed in the analysis (level of significance = 5.0%,  $p \approx 0\%$ ). Therefore, the equality of means was investigated by both a Welch test and a Brown–Forsythe test. Both tests showed that the means were not all equal (level of significance = 5.0%,  $p \approx 0\%$ ). In the post hoc analysis, a Tamhane’s T2 test revealed two separate groups: the means of lab 1, 2, 4 and 6 were equal

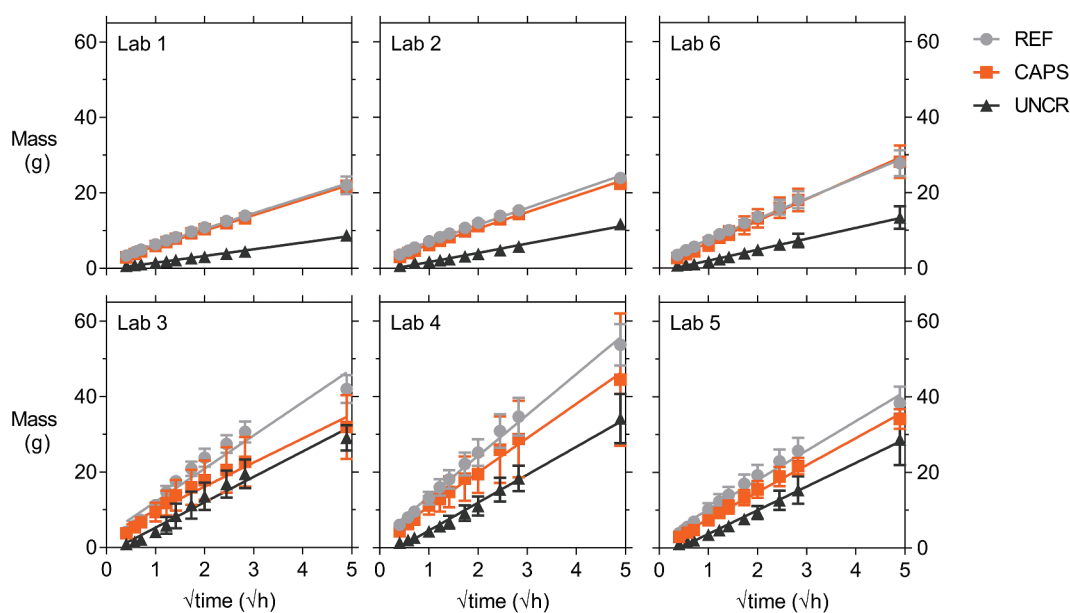
Figure 8. Cumulative mass gain versus the square root of time of REF, CAPS and UNCR specimens (waterproofed with aluminium tape) of all six labs with the linear regression line. Error bars indicate the standard deviation.

In order to calculate the sealing efficiency according to equation 1, the slope of the linear regression curve was determined both for waterproofing with aluminium tape and again for waterproofing with coating. It was noted that for nearly all cracked specimens the value after 24 hours of water contact fell below the regression curve, which was also the case when the specimens were waterproofed with aluminium tape (see Figure 8). In contrast, the uncracked

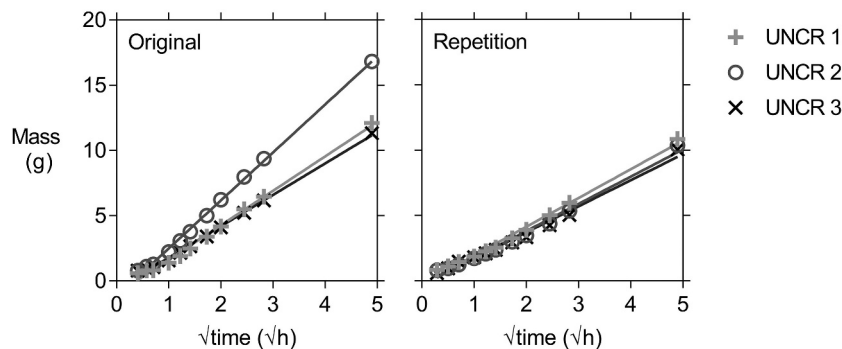
**Figure 9.** Comparison of the cumulative mass gain versus the square root of time for the uncracked specimens of lab 6 with the individual linear regression lines, showing a more uniform behaviour for the repeated waterproofing with aluminium tape compared to the original waterproofing with aluminium tape.

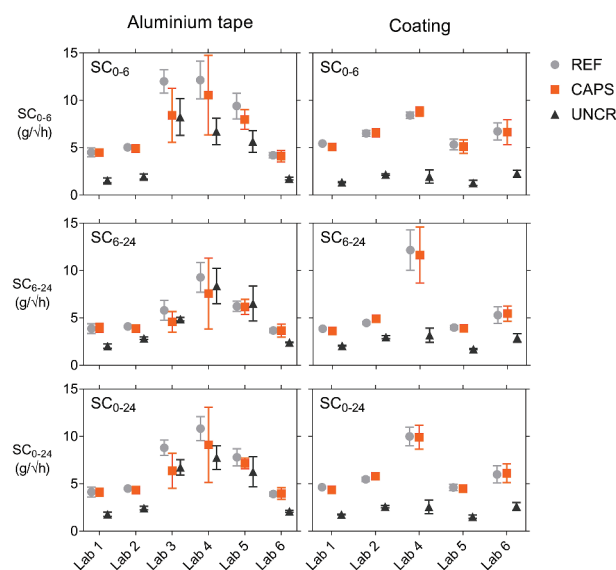
**Figure 10.** Sorption coefficients  $SC_{0-6}$ ,  $SC_{6-24}$  and  $SC_{0-24}$  of REF, CAPS and UNCR specimens highlighting that an improved waterproofing quality results in more homogenous results. Error bars indicate the standard deviation.

Figure 10 gives a comparison of the three sorption coefficients,  $SC_{0-6}$ ,  $SC_{6-24}$  and  $SC_{0-24}$ , in the case of waterproofing with aluminium tape and in the case of coating. The results with aluminium tape for lab 6 are the ones from the repeated test after removing and applying new aluminium tape. For the cracked specimens (REF and CAPS) with aluminium tape, it was clear that  $SC_{6-24}$  is lower than  $SC_{0-6}$ . As explained before, this was a result of the saturation of the concrete above the crack tip. All sets of specimens tested by the different labs exhibited this behaviour, but it was distinctly visible for labs 3, 4 and 5. On the other hand, the sorption coefficient of the second period  $SC_{6-24}$  of the uncracked specimens is higher than the one of the initial period  $SC_{0-6}$ , as can, for example be seen for the uncracked specimens of lab 5 with

aluminium tape which gave a  $SC_{6-24}$  equal to that of the cracked specimens. While this was true for all labs, the large difference observed in lab 5 could have originated from an imperfect sealing of one of the specimens which led to an increase of the SC. The difference is less pronounced for the coated repetition. The uncracked specimens with aluminium tape of lab 3 were an exception to this observation that  $SC_{6-24}$  is higher than  $SC_{0-6}$ . Many of these specimens, also the cracked ones, had a jump in their cumulative mass gain between 1 h 30 min and 2 h. This was the result of excessive water addition in the reservoir to compensate for the drop in water level due to absorption and evaporation. Overall, looking at the results with aluminium tape, the same conclusions can be drawn as for the results in Figure 8: lab 1, 2 and 6 obtained similar results, the results of lab 3, 4 and 5 were significantly higher and also had a higher variation, which in some cases was not explained by a higher mean value.

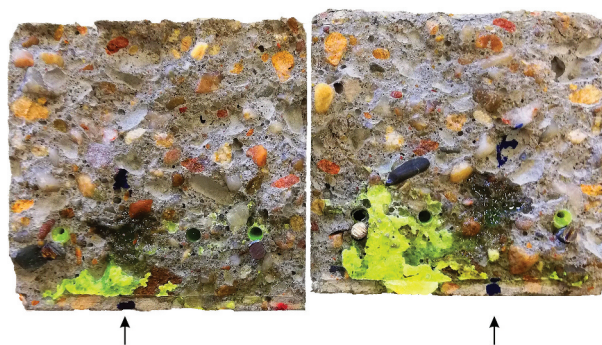
**Figure 11.** Crack surfaces (60 x 60 mm<sup>2</sup>) of one of the best performing CAPS specimen of lab 1. The hardened PU can be seen as fluorescent yellow. Arrows indicate the capsule from which fresh PU (visible as a dark stain) leaked on the surface when the specimen was broken. Image is highly saturated to improve visibility.

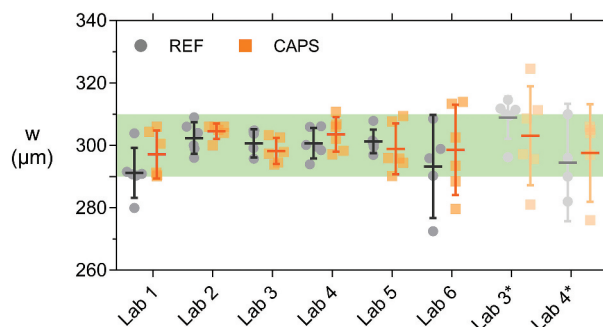
**Figure 12.** Crack width  $w$  of individual mortar specimens for which the mean of the series is indicated by a horizontal line and error bars give the 95% confidence interval on this mean. Most mortar specimens had a crack width  $w$  within the desired crack width range (shaded area).

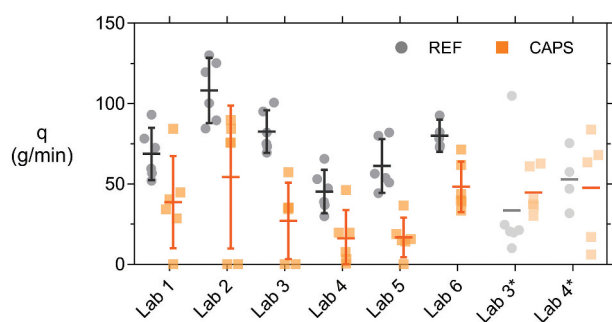
**Figure 13.** Individual flow rates  $q$  and the means of the different specimen batches indicated by horizontal lines. Error bars give the 95% confidence interval on the mean.

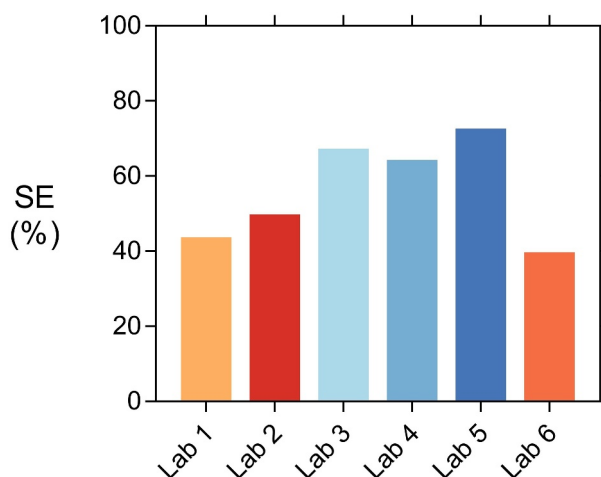
Figure 14. The sealing efficiency  $SE_{flow}$ , measured in the different labs.

Figure 14. Figure 16 shows the water flow of the different specimens in function of their surface coverage. It is noted that it is impossible to obtain a perfect surface coverage since the area of the hole (used to induce the water in the permeability test) was taken into account in the total area. Anglani et al. [37] studied the same PU healing agent but encapsulated in one cementitious capsule with a larger diameter. These capsules had either an internal or an external epoxy coating to make them moisture-proof. They measured an average surface coverage of 36% for specimens with internally coated capsules and 47% for specimens with externally coated capsules. These values are comparable to the average surface coverage of the different labs, although it is noted that the variation is higher for the results reported here. The sealing efficiency measured by Anglani et al. [37], using the same permeability setup as is used in the current study, was equal to 79%, respectively 28%, for the specimens with an internally, respectively externally, coated capsule. Lab 1, 2, 4 and 5 obtained a sealing efficiency between 44% and 73% which falls in between these values.

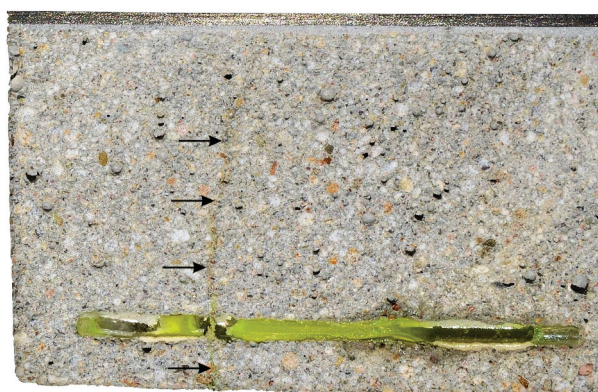
Figure 15. Mortar specimen with mortar removed from the side up to the location of a capsule (length approximately 55 mm) showing that most of the PU was retained in the capsule. Arrows indicate the location of the crack.

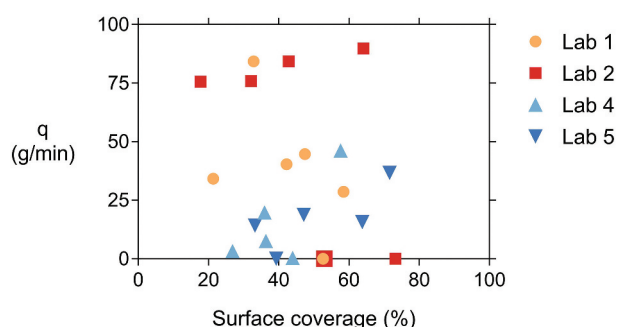
Figure 16. Water flow  $q$  versus the PU surface coverage for labs 1, 2, 4 and 5.

From Figure 16 it could also be concluded that a high surface coverage does not directly translate into a good sealing efficiency. There seems to be no strong relationship between the surface coverage and the water flow. Indeed, the surface coverage only has an indirect influence on the water flow. Figure 17 shows a crack surface overlaid with its filtered segmented image determined using the Trainable Weka Segmentation plugin in ImageJ, see section 2.3.4. The surface coverage of this sample was one of the highest (71.6%), yet the zone below the hole was not completely covered with PU, leaving a path for the water to leak out of the specimen. To seal a crack, it is sufficient if the crack mouth is filled with healing agent, or in the studied specimens if the water-inducing hole is surrounded with healing agent. For many specimens it was noted that the PU spread regions from the individual capsules did not connect, and thus a barrier to withstand the water pressure could not be created.

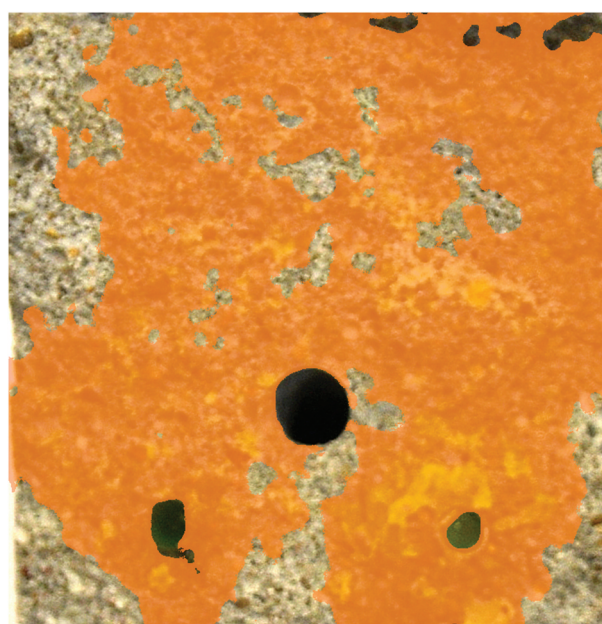
Figure 17. Crack surface ( $40 \times 40 \text{ mm}^2$ ) of one of the specimens with the best PU surface coverage but still a significant flow due to an unconnected crack filling below the cast-in hole (through which water was induced during the permeability test). The crack mouth through which water leaked out of the specimen is oriented to the bottom, like in the water flow test.

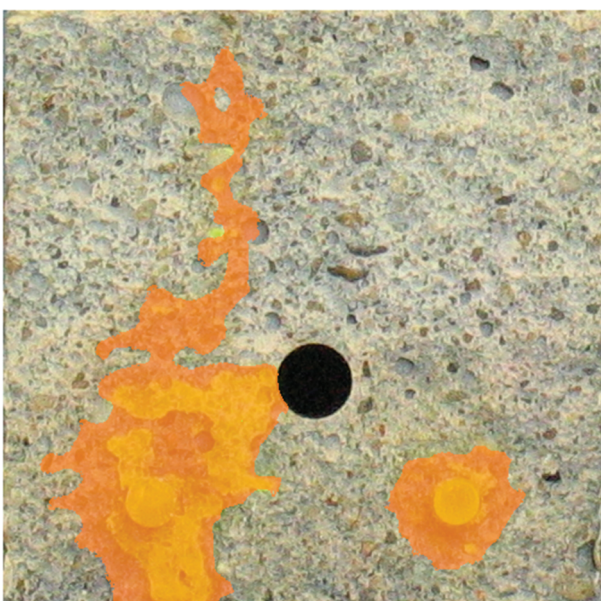
**Figure 18.** Crack surface ( $40 \times 40 \text{ mm}^2$ ) of specimen with limited PU surface coverage. The crack mouth through which water leaked out of the specimen is oriented to the bottom, like in the water flow test.
