Addressing the need for standardization of test methods for self-healing concrete: an inter-laboratory study on concrete with macrocapsules

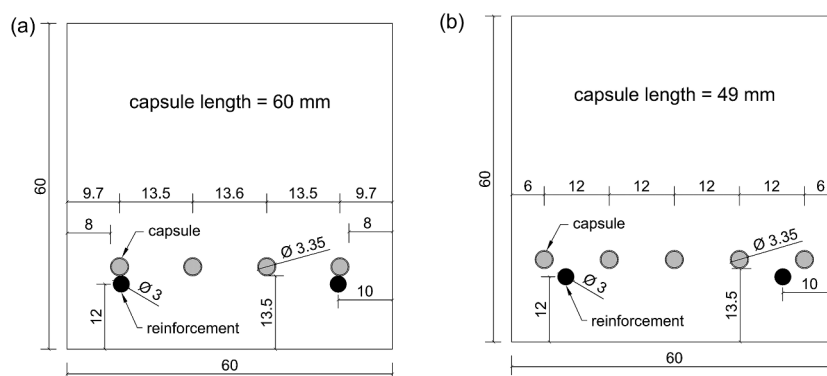
Figure 1. Cross-section of concrete specimens (a: layout with four capsules, b: layout with five capsules) (dimensions in mm).

agent to a slightly larger area of the crack in order to obtain perfect healing, see Figure 1 a. For the layout with five capsules, the requirement that the largest aggregates should be able to pass between the capsules and the side faces was not imposed as this would cause too much deviation from the identical circular outflow for the outermost capsules. Instead extra care was taken in filling and compacting these moulds. In both layouts, capsules were prepositioned in the moulds by gluing them on a nylon wire running just above the reinforcement, see Figure 2.

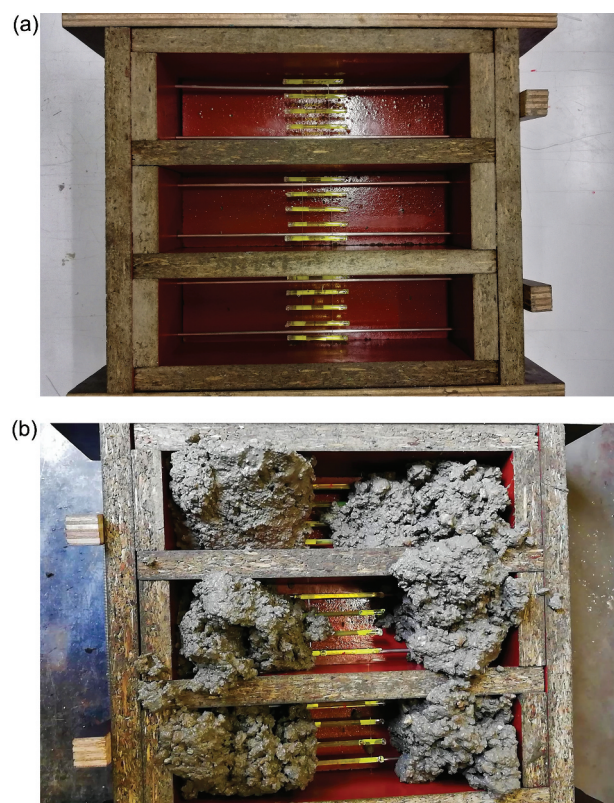
Figure 2. Moulds to make concrete specimens ($60 \times 60 \times 220 \text{ mm}^3$) with capsules (a: mould with five capsules; b: casting of specimens with four capsules).

All specimens were compacted on a vibration table. For the specimens with capsules, concrete was first placed next to the capsules, see Figure 2. The vibration table was then activated allowing the concrete to flow under and between the capsules, after which the rest of the concrete was added. The specimens were stored in a curing room (20°C and >95% relative humidity RH) and the day after casting they were demoulded. No compaction defects were visible for the specimens with five capsules, despite the limited distance between the outer capsules and the walls of the mould. The specimens were sealed in plastic foil in groups of three to prepare them for shipping. Up until the moment of shipping the specimens remained in a climate room at 20°C.

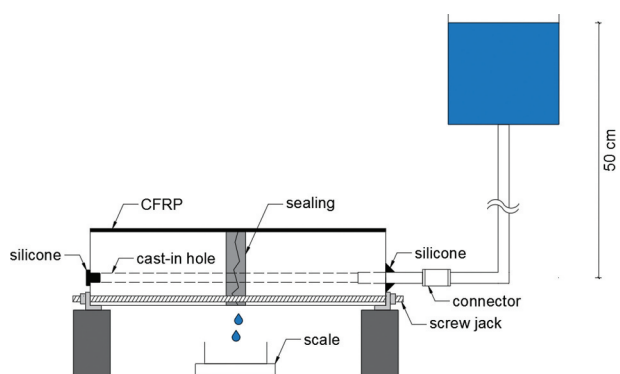
Figure 5. Water permeability measured by a constant head water flow test [33].

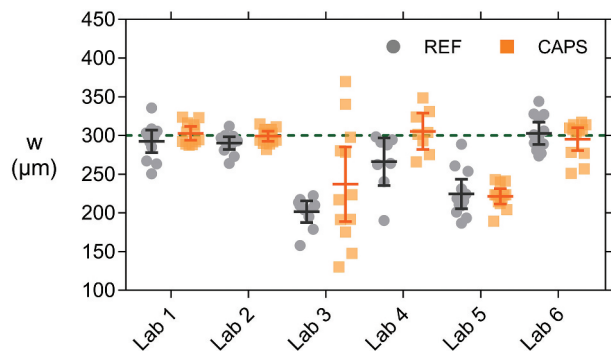
Figure 7. Crack width w of individual concrete specimens for which the mean of the series are indicated by horizontal lines and error bars give the 95% confidence interval on this mean. The horizontal dashed line indicates the target crack width of 300 μm .

After cracking, the crack width w at the bottom side of the concrete specimens was measured. Figure 7 shows the individual mean crack width of each specimen, as well as the mean of the series (horizontal lines) and the 95% confidence interval on this mean (error bars) for both REF and CAPS specimens. The horizontal-dashed line indicates the target crack width of 300 μ m. It is evident that there was quite some variation on the results, even though two minimal outliers (one of lab 3 REF and one of lab 4 REF) and two maximal outliers (two of lab 4 CAPS) were discarded from the dataset prior to plotting this graph and performing the subsequent statistical analysis. Table 5 shows the number of specimens for each lab after removing the outliers (lab 3 and lab 4 also lost some specimens while calibrating the cracking procedure). For each lab it was statistically analysed if the mean crack width of the REF, respectively CAPS specimens, was equal to the target crack width of 300 μ m (level of significance = 5.0%). Table 6 indicates that this

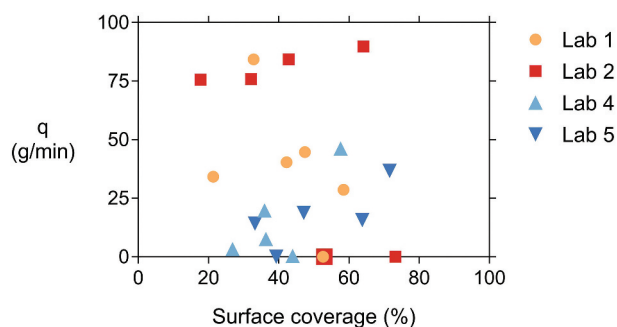
Figure 16. Water flow q versus the PU surface coverage for labs 1, 2, 4 and 5.

Figure 14. Figure 16 shows the water flow of the different specimens in function of their surface coverage. It is noted that it is impossible to obtain a perfect surface coverage since the area of the hole (used to induce the water in the permeability test) was taken into account in the total area. Anglani et al. [37] studied the same PU healing agent but encapsulated in one cementitious capsule with a larger diameter. These capsules had either an internal or an external epoxy coating to make them moisture-proof. They measured an average surface coverage of 36% for specimens with internally coated capsules and 47% for specimens with externally coated capsules. These values are comparable to the average surface coverage of the different labs, although it is noted that the variation is higher for the results reported here. The sealing efficiency measured by Anglani et al. [37], using the same permeability setup as is used in the current study, was equal to 79%, respectively 28%, for the specimens with an internally, respectively externally, coated capsule. Lab 1, 2, 4 and 5 obtained a sealing efficiency between 44% and 73% which falls in between these values.

From Figure 16 it could also be concluded that a high surface coverage does not directly translate into a good sealing efficiency. There seems to be no strong relationship between the surface coverage and the water flow. Indeed, the surface coverage only has an indirect influence on the water flow. Figure 17 shows a crack surface overlaid with its filtered segmented image determined using the Trainable Weka Segmentation plugin in ImageJ, see section 2.3.4. The surface coverage of this sample was one of the highest (71.6%), yet the zone below the hole was not completely covered with PU, leaving a path for the water to leak out of the specimen. To seal a crack, it is sufficient if the crack mouth is filled with healing agent, or in the studied specimens if the water-inducing hole is surrounded with healing agent. For many specimens it was noted that the PU spread regions from the individual capsules did not connect, and thus a barrier to withstand the water pressure could not be created.

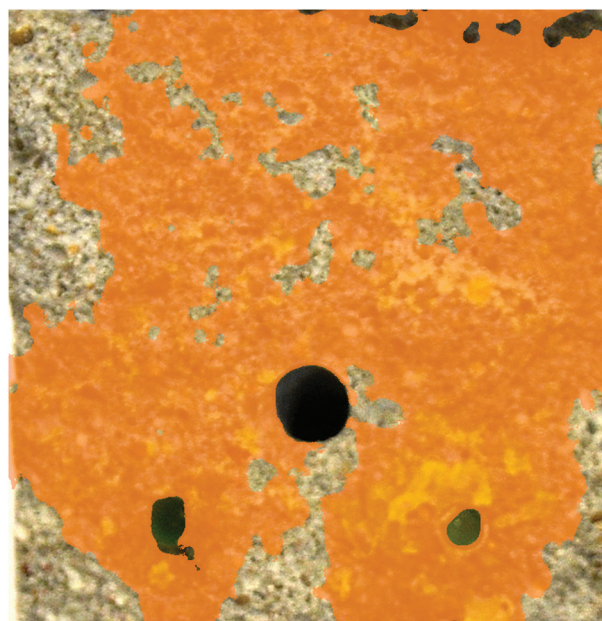
Figure 17. Crack surface ($40 \times 40 \text{ mm}^2$) of one of the specimens with the best PU surface coverage but still a significant flow due to an unconnected crack filling below the cast-in hole (through which water was induced during the permeability test). The crack mouth through which water leaked out of the specimen is oriented to the bottom, like in the water flow test.
