Vinyl-Asbestos Floor Risk Exposure in Three Different Simulations

Lorena Zichella * , Fiorenza Baudana, Giovanna Zanetti and Paola Marini

Abstract: Vinyl floors are widely used in public areas for their low cost and easy cleaning. From 1960 to 1980, asbestos was often added to improve vinyl floor performances. The Italian Ministerial Decree (M.D.) 06/09/94 indicates asbestos vinyl tiles as non-friable materials and, therefore, few dangerous to human health. This work aims to check through three different experimental tests if asbestos floor tiles, after decades of use, maintain their characteristics of compactness and non-friability. The effect of a small stone fragment stuck in the sole of rubber shoes was reproduced by striking the vinyl floor with a crampon. A vinyl tile was broken into smaller pieces with the aid of pliers to simulate what normally happens when workers replace the floors or sample it to verify the presence of asbestos. The third test reproduced the abrasion of the tile surface due to the dragging of furniture or heavy materials or sand grains that remain attached to the soles of shoes. The tests were carried out in safe conditions, working under an extractor

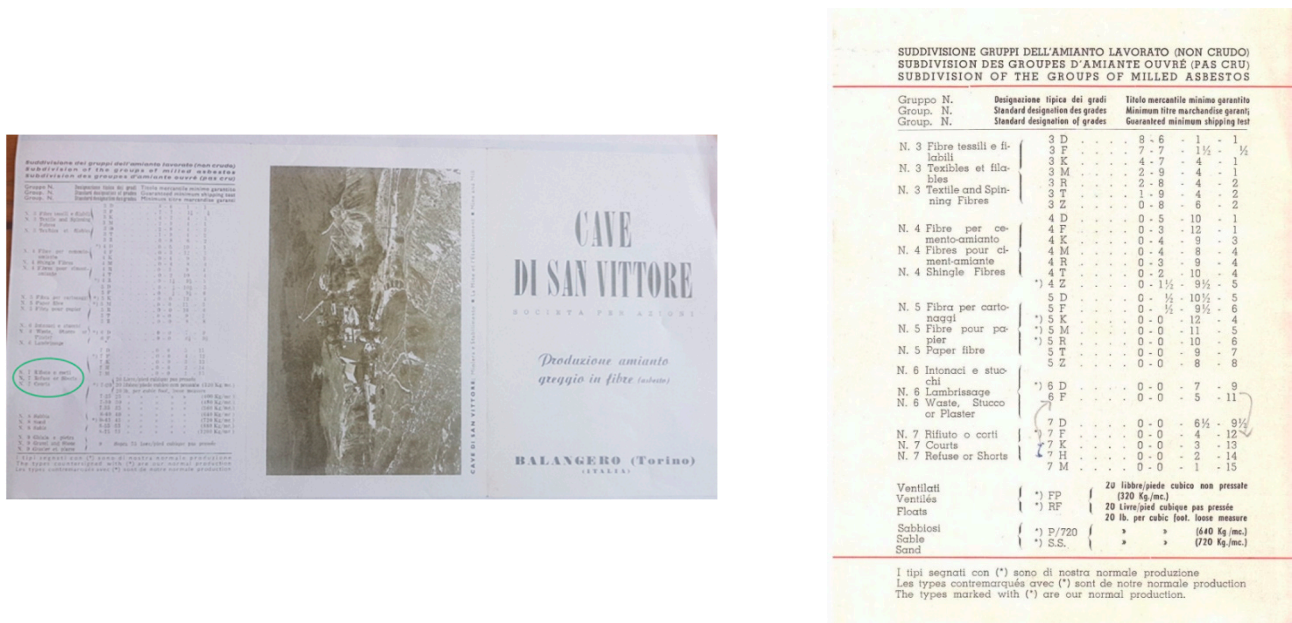
Figure 1. (a) San Vittore (Balangero, Turin, Italy) quarry, flyer extract for asbestos fiber production. Asbestos group 7 is circled in green, probably used for vinyl-asbestos floor. (b) Particularities of the subdivision of the group of milled asbestos (source: https://it.wikipedia.org/wiki/Amiantifera_di_Balangero; accessed on 10 January 2021).

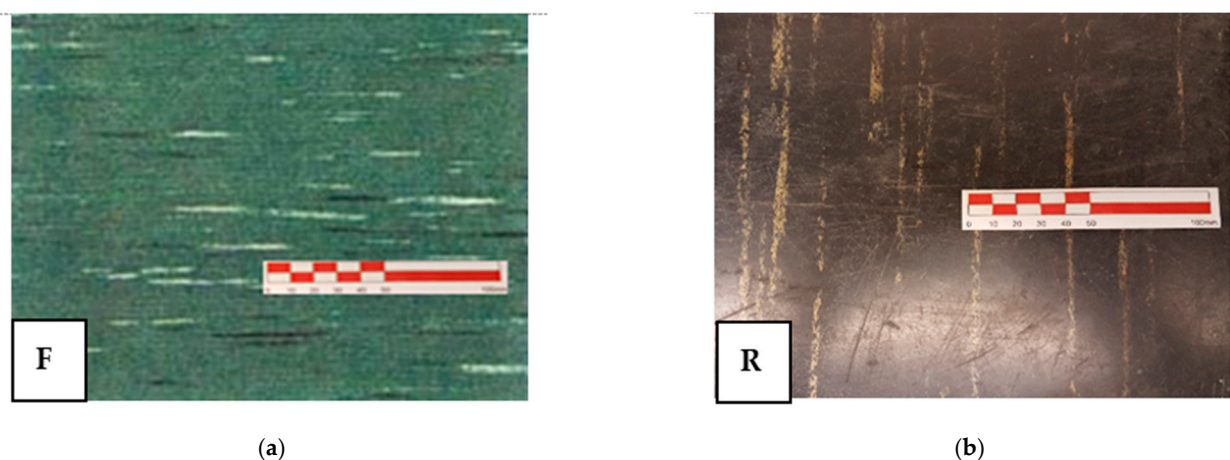
Figure 3. (a) Sample F—squared floor green tiles with white and black stripes, more flexible and in good condition (b) Sample R—squared floor black tiles with beige stripes, quite rigid and in fairly good condition.

The prevalent use of vinyl floors containing asbestos was in public buildings and popular housing. In this context, two types of vinyl from public buildings have been considered. In Figure 3, they are shown macroscopically. The green vinyl (F) on the left was laid in the 1990s and shows a flexible structure. The black vinyl (R) on the right was laid in the 1980s and shows a more rigid structure.

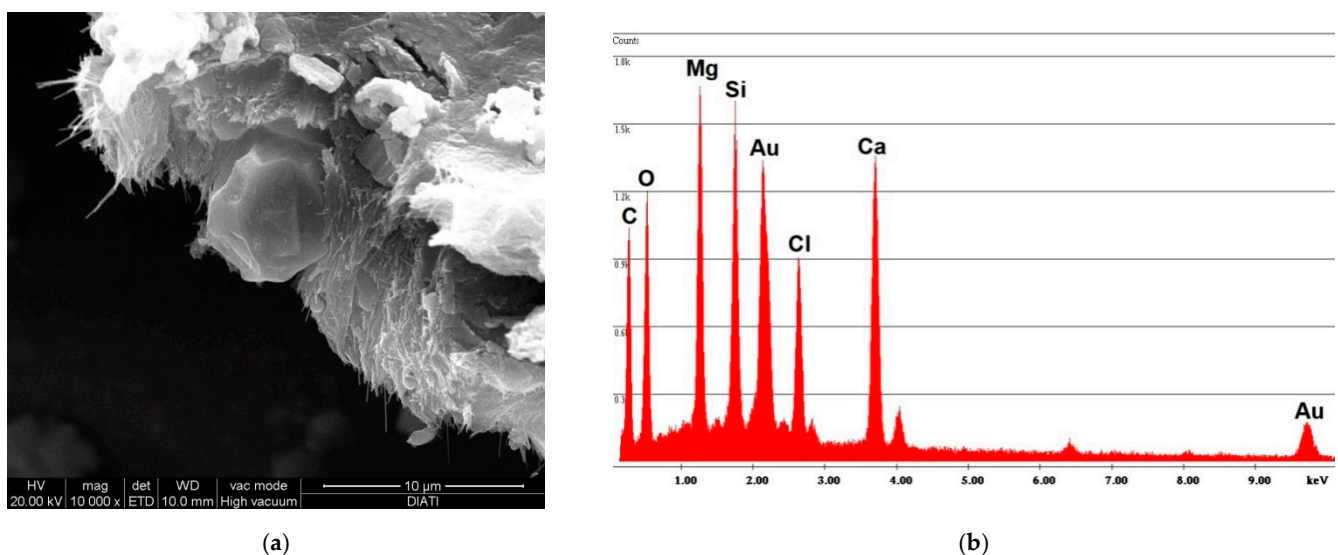
Figure 4. F sample SEM analysis. (a) Photo of incorporated fibers of chrysotile; (b) spectrum of chrysotile and vinyl chloride composition.

The simple abrasion of surface tile powder was analyzed with SEM/EDS; Figure 4 shows the spectrum obtained by analyzing the powder from vinyl F. The photo on the left shows how the fibers are completely incorporated within the vinyl matrix. The spectrum shows both of the elements that compose chrysotile, Mg and Si, where the Mg peak is greater than the Si peak; the spectrum also reports the elements that compose the vinyl matrix, Cl and Ca.

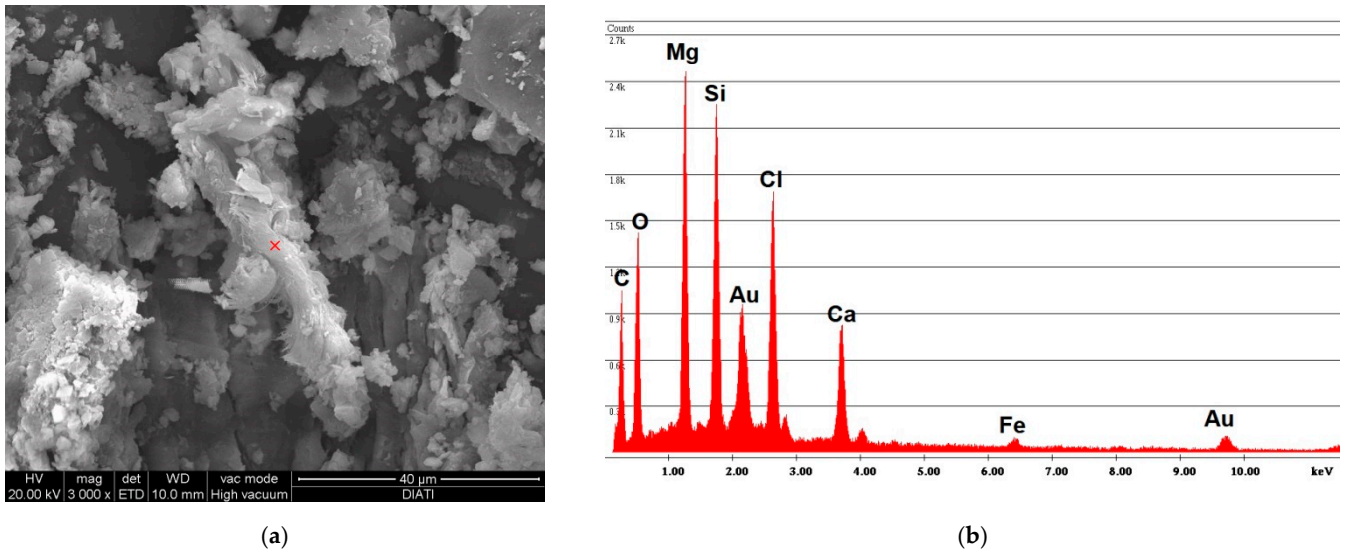
Figure 5. R sample SEM analysis. (a) Photo of incorporated fibers of chrysotile; (b) spectrum of chrysotile and vinyl chloride composition.

Figure 5 shows the same analysis, performed on the powder obtained from the vinyl sample R. In addition, in this case, the fibers are incorporated in the vinyl matrix; the spectrum confirms this aspect due to the presence of Mg and Si components of the chrysotile.

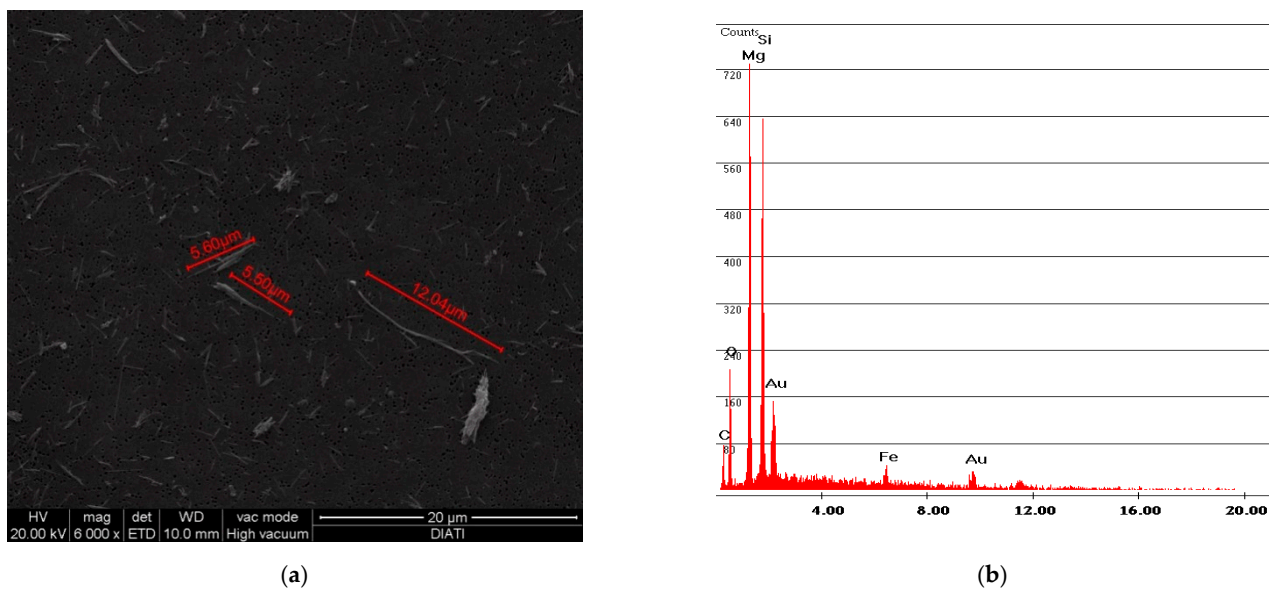
Figure 7. R sample SEM analysis. (a) Photo of free fibers of chrysotile with measurement values; (b) spectrum of chrysotile.

Figures 6 and 7 show the free fibers obtained, respectively, from samples F and R. The measurements of the fibers of both samples are in line with the particle size dimension declared by Petry US Patent [2], that is, below 2 μm . A difference can also be observed between the particle size dimension of sample R and sample F: the older and more rigid sample R has smaller fiber sizes than sample F.

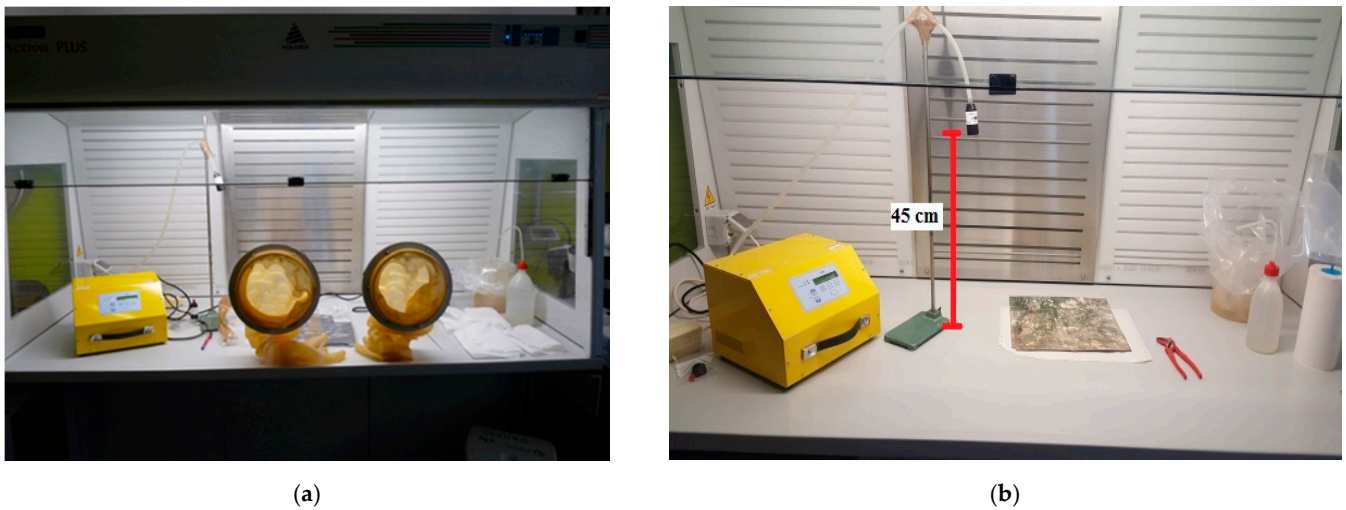
Figure 8. (a) Confined hood with gloves for simulation tests. (b) The airborne retrieval through a polycarbonate membrane.

Figure 8 shows the preparation of the hood to carry out the tests. All tests were performed safely in a confined environment using a glove box with the fan off. Airborne sampling was done with a polycarbonate membrane at 45 cm from the table. Between tests, a cleaning of the hood and an airborne analysis was always been carried out to verify the cleanness of the hood to avoid contamination.

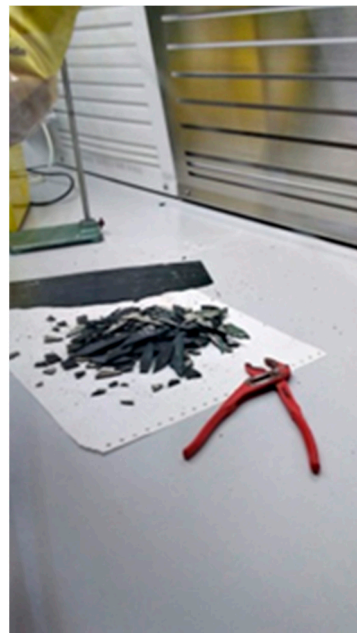
Figure 9. Multigrip plier breakage test.

During the sampling phase for the ACM mapping, a piece of tile is detached manually. This procedure must normally be carried out wet. The purpose of this test, however, was to check whether there is a release of fibers during this ACM sampling phase. In this case, the test was carried out in a confined environment, with multigrip pliers in dry condition (Figure 9). The duration time of the test was 15'. The airborne samples were then analyzed with SEM/EDS.

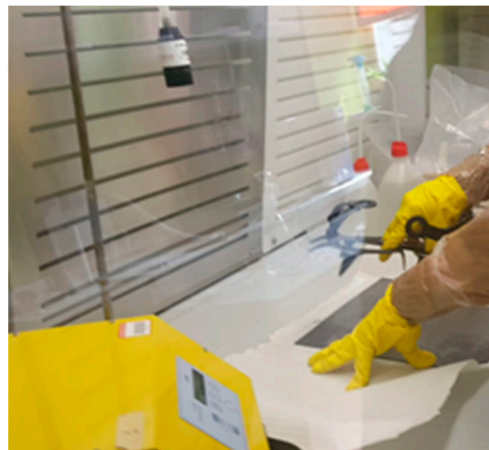
Figure 10. Vinyl tile crampon test inside the confined hood.

A vinyl floor is subject to pedestrian traffic. This test was carried out using NiCrMo steel crampons (Camp_Cassin brand (Premana, Italy)) with Hardness HRC (Rockwell scale) $53 \div 58$, to simulate the pedestrian traffic with impact and drag. The test was performed with 100 crampon shots (impact and drag) by the same operator in ten minutes. This test was performed manually from about 40 cm in height by letting the crampon fall without applying force. The number of shots could underestimate the wear carried out over time by the pedestrian traffic, but the hardness of steel is greater than any shoe worn, therefore, a possible release of fibers during the test can be representative. Figure 10 shows the performed test.

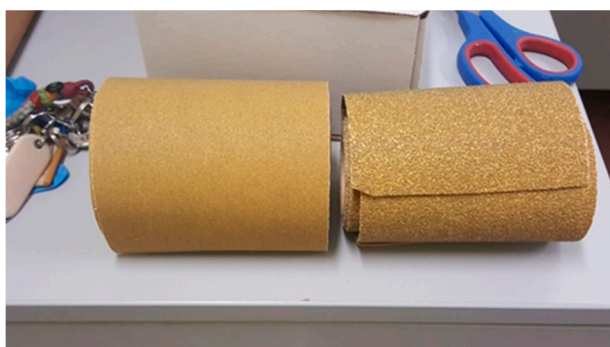
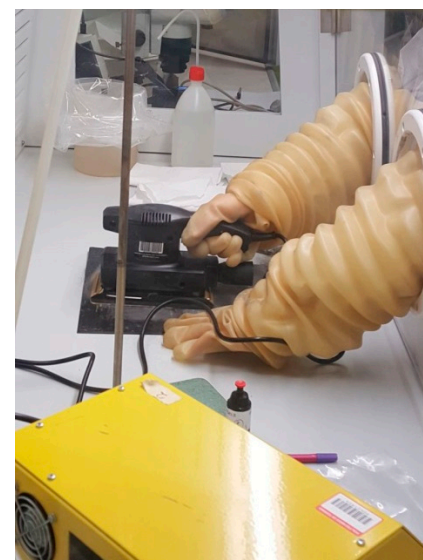
Figure 11. (a) Sandpaper used for the test. Left: fine sandpaper (dimensions: P120). Right: coarse sandpaper (dimensions: P40). (b) Performed mechanical abrasion test inside the confined hood.

In the present study, a strong mechanical abrasion of R and F vinyl tile samples was carried out using two types of sandpapers, one with a fine grain of P120 and one with a coarse grain of P40 (Figure 11). The abrasion time for each sample was 5 min.

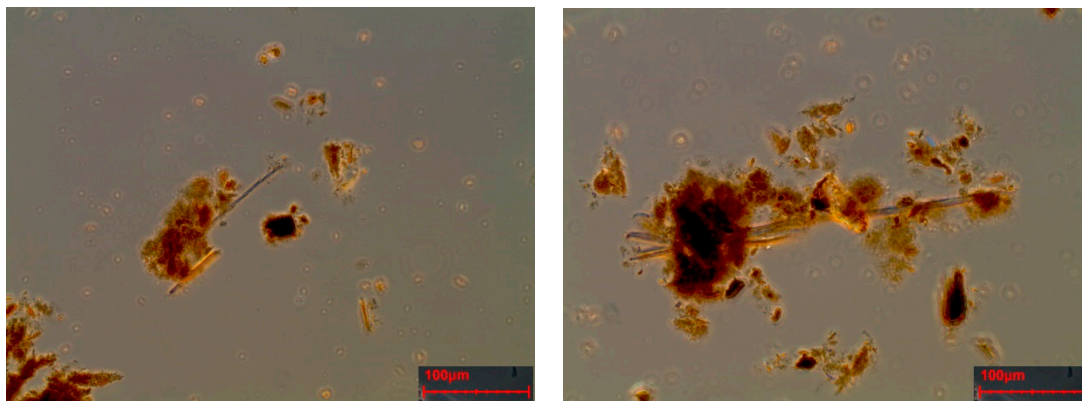
**Figure 12.** Phase-contrast microscope (PCOM) photos of the powder obtained by means of abrasion test. Chrysotile fiber with part of the vinyl glue remain attached.

The simulation tests performed on the two vinyl floor samples provided the airborne analysis for a quantitative evaluation of any release of asbestos fibers (free asbestos content). The release of free fibers into the powder, obtained from abrasion test was also quantitatively assessed (last column Table 5). The values obtained confirm, as shown in the D.M., that the percentage of chrysotile present in the vinyl flooring is in a range between 10% and 12% [3,4]. In Figure 12, two PCOM photos of the powder obtained by means of the abrasion test are reported; the presence of Chrysotile fibers is evident.

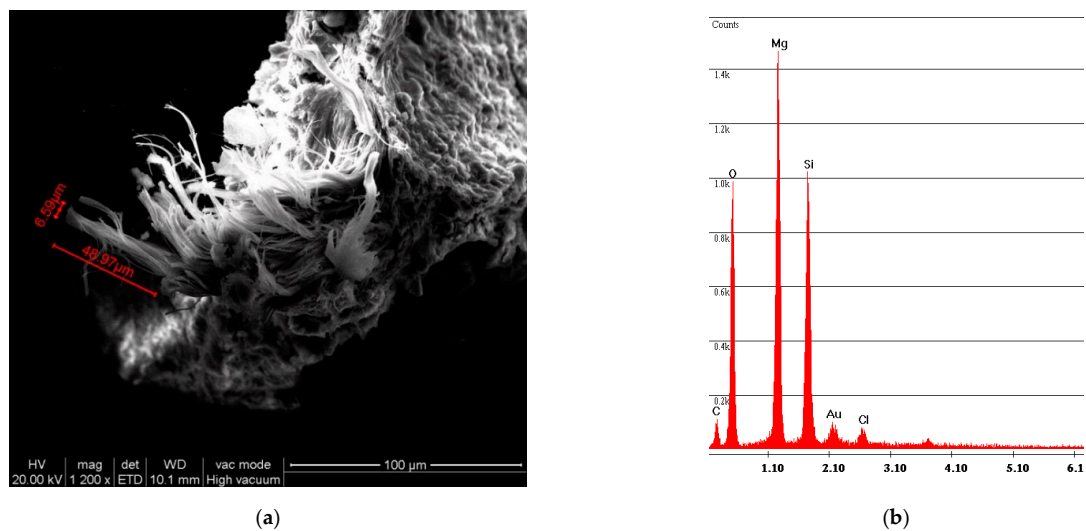
Figure 13. Sample F airborne sample of multigrip plier breakage simulation. (a) SEM photo; (b) spectrum with Mg and Si peaks indicating Chrysotile presence.

Figure 13 shows that in sample F, many fibers remain incorporated in the adhesive matrix of the vinyl, while the fibers found for the sample R (Figure 14) are free fibers.

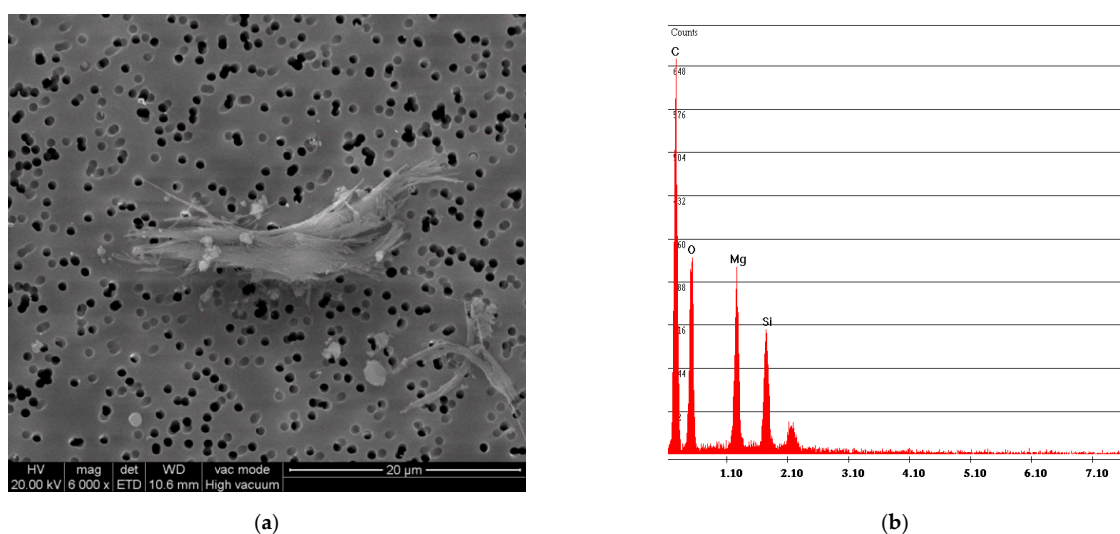
Figure 14. R airborne sample of multigrip plier breakage simulation. (a) SEM photo; (b) spectrum with Mg and Si peaks indicating Chrysotile presence.

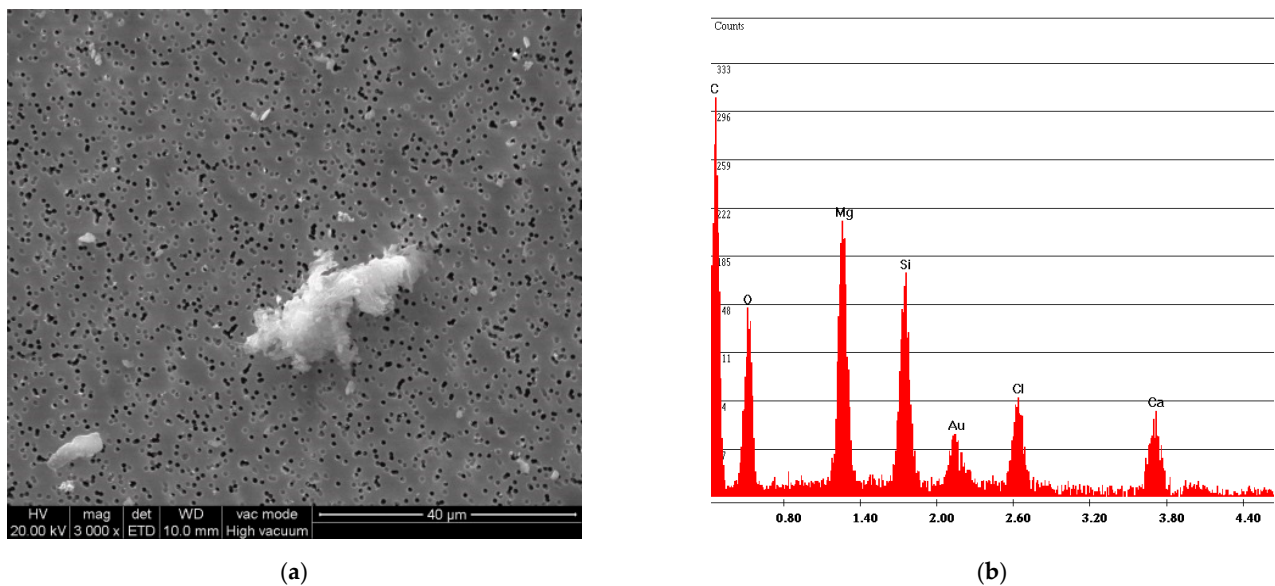
Figure 15. Sample R airborne sample of simulation for impact and drag with crampons. (a) SEM photo of incorporated asbestos fibers in the vinyl-adhesive matrix. (b) Spectrum with Mg and Si Chrysotile peaks and Cl and Ca adhesive matrix peaks.

This test was carried out with impacts and drag that simulate the trampling of the vinyl floor; this simulation did not produce fiber release. The test did not produce powder. The results obtained with Equation (1) are $C = 0$ fibers/liter for both samples. This confirms the indications given by the Italian Ministerial Decree 06/09/1994 [4], which states that there is a release of fibers only in the case of abrasion, perforation, brushing or if the vinyl floor is very deteriorated (Table 3). Figure 15 shows incorporated asbestos fibers in adhesive vinyl matrix. Figure 16 shows a piece of the adhesive matrix of the vinyl floor.

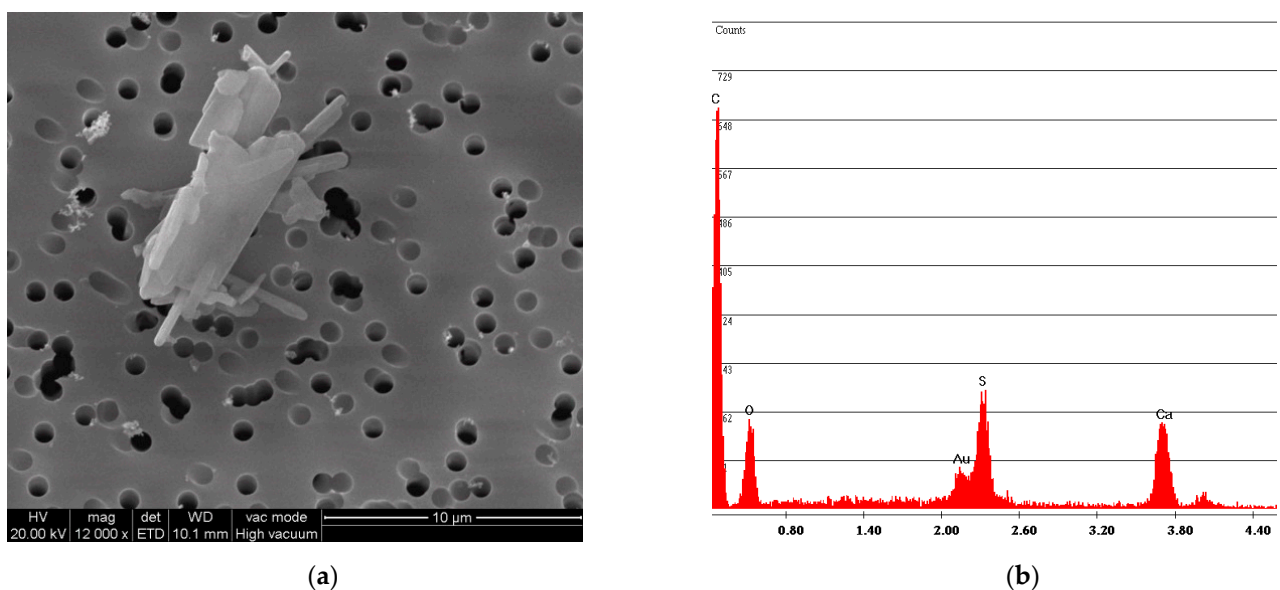
Figure 16. Sample F airborne sample of simulation for impact and drag with crampons. (a) SEM photo of part of the matrix without asbestos fibers. (b) Spectrum of the adhesive matrix.

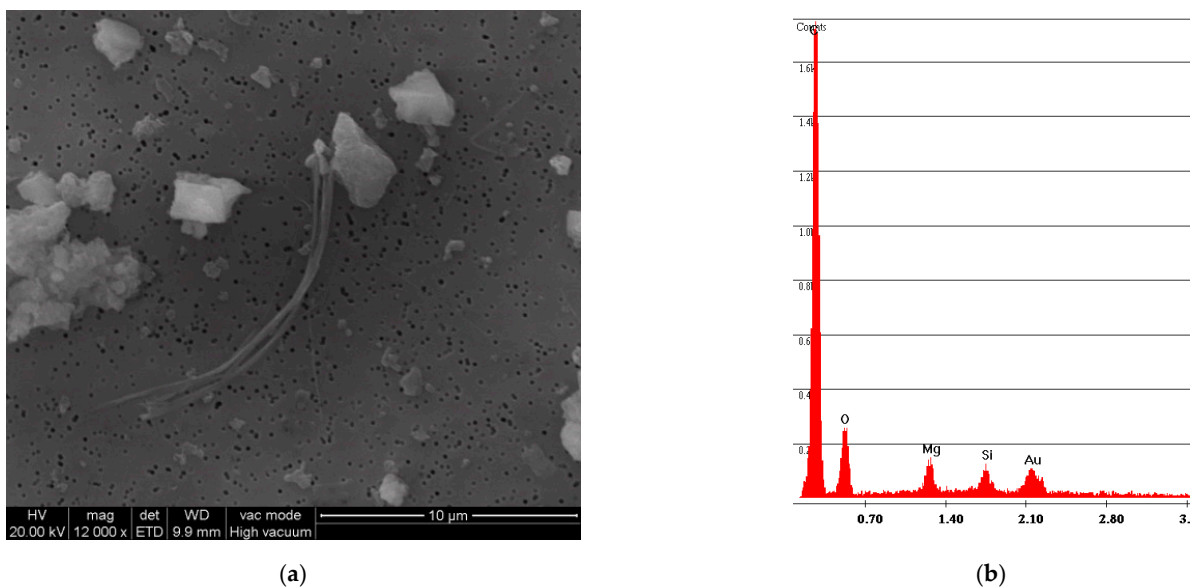
Figure 17. F airborne sample of abrasion simulation test with fine-grained sandpaper. (a) SEM photo of Chrysotile bundle. (b) Spectrum of Chrysotile with typical Mg and Si peaks.

The results obtained for abrasion with fine-grained sandpaper are $C = 12.97$ fibers/liter for sample F and $C = 24.42$ fibers/liter for sample R. The abrasion of sample R produced more longer and free fibers compared to the ones of sample F. This particular aspect is shown in Figures 17 and 18. The smaller fiber dimension of sample R had already been observed during the vinyl characterization test (Figures 6 and 7).

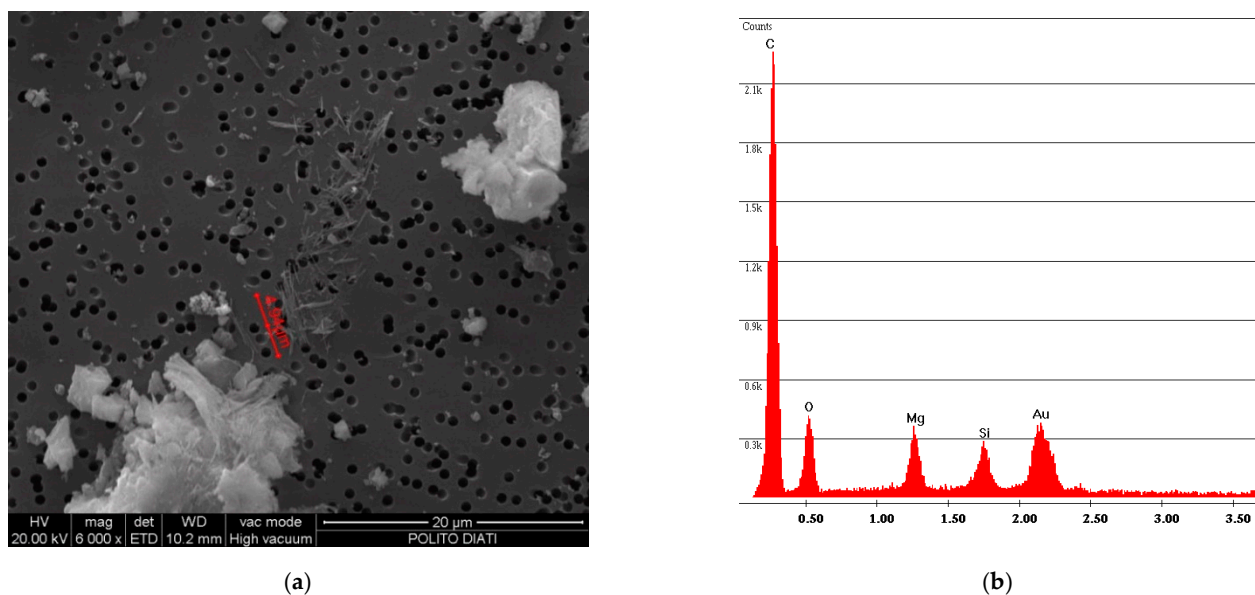
Figure 18. R airborne sample of abrasion simulation test with fine-grained sandpaper. (a) SEM photo of little Chrysotile free fibers; (b) spectrum of Chrysotile with typical Mg and Si peaks.

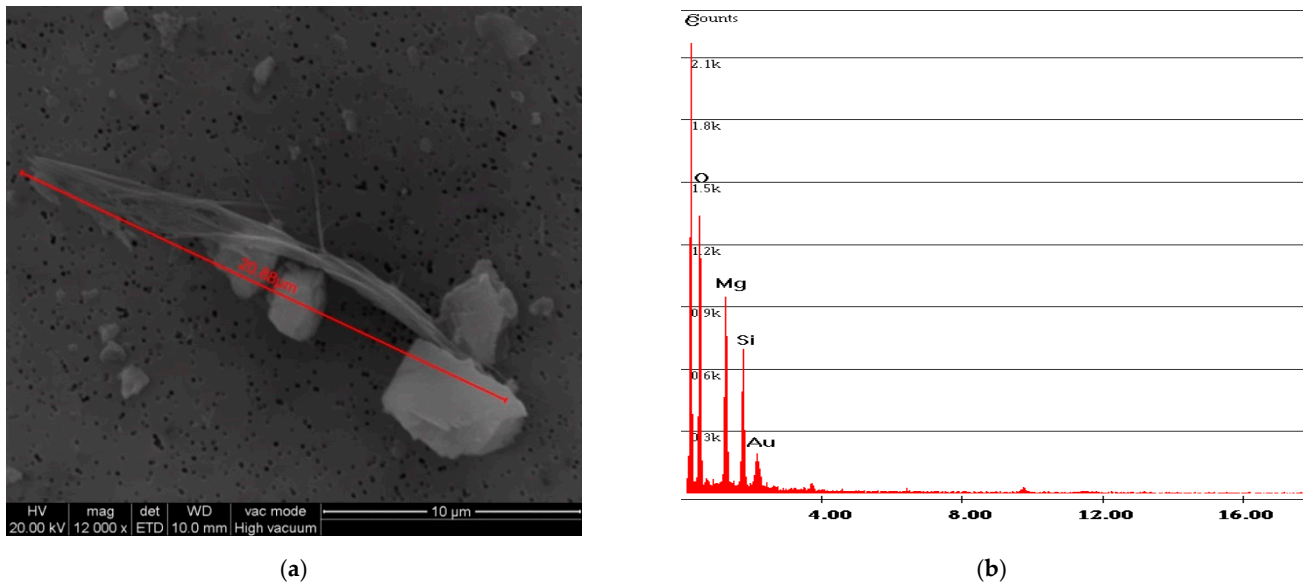
Figure 19. F airborne sample of abrasion simulation test with coarse-grained sandpaper. (a) SEM photo of Chrysotile bundle; (b) spectrum of Chrysotile with typical Mg and Si peaks.

fibers obtained with coarse-grained sandpaper were larger than the free fibers obtained with fine-grained abrasive sandpaper for both samples. Furthermore, the same trend that was observed for fine-grained abrasive sandpaper can also be observed for coarse-grained abrasive sandpaper, i.e., the fiber sizes from sample F were larger than the fiber sizes of sample R (Figures 19 and 20).

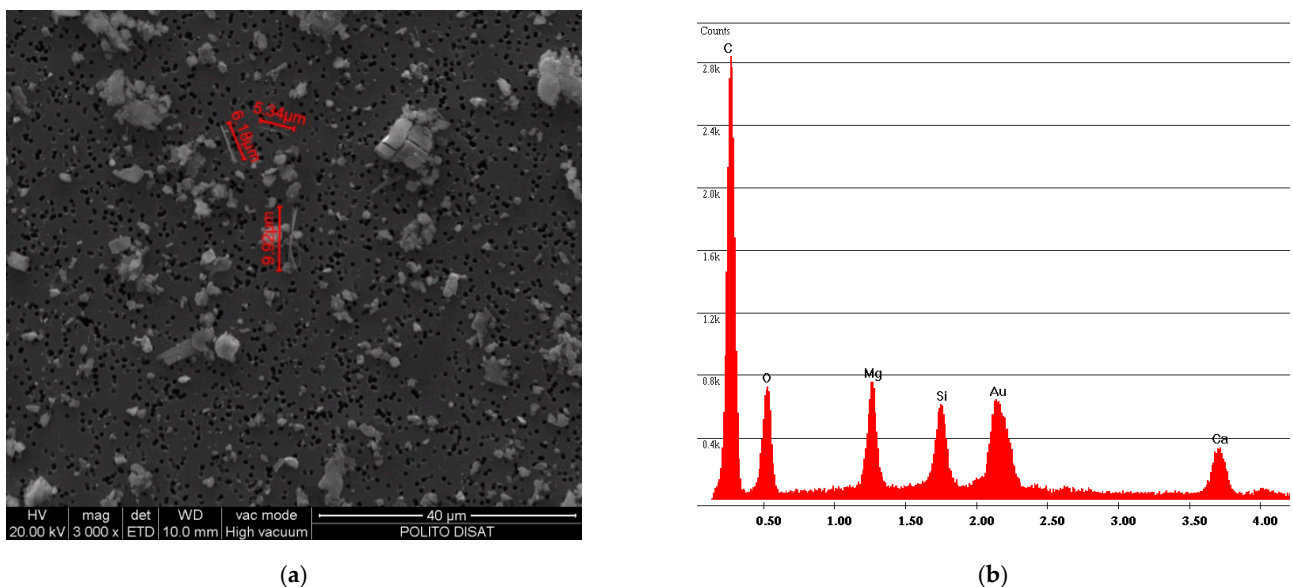
Figure 20. R airborne sample of abrasion simulation test with coarse-grained sandpaper. (a) SEM photo of Chrysotile free fiber bundle; (b) spectrum of Chrysotile with typical Mg and Si peaks.

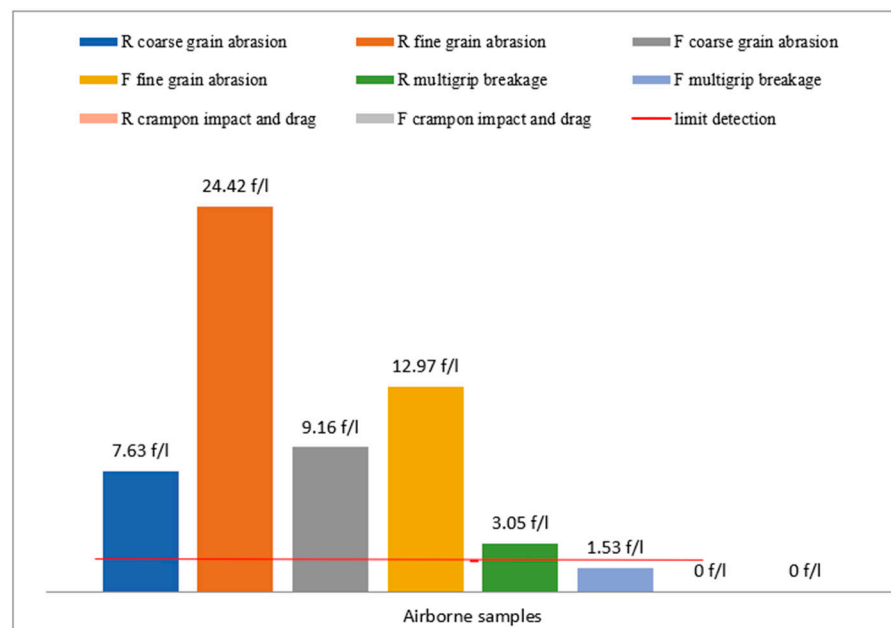
Figure 21. Histogram of the fiber/liter values calculated according to Ministerial Decree 06/09/1994 [4], for all tests carried out on samples R and F. The horizontal red line indicates the limit detection value.

Figure 21 shows a representation of all simulation tests on samples R and F. The red line represents the limit detection value according to Italian Ministerial Decree 06/09/1994 [4]. It can be observed that, in general, the R sample shows worse results than the vinyl sample F, due to its rigidity and ageing comparing to vinyl floor F.
