Vinyl-Asbestos Floor Risk Exposure in Three Different Simulations

Lorena Zichella * , Fiorenza Baudana, Giovanna Zanetti and Paola Marini

Department of Environment, Land and Infrastructure Engineering (DIATI), Politecnico di Torino, 10129 Turin, Italy; fiorenza.baudana@polito.it (F.B.); giovanna.zanetti@polito.it (G.Z.); paola.marini@polito.it (P.M.)

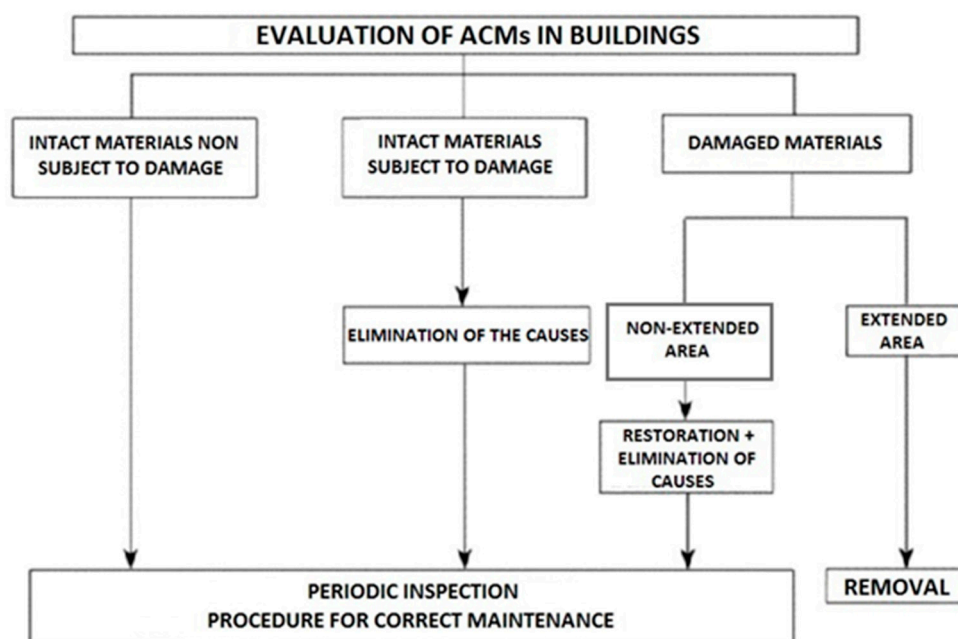
Figure 2. Evaluation scheme of asbestos-containing materials (ACMs) in building and recommendations (from Article 1, Annex: Standards and Technical Methods for Risk Assessment, Control, Maintenance and Remediation of Materials Containing Asbestos Present in Building Structure, Risk Assessment, Table 2 of M.D. 6/9/94 [4]).

Figure 2 describes the different situations that can occur during the evaluation of ACMs in buildings and the related recommendations in these different cases required by M.D. 6/9/94 [4].

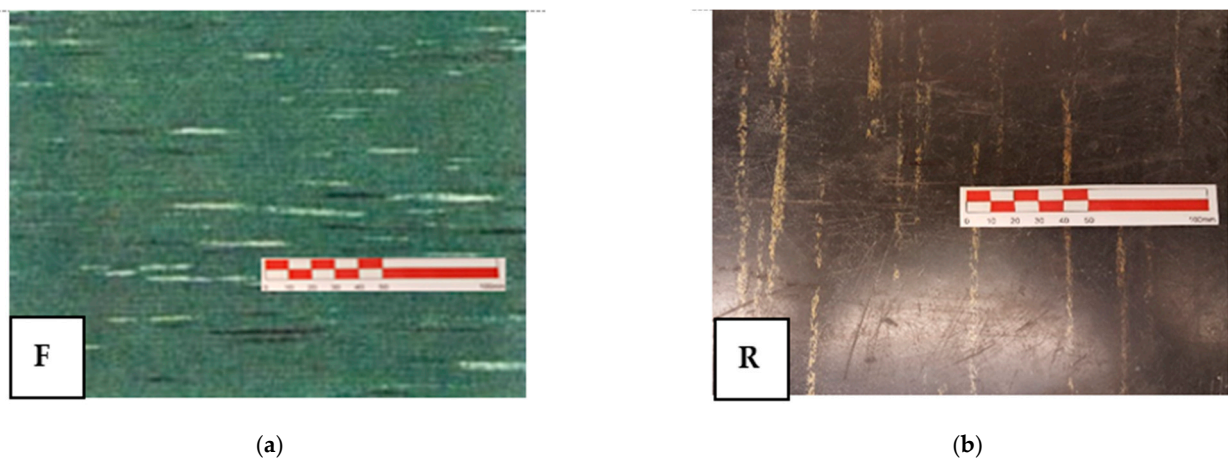
Figure 3. (a) Sample F—squared floor green tiles with white and black stripes, more flexible and in good condition (b) Sample R—squared floor black tiles with beige stripes, quite rigid and in fairly good condition.

The prevalent use of vinyl floors containing asbestos was in public buildings and popular housing. In this context, two types of vinyl from public buildings have been considered. In Figure 3, they are shown macroscopically. The green vinyl (F) on the left was laid in the 1990s and shows a flexible structure. The black vinyl (R) on the right was laid in the 1980s and shows a more rigid structure.

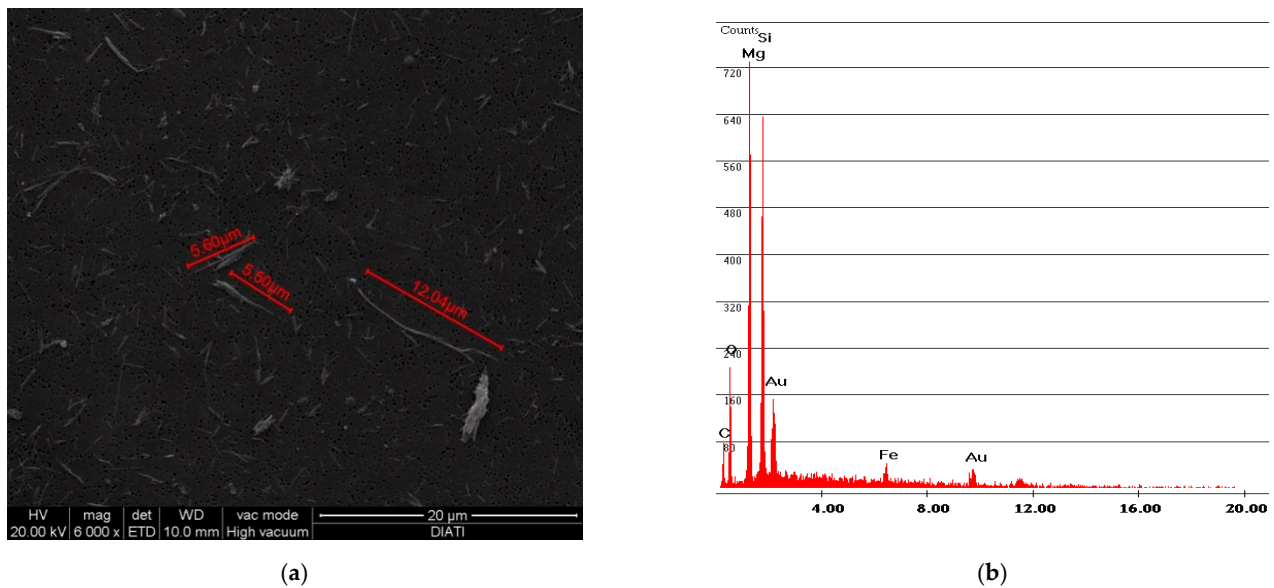
Figure 7. R sample SEM analysis. (a) Photo of free fibers of chrysotile with measurement values; (b) spectrum of chrysotile.

Figures 6 and 7 show the free fibers obtained, respectively, from samples F and R. The measurements of the fibers of both samples are in line with the particle size dimension declared by Petry US Patent [2], that is, below 2 μm . A difference can also be observed between the particle size dimension of sample R and sample F: the older and more rigid sample R has smaller fiber sizes than sample F.

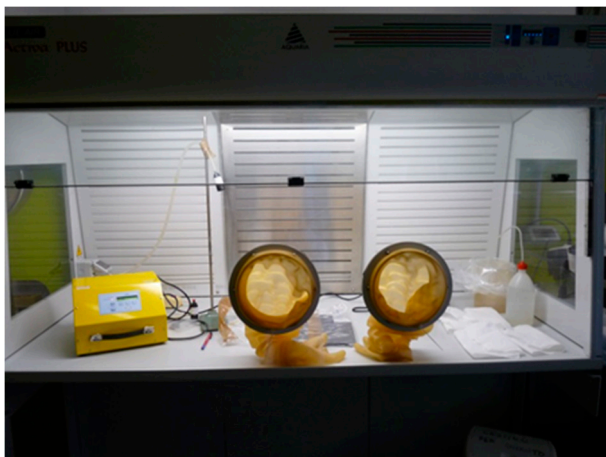
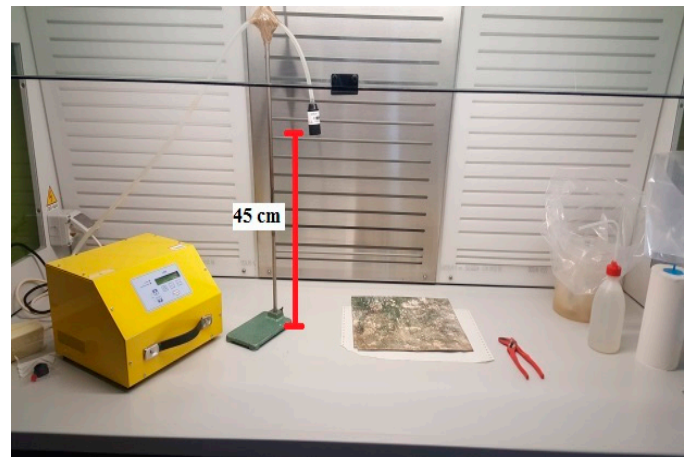
Figure 8. (a) Confined hood with gloves for simulation tests. (b) The airborne retrieval through a polycarbonate membrane.

Figure 8 shows the preparation of the hood to carry out the tests. All tests were performed safely in a confined environment using a glove box with the fan off. Airborne sampling was done with a polycarbonate membrane at 45 cm from the table. Between tests, a cleaning of the hood and an airborne analysis was always been carried out to verify the cleanness of the hood to avoid contamination.

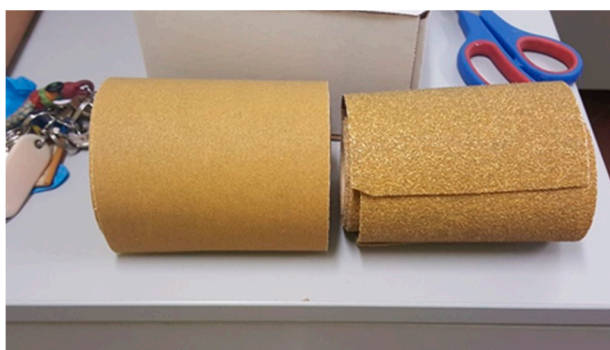
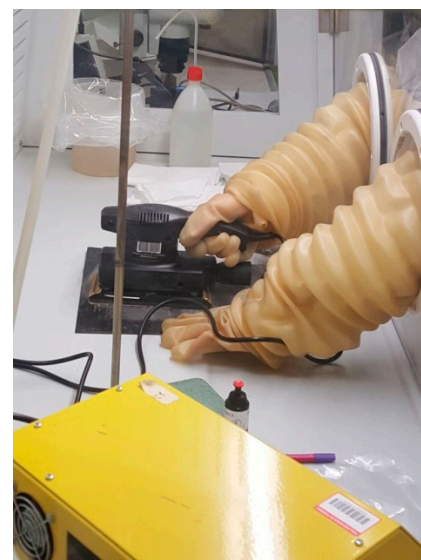
Figure 11. (a) Sandpaper used for the test. Left: fine sandpaper (dimensions: P120). Right: coarse sandpaper (dimensions: P40). (b) Performed mechanical abrasion test inside the confined hood.

In the present study, a strong mechanical abrasion of R and F vinyl tile samples was carried out using two types of sandpapers, one with a fine grain of P120 and one with a coarse grain of P40 (Figure 11). The abrasion time for each sample was 5 min.

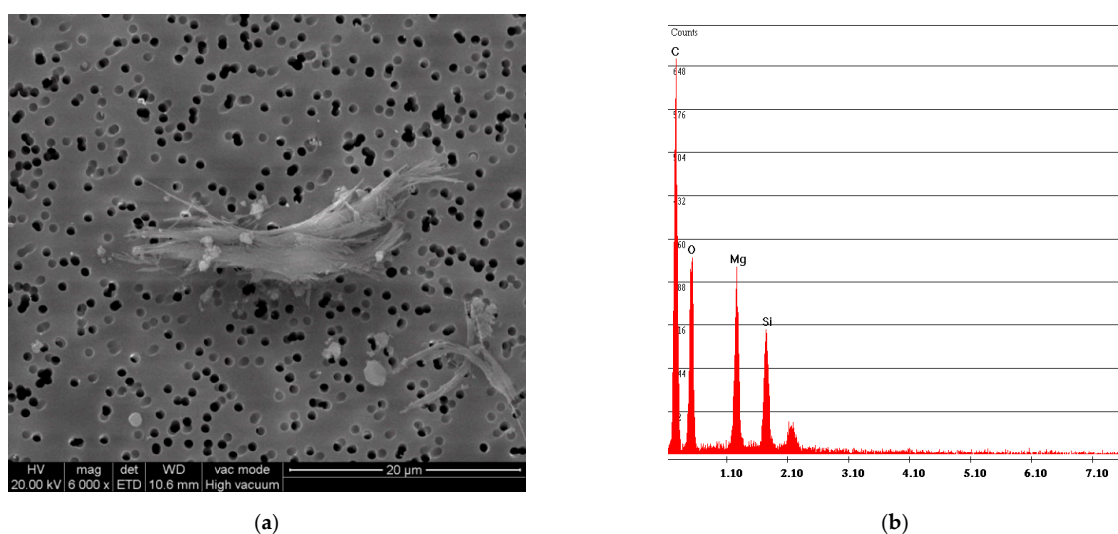
Figure 14. R airborne sample of multigrip plier breakage simulation. (a) SEM photo; (b) spectrum with Mg and Si peaks indicating Chrysotile presence.

Figure 13 shows that in sample F, many fibers remain incorporated in the adhesive matrix of the vinyl, while the fibers found for the sample R (Figure 14) are free fibers.

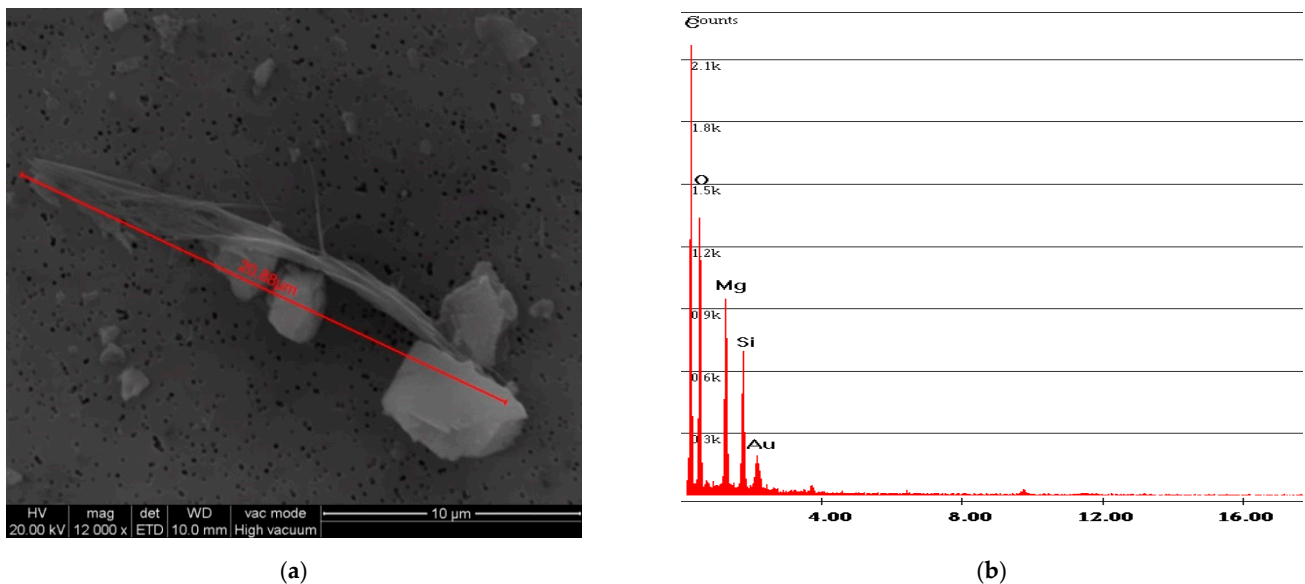
Figure 19. F airborne sample of abrasion simulation test with coarse-grained sandpaper. (a) SEM photo of Chrysotile bundle; (b) spectrum of Chrysotile with typical Mg and Si peaks.

The results obtained with abrasion simulation test using coarse-grained sandpaper were $C = 9.16$ fibers/liter for sample F and $C = 7.63$ fibers/liter for sample R. The free

fibers obtained with coarse-grained sandpaper were larger than the free fibers obtained with fine-grained abrasive sandpaper for both samples. Furthermore, the same trend that was observed for fine-grained abrasive sandpaper can also be observed for coarse-grained abrasive sandpaper, i.e., the fiber sizes from sample F were larger than the fiber sizes of sample R (Figures 19 and 20).

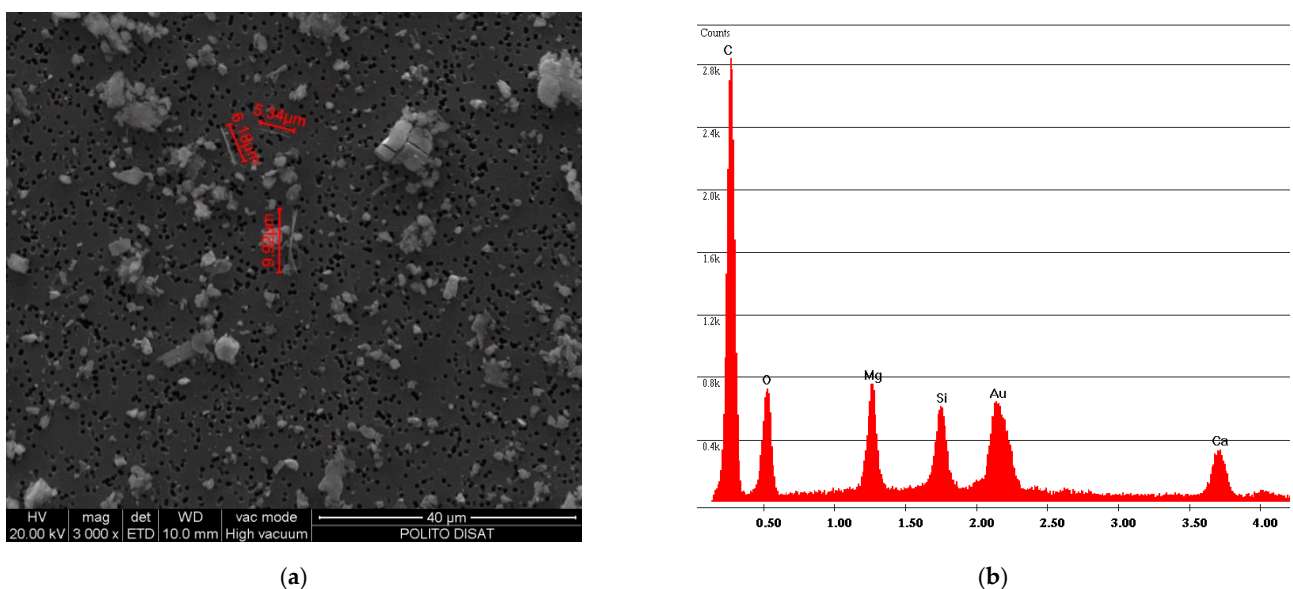
Figure 20. R airborne sample of abrasion simulation test with coarse-grained sandpaper. (a) SEM photo of Chrysotile free fiber bundle; (b) spectrum of Chrysotile with typical Mg and Si peaks.
