Condition Assessment of an Early Thin Reinforced Concrete Vaulted System

# Condition assessment of an early thin reinforced concrete vaulted system

This paper reports the direct experience acquired from an extensive experimental campaign conducted on the Paraboloid in Casale Monferrato. The study aims to be an example of how condition assessment of the structural heritage of the early 1900s, with an apparently simple geometric shape and composition, can actually contribute in understanding hidden structural complexity. Moreover, this work may provide useful information to researchers and practitioners who are approaching this specific structural typology (e.g., the industrial heritage represented by parabolic concrete silos). In more details, results are presented regarding the in-situ investigations, and the laboratory tests carried out to analyze the mechanical performance inherent to both (i) local aspects of the structure, such as the quality of the materials and connections, and (ii) global aspects, such as the modal response of the structure. Furthermore,

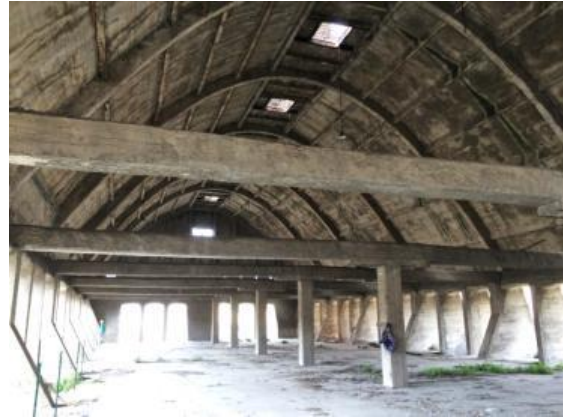
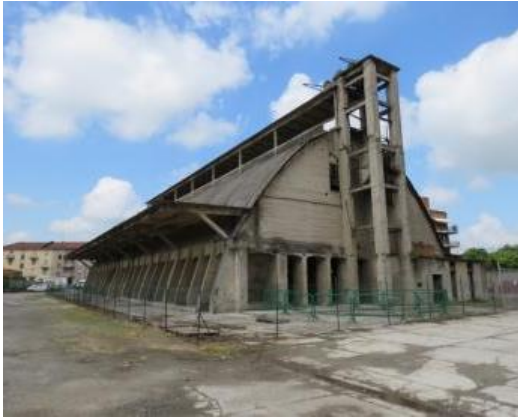
*Figure 4: Current state of the building: exterior seen from the north side (a), interior view (b).*

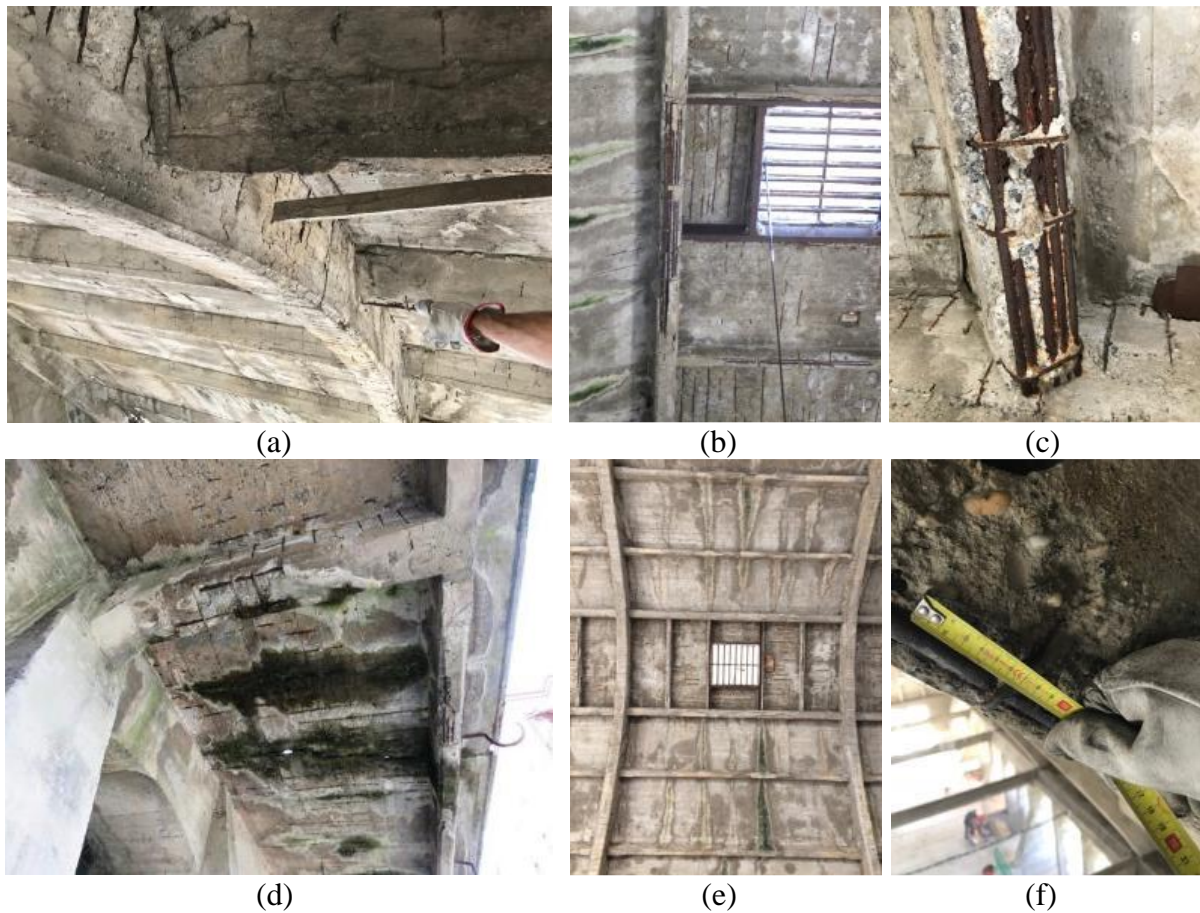
The visual investigations detected a diffuse degradation of the concrete, moisture stains, bio growth, rust stains, cracks, delamination and detachments, and consequent corrosion of the reinforcements. Moreover, pronounced and widespread cracks and high degrees of corrosion of the reinforcements are present in the whole body of the building, often accompanied by the complete detachment of the concrete cover. The degradation is mainly due to physical causes,

The decay is particularly noticeable on the intrados of the building and especially on the elements constituting the parabolic vault: the arches, the joists, and the panels (Figure 7) where Invernizzi et al. [14] highlighted that water staining and bio-growth cover the 40% of the area of the roofing.

*Figure 7: Damage and degradation on the building: (a) exposed rebars on the AR; (b-c) exposed rebars and detachments of concrete of the joists and roofing panels; (d) water staining and bio growth on the elements of the outdoors shelter; (e) a general view of the interior of the Paraboloid showing water staining and bio growth on the roofing panels; (f) a detail of the exposed rebars of a parabolic arch.*

linked to frost and defrost cycles, and corrosion phenomena, due to the lack of maintenance of the building, that favored infiltration and percolation of rainwater.
