Mechanical Properties of Historic Masonry Stones Obtained by In Situ Non-Destructive Tests on the St. Agostino Church in Amatrice (Italy) / Grazzini, A., Lacidogna, G.. - In: APPLIED SCIENCES. - ISSN 2076-3417. - ELETTRONICO. - 11:(2021), pp. 1-14. [10.3390/app11146352]

Mechanical Properties of Historic Masonry Stones Obtained by In Situ Non-Destructive Tests on the St. Agostino Church in Amatrice (Italy)

Featured Application: The use of non-destructive diagnostic techniques for the in situ and non-invasive mechanical characterization of historic stone masonry.

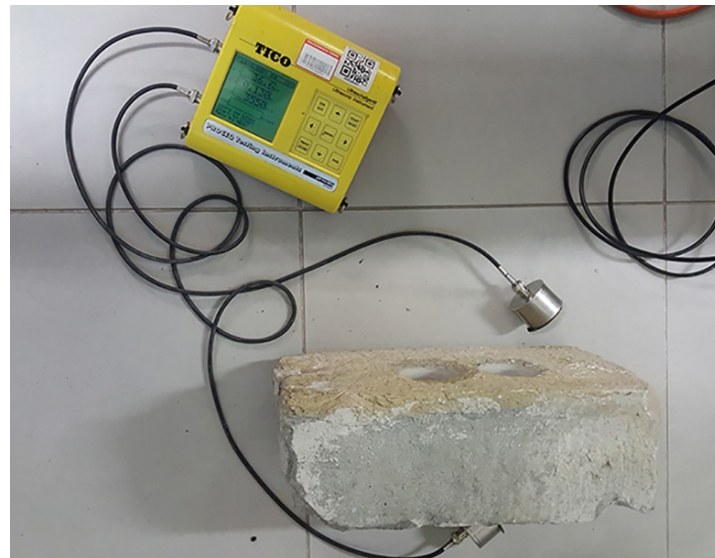
Figure 4. Ultrasonic test setup.

- Ultrasonic tests for the determination of the elastic dynamic modulus performed on the same stones (Figure 4);
- Impact tests carried out on the same stones (Figure 5).

Ultrasonic tests were also conducted on the same stones to estimate the dynamic elastic modulus (E_d). Ultrasonic inspection is a non-destructive method, in which high frequency sound waves are introduced into the material to be examined, in order to highlight any surface or internal defects. Longitudinal waves were produced by means of an electro-acoustic transducer (emitting probe in piezoelectric or magnetostrictive material) placed in contact with the stone surface under test; after passing through a path of known length, the train of waves was converted by a second transducer (receiving probe) into an electrical signal processed by electronic timing circuits that allow measurement of the transit time of the impulses. The ultrasonic test device consisted of: a Proceq Tico[®] pulse generator; two transducers of 54 kHz (one emitting and the other receiving); a pulse amplifier; and an electronic device for measuring the time interval (Figure 4). The speed of the wave (v) depends on the presence of any defects inside the material, and is related to the value of the dynamic elastic modulus (E_d) through the density (ρ) and the Poisson's ratio (ν) of the material. Therefore, the value of the dynamic elastic modulus (E_d) of the stone can be obtained using the following relationship, in accordance with the technical standards ASTM D2845 1995 and UNI EN 12504-4: 2005 [27,28]:

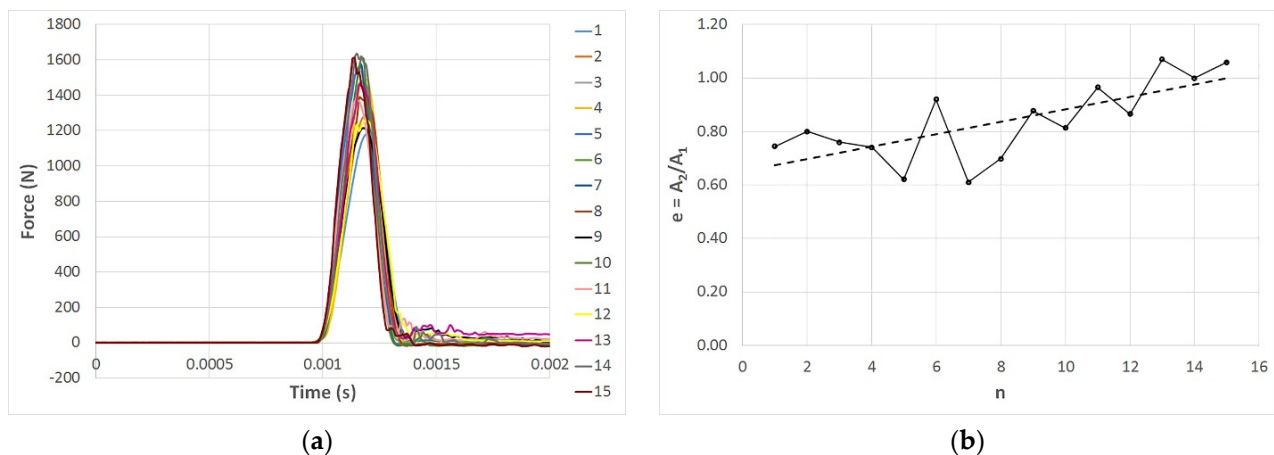
Figure 14. Impact test on stone n. 4: (a) time–force diagram of the 15 beats; (b) trend of the restitution coefficient (e) vs. number of beats (n).

Regarding the impact test, 15 strokes were performed on each stone taken from the ruins of the St. Agostino church. Figure 14a showed, as an example, the time–force diagram of an impact test (stone n. 4). To fall within a range of greater stabilization of the material, the value of the elastic modulus (E_s) was obtained only between the tenth and the fifteenth beat that recorded $e > 0.90$, which was considered more stable (Figure 14b) [31].
