Mechanical Properties of Historic Masonry Stones Obtained by In Situ Non-Destructive Tests on the St. Agostino Church in Amatrice (Italy)

Featured Application: The use of non-destructive diagnostic techniques for the in situ and non-invasive mechanical characterization of historic stone masonry.

Keywords: historic building; masonry stone; Amatrice earthquake; structural safety; non-destructive techniques (NDT); ultrasonic test; impact test

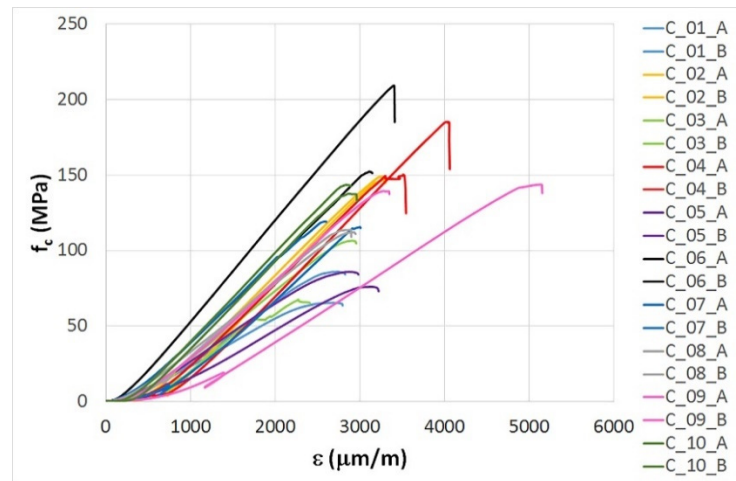
Figure 7. $f_c - \epsilon$ diagrams of compression tests.

The compressive mean strength and the mean strain recorded at peak stress were of 125.2 MPa and 3143 $\mu\text{m}/\text{m}$, respectively. The $f_c - \varepsilon$ diagrams (Figure 7) highlighted an expected dispersion of the results due to the anisotropy of material, most likely accentuated by any internal microcracks that the stones of masonry walls may have undergone during the collapse. The Gauss distribution of cylindrical compression strength (f_c), elastic secant and dynamic modulus (E_s , E_d) of each stone specimen were evaluated in Figures 8–10.
