AUTOMATIZING DEGRADATION MAPPING OF ANCIENT STELAE BY DUAL-BAND IMAGING AND  
MACHINE LEARNING-BASED CLASSIFICATION

# AUTOMATIZING DEGRADATION MAPPING OF ANCIENT STELAE BY DUAL-BAND IMAGING AND MACHINE LEARNING-BASED CLASSIFICATION

**KEY WORDS:** Heritage, Degradation Documentation, Stelae, Stone Weathering, Mapping, Image Classification, Machine Learning

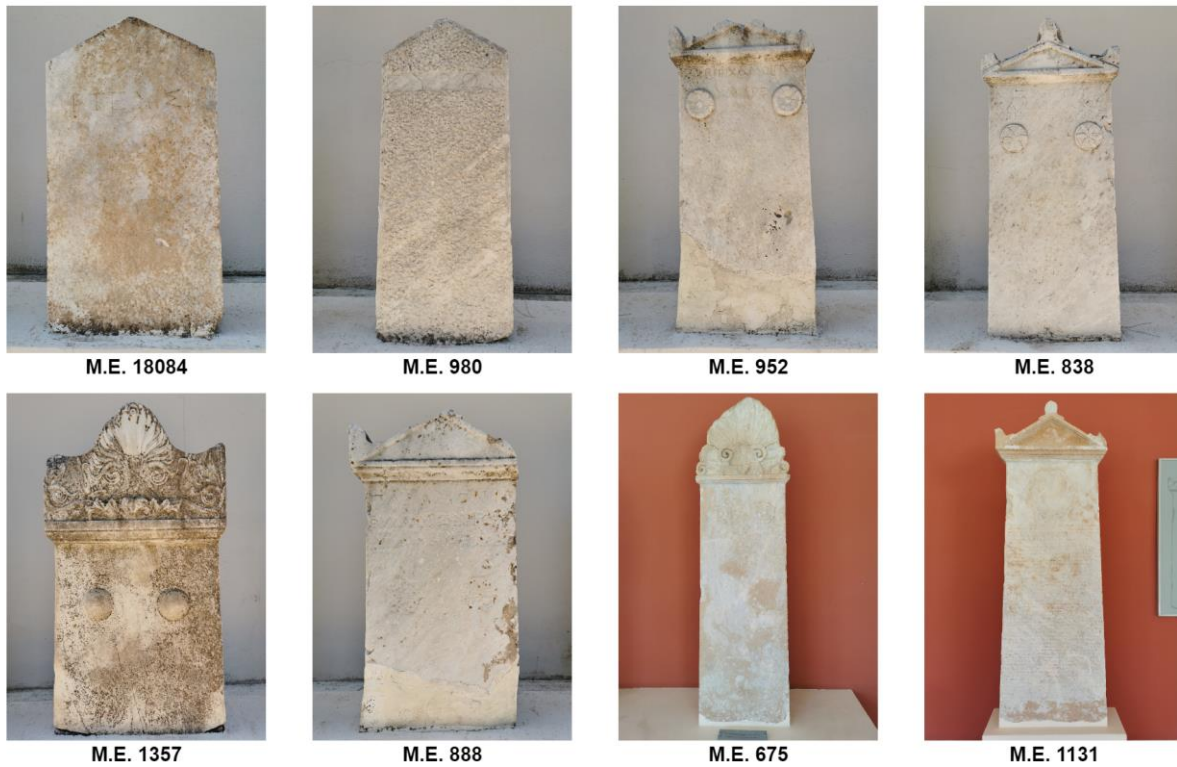
**Figure 2.** Stelae at the Archaeological Museum of Eretria.

The instrumentation used for the dual-band image acquisition included a modified Canon Rebel-SL1 digital camera (with a resolution of  $5184 \times 3456$  pixels) with an external NIR-pass filter and a Canon EF-S 18–55 mm f/4–5.6 IS II zoom lens for NIR-reflectance imaging, and a smartphone employing a Sony IMX600 sensor (with a resolution of  $3648 \times 2736$  pixels, at RAW capturing mode) with LEICA optics for color imaging. The antiquities involved in this work were eight inscribed and unscripted stelae from the Archaeological Museum of Eretria in Euboea, Greece (**Figure 2**). Images of the stelae were captured, exported and prepared for digital processing as described in Section 2.2, considering a 1:2 scale.

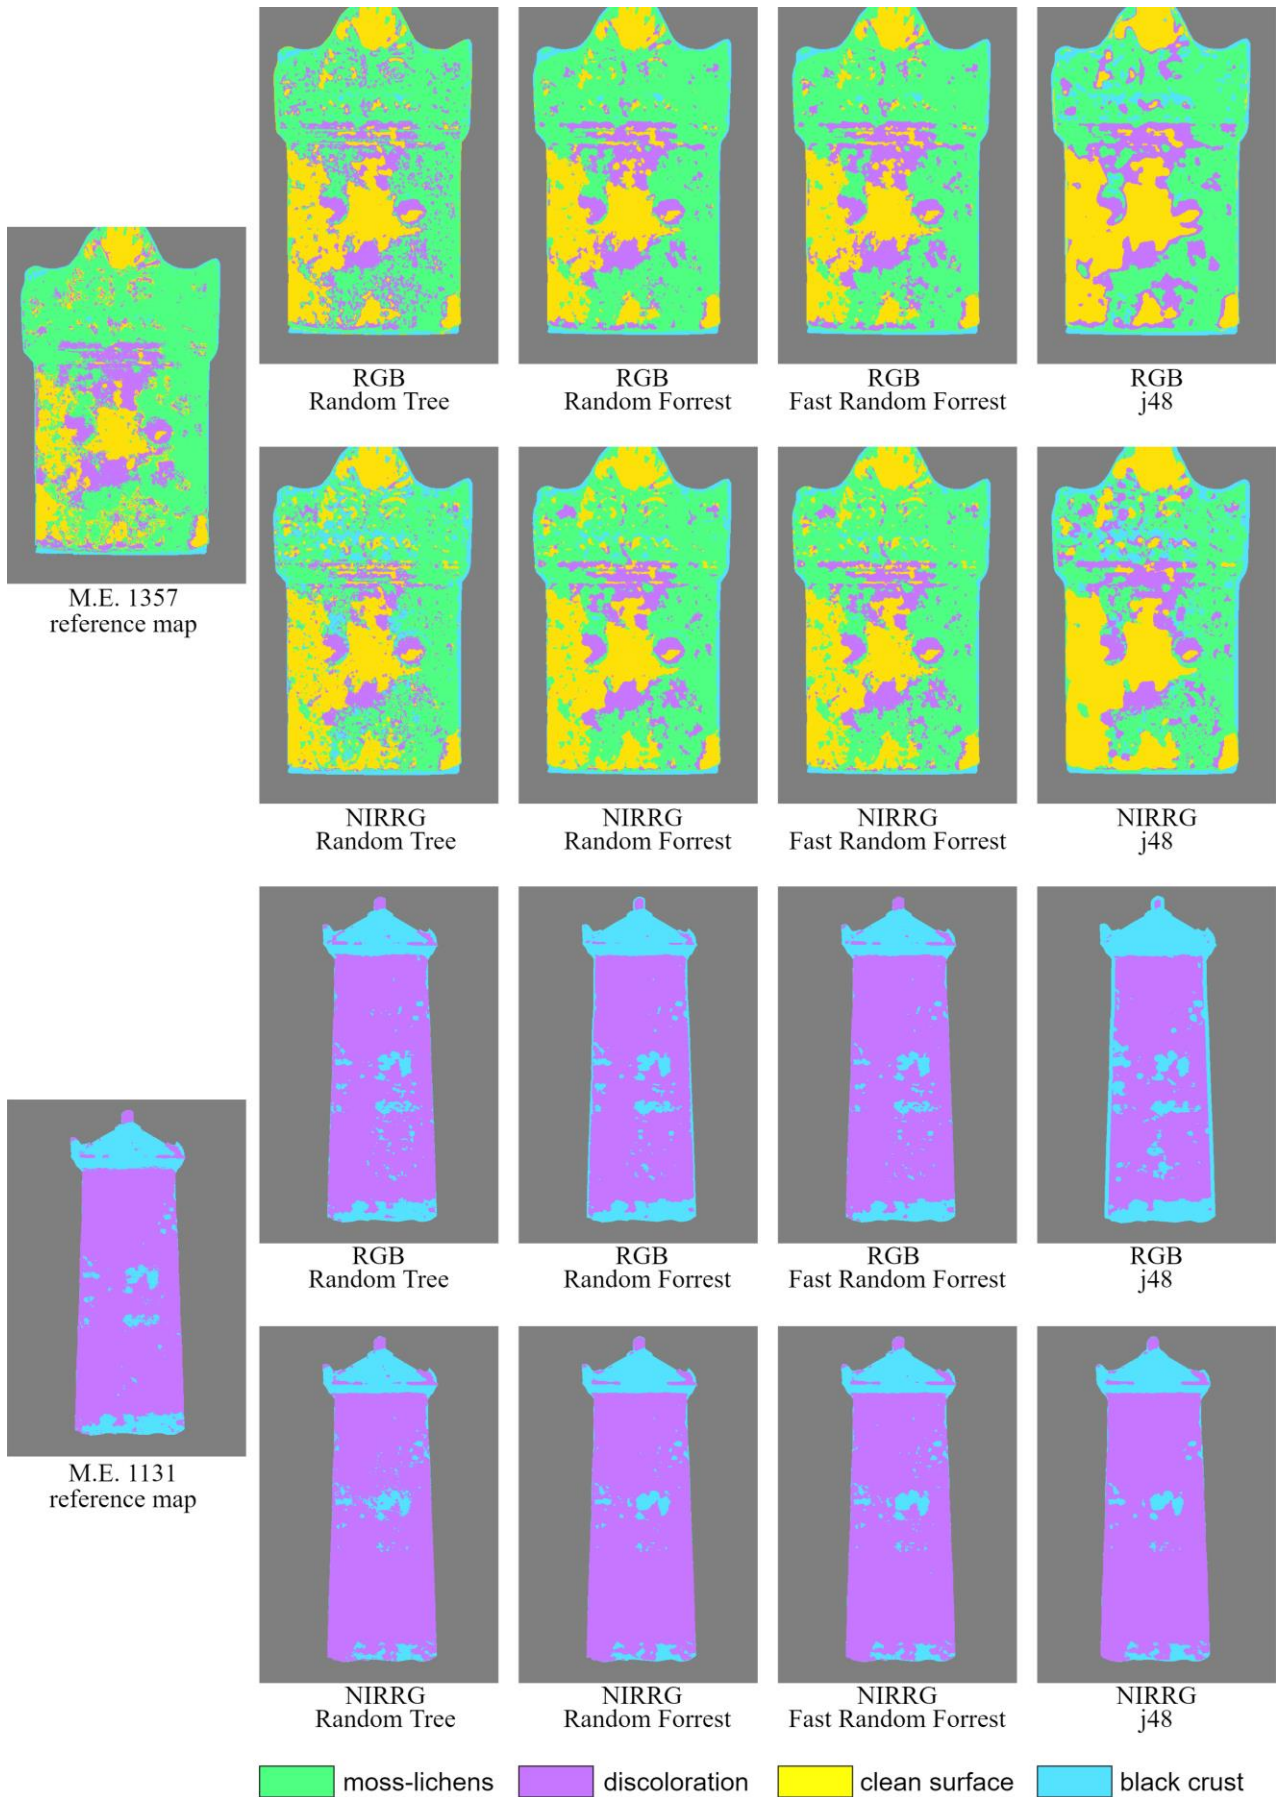
**Figure 4.** Classification results stelae M.E. 1357 and M.E. 1131

All approaches generated results with over 70% accuracy. Among them, consistently high accuracy results were achieved with the Random Tree implementation for the more decayed stelae and with the Fast Random Forest for the less decayed stelae. **Figure 3** and **Figure 4** present the comparison between reference maps and generated results. The ability of the random forest method to tackle problems in decision tree learning such as learning unusual irregular patterns and overfitting training data, by assigning random subsets of the training and from them random input feature subsets, facilitated better accuracies when the distinction between pathologies and cleaned/cleaner surface was clearer. However, when there was overlap between degradation forms, and when small enclaves of moss-lichens pixels were present inside discolored areas, the decision tree method, which uses all features of interest for the training, proved more efficient.

It is evident from error matrixes **Table 2** and **Table 3**, that when multiple degradation forms were present, the most common misclassification was between moss-lichens and discoloration, but also clean surface and discoloration when discoloration was not very intense (considering the dual-band Random Tree approach as the most accurate for stelae 18084 and 1357).
