INTEGRATING MULTIBAND PHOTOGRAMMETRY, SCANNING, AND GPR FOR BUILT HERITAGE SURVEYS: THE FAÇADES OF CASTELLO DEL VALENTINO

KEY WORDS: Photogrammetry, Laser Scanning, Thermography, Ground-Penetrating-Radar, Data Fusion, Built Heritage

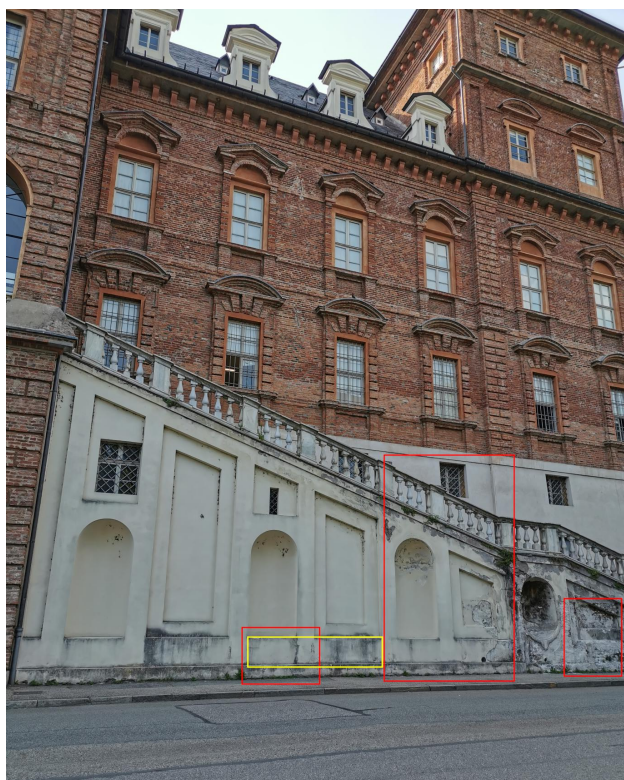
Figure 2. *Castello del Valentino* riverside (east) façade. The preliminary surveys are indicated with red and the detailed surveys with yellow color.

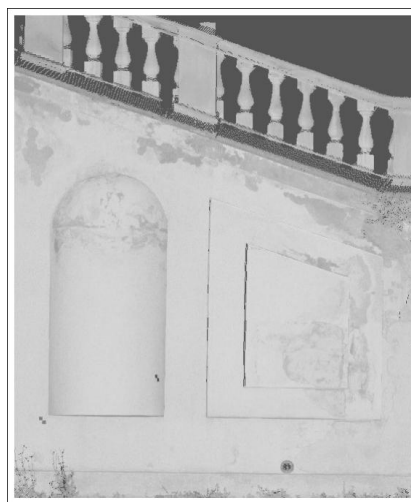
Figure 4: View of point-cloud pseudocolored with architectural surfaces' weathering indices (lower riverside façade)

The first phase of the surveys involved TLS range data acquisitions at the lower areas of the riverside façade and the main part of the east façade. The stations were placed to acquire homogeneously dense point clouds without occlusions, and thus two scans were performed on the east façade and six on the west, with large overlaps, which could facilitate accurate registration. The scans were used to generate general plans and low-resolution models of architectural surfaces after registering, denoising, and subsampling the 3D point clouds. Furthermore, the near-infrared scanning intensities were corrected (Suchocki et al., 2020) and exploited to create rapidly and cost-efficiently a representation of weathering stages (**Figure 4**), since the majority of the observed surface deterioration patterns belonged to a single typology—grey biogenic crusts.

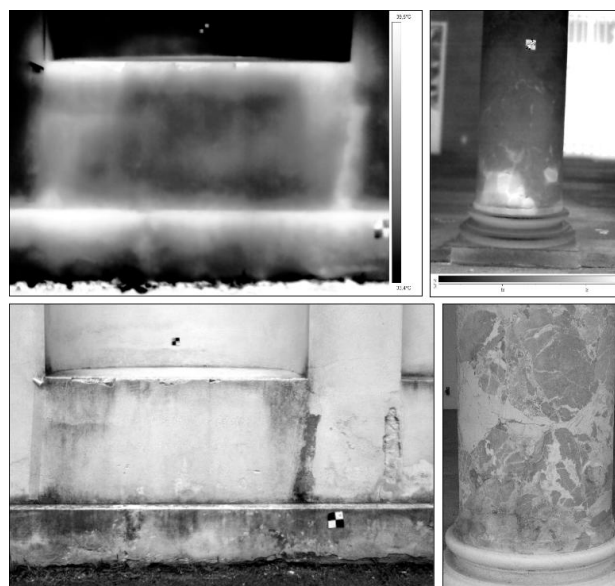
Figure 7. East façade (left), and main façade left column (right) anomalies observed by thermographic imaging and principal component analysis of the multiband data (first components).

Wide-scale representations and 2D preliminary surveys led to identifying areas of interest for in-depth investigations by integrating higher resolution data and the elaborated GPR measurements. These two presented significant radiometric anomalies in the multiband analysis results (**Figure 7**).
