Very High Cycle Corrosion Fatigue Study of the Collapsed Polcevera Bridge, Italy

Stefano Invernizzi¹; Francesco Montagnoli²; and Alberto Carpinteri, F.ASCE³

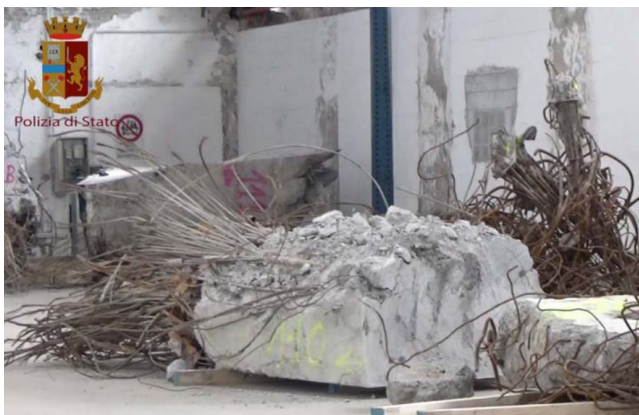
Fig. 2. (a) Triggering of the bridge collapse, which started from the failure of the SE cable-stay cross-section close to the antenna (image courtesy of Guardia di Finanza di Genova 2019); and (b) picture of the corroded strands subjected to forensic analysis (image courtesy of Polizia di Stato, republished from Bonchi (2020) with permission from Genova24).

As shown in the following, the cross-section of the cable-stay close to the antenna is the most critical. This hypothesis is consistent with the image shown in Fig. 2(a), which was taken from a recently declassified video, where it is possible to appreciate the very first instants of the collapse. First, the cross-section close to the antenna of the South-East (SE) cable-stay suddenly broke apart (A). Then the bridge-deck and the adjacent Gerber beam (on the right) collapsed (B). At the same time, due to dynamic rebound and missing balance, the top of the antenna broke and rotated anticlockwise (C). The rebound was such that the cable-stay on the left side buckled in compression (D), propagating the failure to the left side of the bridge deck and Gerber beam (E). A key role in the collapse was certainly played by corrosion. Fig. 2(b) shows part of the corroded tendons that were considered in the forensic analysis.

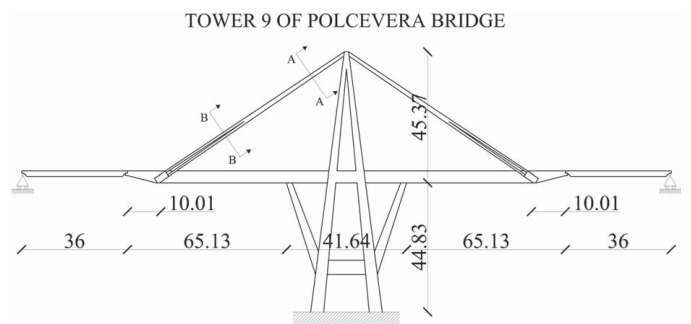
Fig. 5. Lateral view of the self-standing system.

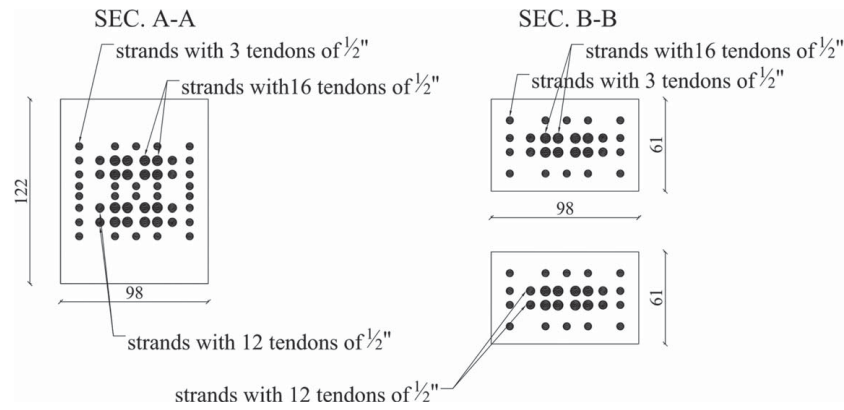
Fig. 8. Cross-section of the stay.

In order to evaluate the effect of corrosion in terms of redistribution of stresses among concrete and steel in the closest section to the antenna, we developed a simple but effective model where the cross-section of the cable-stay (Fig. 8) is schematized by three springs in parallel (Fig. 13), representing the 352 inner strands, the concrete covering, and the 112 outer strands, respectively.

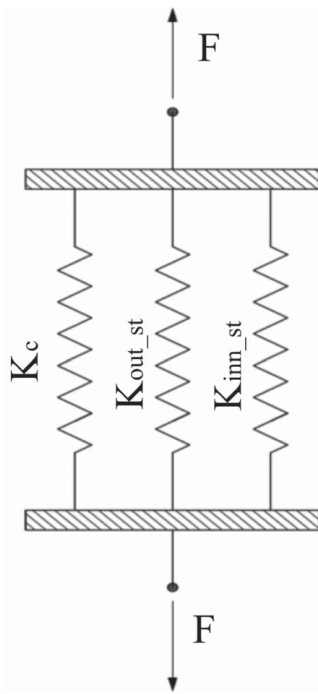
Fig. 13. Simplified structural scheme used to evaluate the unit-length stiffness of the stay cable and redistribution of the normal stresses among the three components.

where $K_{inn_st}(C\%)$, $K_{out_st}(C\%)$, and $K_c(C\%)$ are the secant stiffness per unit length of the inner tendons, the outer tendons, and the concrete covering, respectively, for increasing corrosion level. Moreover, the total cable-stay stiffness, $K_{tot}(C\%)$, according to the parallel spring scheme (shown in Fig. 13), is the sum of each term.

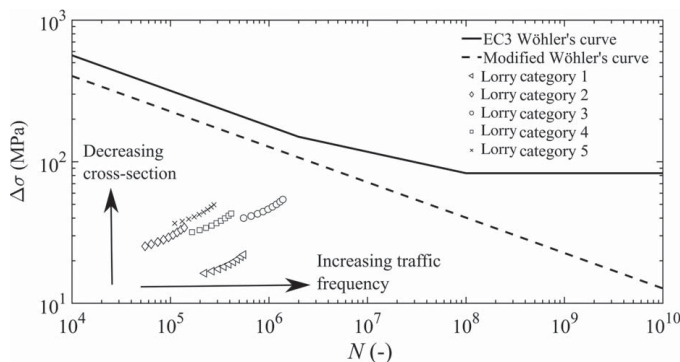
Fig. 23. Application of the Palmgren–Miner rule according to fatigue load spectrum with a corrosion level equal to 33%. Note that, for the sake of clarity, each marker is representative of an almost 6-year time interval.
