A durable coating to prevent stress corrosion effects on the surface strength of annealed glass

A durable coating to prevent stress corrosion effects on the surface strength of annealed glass / Marigiò, G.; Dalle Vacche, S.; Bongiovanni, R.; Louter, C.; Corrado, M.. - In: GLASS STRUCTURES & ENGINEERING. - ISSN 2363-5150. - ELETTRONICO. - 6:4(2021), pp. 449-462. [10.1007/s40940-021-00161-x]

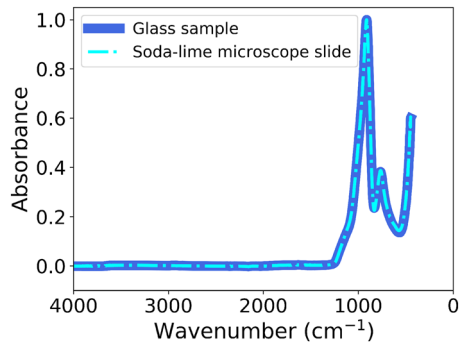
**Fig. 1** FTIR-ATR spectra of the glass used in the present work compared to that of a reference soda-lime glass

Square soda-lime silica plates were employed for preparing the specimens. FTIR-ATR (Fourier Transform InfraRed Attenuated Total Reflection) spectroscopy was performed to assess the glass chemical composition. The InfraRed (IR) spectra of the glass used in this study is compared to that of a microscope slide made of low-iron soda-lime silica glass. The two spectra shown in Fig. 1 are perfectly overlapped. Furthermore, the peaks of absorbance at 910 cm⁻¹ and 768 cm⁻¹ are representative of the symmetric and asymmetric vibration of the Si-O-Si bond (Amma et al. 2015).

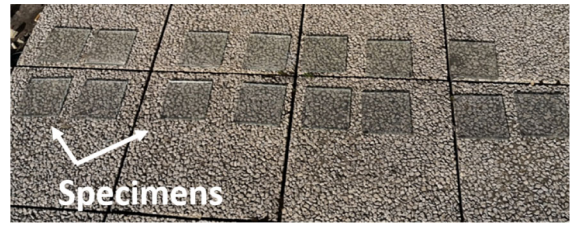
Fig. 4 Set of 15 coated glass specimens exposed to atmospheric agents

A set of 15 coated square glass samples having $l = 120$ mm and $h = 4$ mm were exposed to atmospheric agents for 510 days (17 months), from February 4th 2019, to June 30th 2020, to assess the durability of the coating against natural weathering. The samples were mounted on a frame placed horizontally on the roof of a building of Politecnico di Torino, Corso Duca degli Abruzzi, 24, Torino (Lat: 45.0628, Long: 7.6621, Alt: 254 m. a.s.l) (see Fig. 4). The actual peak to peak variations in temperature and maximum irradiance (SRmax) were between 38.8°C (summer) and -1.5°C (winter) and
