The October 2000 flooding in Valle d'Aosta (Italy): Event description and land planning measures for the risk mitigation

The October 2000 flooding in Valle d'Aosta (Italy): Event description and land planning measures for the risk mitigation / Ratto, S., Bonetto, F., Comoglio, C.. - In: INTERNATIONAL JOURNAL OF RIVER BASIN MANAGEMENT. - ISSN 1571-5124. - 1:2(2003), pp. 105-116. [10.1080/15715124.2003.9635197]

SARA RATTO and FRANCO BONETTO, *Geologist, Valle d'Aosta Autonomous Region, Land, Environment and Public Works Department, Cartography and Hydrogeological Asset Service, Via Promis, 2, 11100 Aosta, Italy*

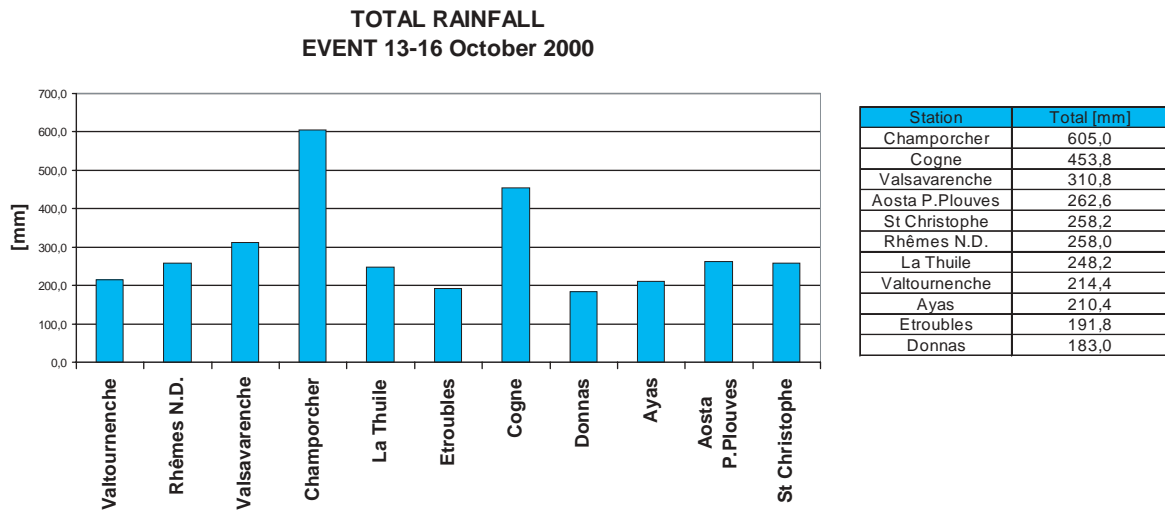
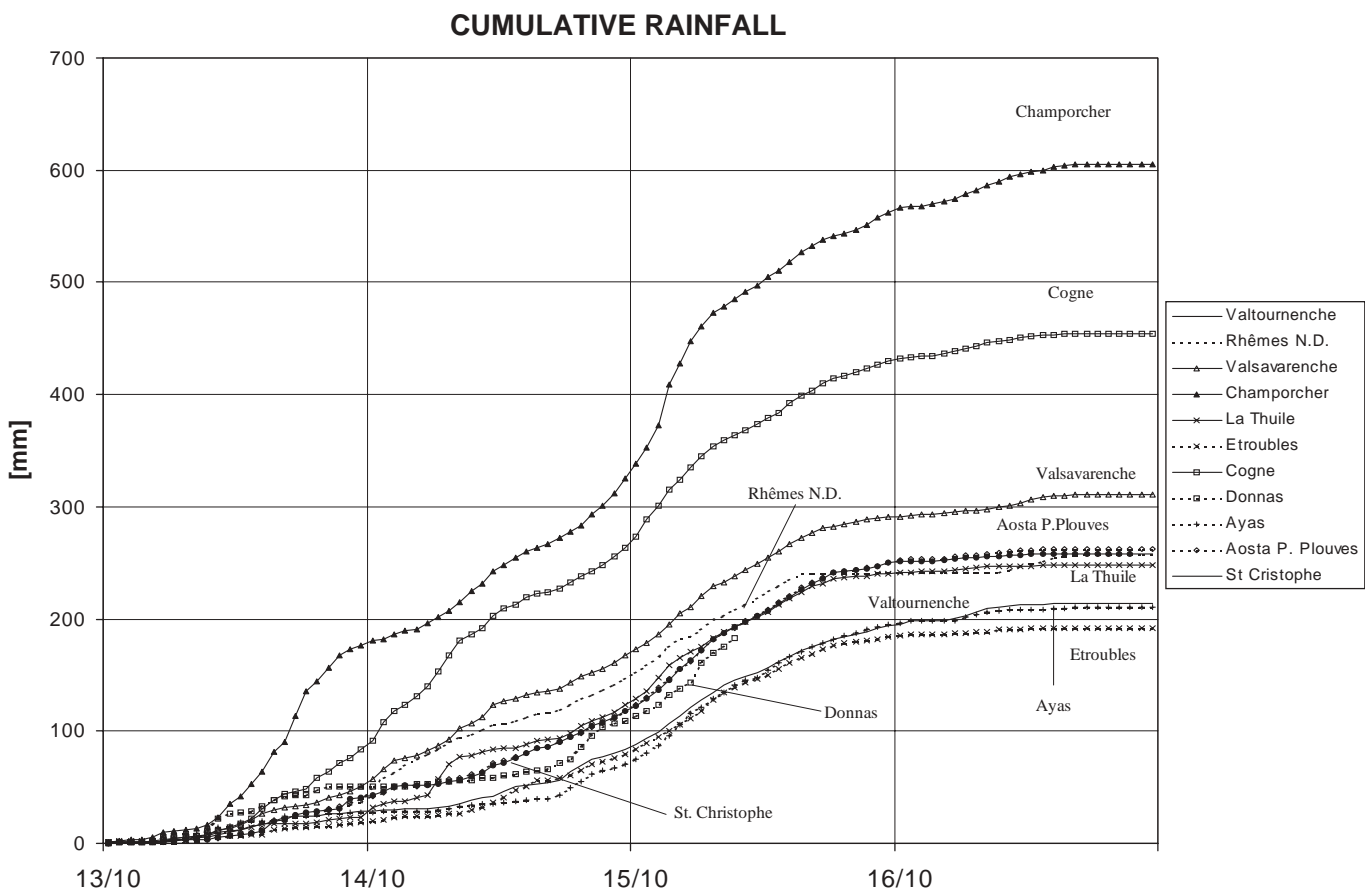
Figure 7 Total rainfall.

Figure 8 Cumulative rainfall.

- Champorcher and Cogne stations (and so the southern sector of Valle d'Aosta) recorded maximum total values exceeding 450 mm;
- the other stations anyway recorded maximum total values higher than 200 mm;
- 7 stations recorded the maximum of hourly intensity between the 03:00 a.m. and the 08:00 a.m. of Sunday 15th;
- 4 stations recorded the maximum of hourly intensity between the 00:00 a.m. and the 07:00 a.m. of Saturday 14th.

Taking into account the whole event of October 13–16th, from the values of the cumulative rainfalls (Figures 7 and 8) and of the

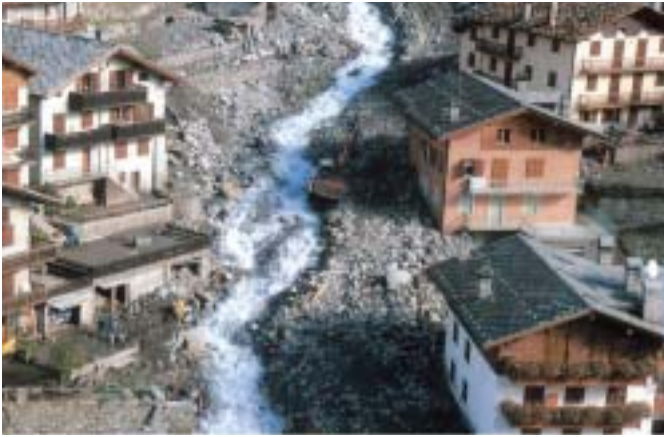
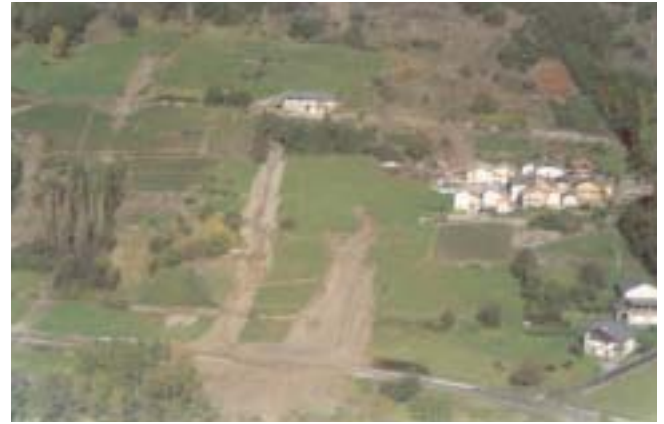
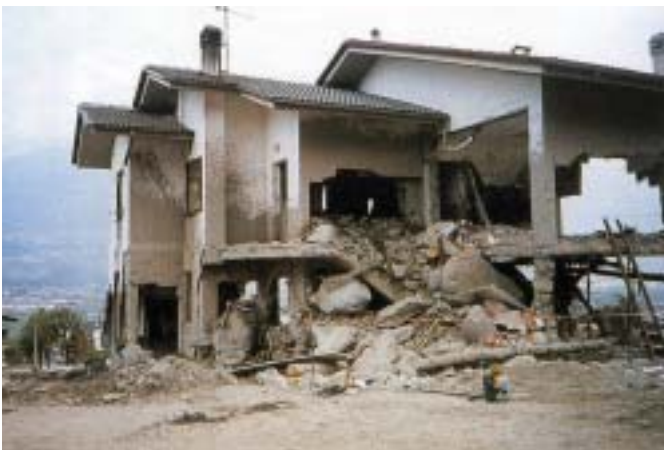
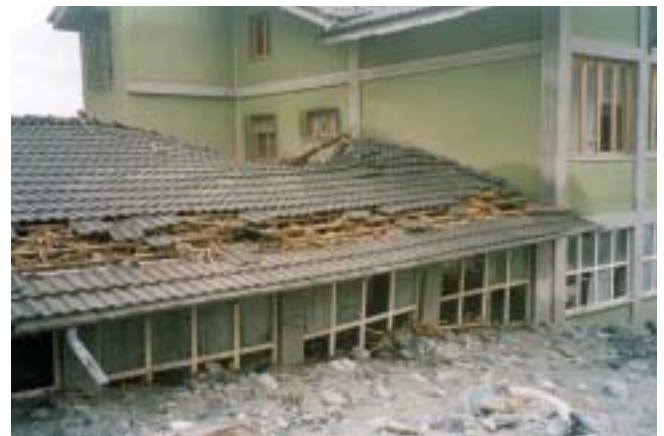
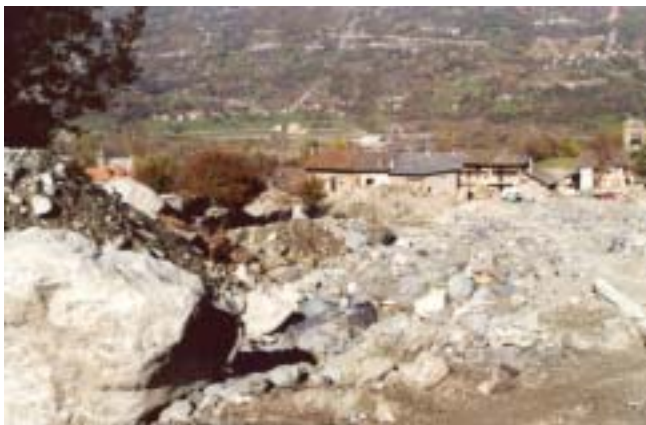
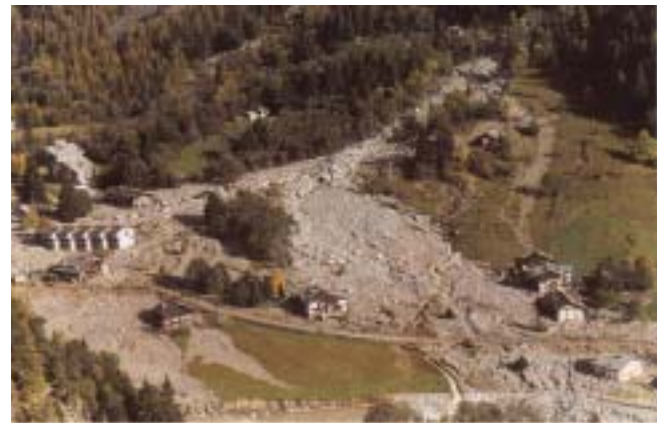
Photo 3 Cogne – Epinel Arpisson torrent. (author: local media).

Photo 6 Nus – Soil-slip.

Photo 4 Pollein – Effects of debris flow (author: local media).

Photo 7 Nus – Solid transport of St. Barthélemy Torrent.

Photo 5 Fénis – Debris flow deposit.

Photo 8 Gressoney-St-Jean – Debris flow.

- A drastic increase of the water levels in all the regional watercourses, with the Dora Baltea river already reaching its overflow threshold levels since Saturday 14th (Photos 1 and 2).
- Debris/earth flows, landslides and soil slips activation between Saturday 14th (Cogne area) and Sunday 15th morning from 07:00 to 09:00 a.m. (in the rest of the region) (Photos 3–8).

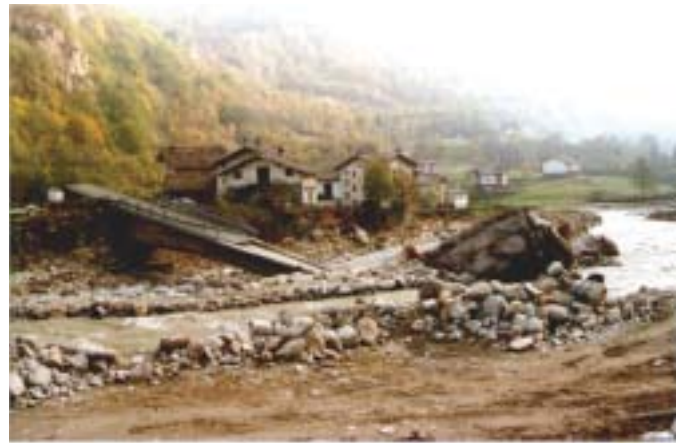
Photo 13 Issime. Lys torrent – Flood effects.

Photo 14 Gressoney-St-Jean. Lys torrent – Flood effects (*author: local media*).

- Dora Baltea river flood, even through its peak was recorded on Sunday 15th between 09:00 a.m. (central region) and 14:00 p.m (lower region) (see Photos 9–11), already caused serious damages on Saturday 14th.
- Surveys on the damages along the watercourses during the days after the flood transit (Photos 12–14).
- Activation/reactivation of landslides phenomena involving broad areas and huge volumes, some of them still developing nowadays (Photos 15–16).

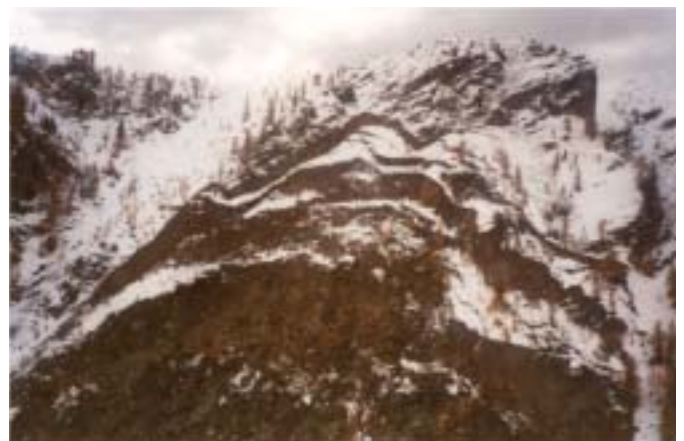
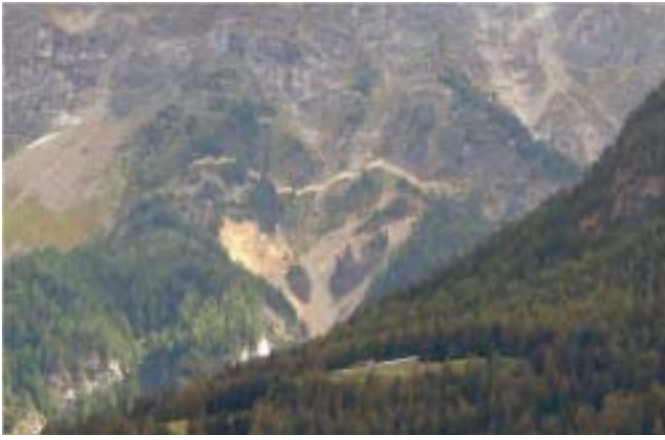
Photo 15 G.S. Bernardo valley – Citrin landslide.

Photo 16 Becca di Nona landslide (author: Ketty Carere).
