The October 2000 flooding in Valle d'Aosta (Italy): Event description and land planning measures for the risk mitigation

The October 2000 flooding in Valle d'Aosta (Italy): Event description and land planning measures for the risk mitigation / Ratto, S.; Bonetto, F.; Comoglio, C.. - In: INTERNATIONAL JOURNAL OF RIVER BASIN MANAGEMENT. - ISSN 1571-5124. - 1:2(2003), pp. 105-116. [10.1080/15715124.2003.9635197]

SARA RATTO and FRANCO BONETTO, *Geologist, Valle d'Aosta Autonomous Region, Land, Environment and Public Works Department, Cartography and Hydrogeological Asset Service, Via Promis, 2, 11100 Aosta, Italy*

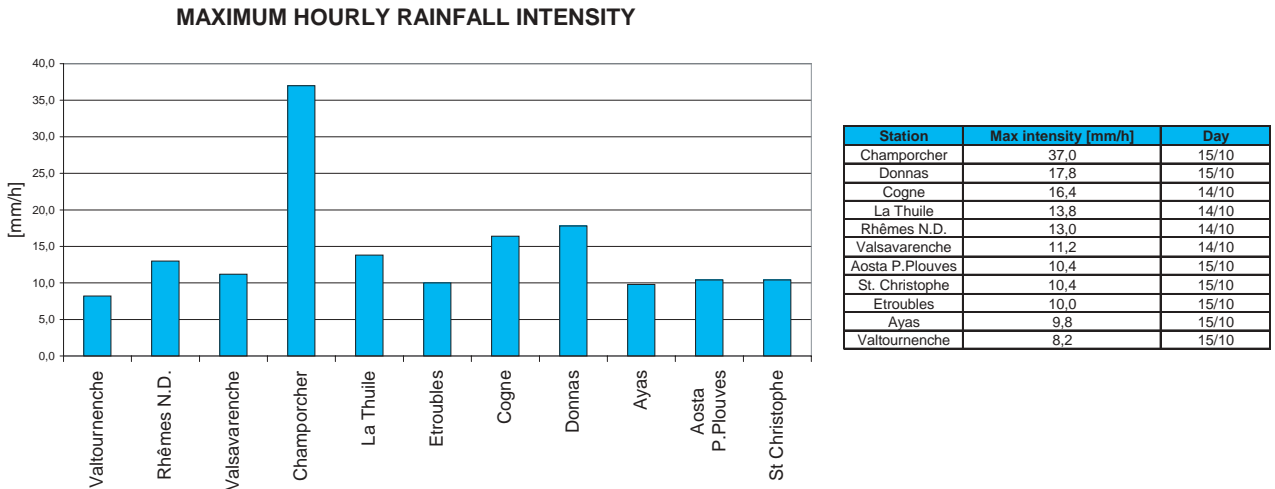
Figure 9 Maximum hourly rainfall intensity.

maximum hourly intensity (Figure 9) it is clear that:

- Champorcher and Cogné stations (and so the southern sector of Valle d'Aosta) recorded maximum total values exceeding 450 mm;
- the other stations anyway recorded maximum total values higher than 200 mm;
- 7 stations recorded the maximum of hourly intensity between the 03:00 a.m. and the 08:00 a.m. of Sunday 15th;
- 4 stations recorded the maximum of hourly intensity between the 00:00 a.m. and the 07:00 a.m. of Saturday 14th.

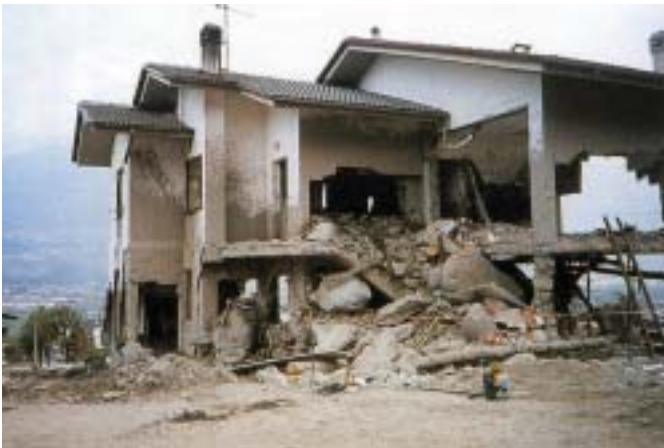
Photo 4 Pollein – Effects of debris flow (author: local media).

- A drastic increase of the water levels in all the regional watercourses, with the Dora Baltea river already reaching its overflow threshold levels since Saturday 14th (Photos 1 and 2).
- Debris/earth flows, landslides and soil slips activation between Saturday 14th (Cogne area) and Sunday 15th morning from 07:00 to 09:00 a.m. (in the rest of the region) (Photos 3–8).

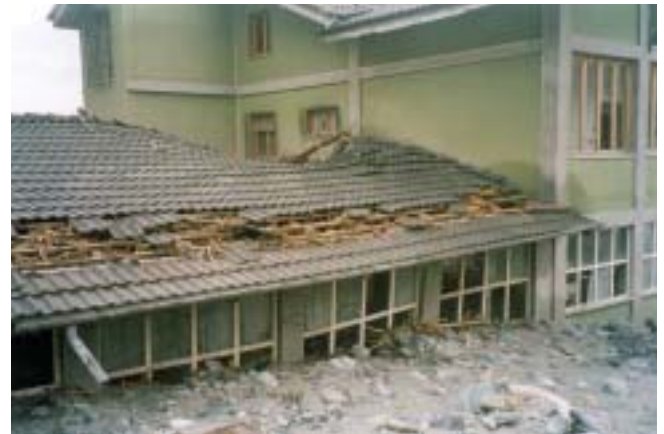
Photo 7 Nus – Solid transport of St. Barthélemy Torrent.
