Technology, Diagnosis and Structural Assessment on Timber Composite Beams in Venice Arsenal at the Biennale

Technology, diagnosis and structural assessment on timber composite beams in Venice Arsenal at the Biennale

Abstract In the architectural and cultural heritage of the Arsenale of Venice, the authors have worked on several interventions for diagnosis and recovery of roofs, foundations and floors of the so-called "woods of Venice". The work refers to the complex of the "Sale d'Armi" located in the central area of the Arsenale, currently used as exhibition space for the Biennale of Venice. The original nucleus (1460) was used as weapons deposit of the Serenissima. The South "Sala d'Armi", three buildings on two levels realized in the 17th century, were rebuilt after the fire of 1728. This article describes the diagnostic assessment, including dendrochronological and mechanical assessment, carried out in one of these buildings, the largest one, a large room at full height, which currently preserves original timber elements left in place after the fire: composite beams belonging to a timber floor supported by timber columns. The paper focuses on a very interesting construction s

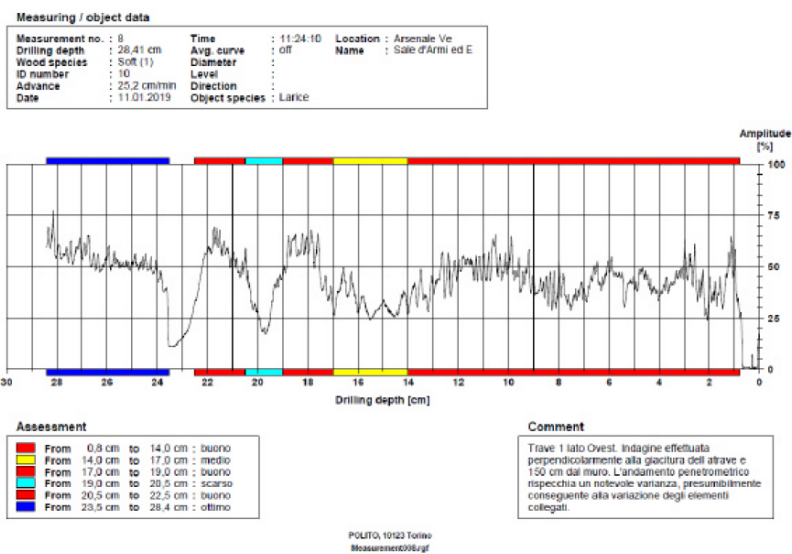
Fig. 9 Diagnostic survey on the composite beam. Overlapping of the different wooden elements composing the beam. Example of resistance drilling carried out on the beam.

These types of surveys went alongside with instrumental investigations, with the help of resistance drilling for wooden elements whose state of conservation needed to be verified. Furthermore, also the constructive survey was integrated with the use of resistance drilling to verify the thickness of the different parts constituting the joint, a very important indication for the assessment of the state of conservation and mainly of the stability of the structure.

The diagnostic assessment mainly concerned the timber elements of the main supporting structure of the trusses, to which the investigations on secondary elements were added (Fig. 9).
