Raman spectroscopic characterization of corrosion products of archaeological iron / Vietti, A; Angelini, E; Grassini, S; Donato, N. - In: JOURNAL OF PHYSICS. CONFERENCE SERIES. - ISSN 1742-6588. - 2204:(2022), p. 012066. ( International Conference on Metrology for Archaeology and Cultural Heritage (MetroArchaeo) Milan, Italy 20-22 October 2021) [10.1088/1742-6596/2204/1/012066].

## Raman spectroscopic characterization of corrosion products of archaeological iron

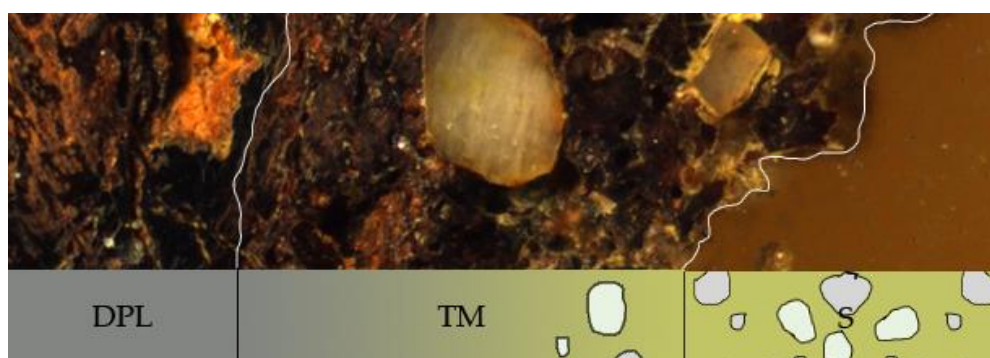
The Transition Zone, where the corrosion products are less crystallized, is composed essentially of goethite, maghemite and lepidocrocite. Regarding the lepidocrocite, which is a very reactive phase most probably formed after the excavation, is located especially in the cracks of the nail or at the interface with the soil. An example of the general corrosion stratigraphy is briefly schematized in Figure 5.

**Figure 5.** The schematic corrosion layers correlated with the section of sample CH\_03. The soil layer (S) is not present anymore, because the sample was cleaned before the inclusion in resin.
