# Garden building diagnostic systems for sustainable preservation

**Abstract**—A garden building located in Torino, 25 VERDE, designed by the architect Luciano Pia is object of a monitoring diagnostic campaign, started in 2016 and still in progress, for ensuring a long-lasting sustainable preservation. The residential complex of sixty-three apartments conceived as a habitable forest in which almost 200 trees cut down the fine dust caused by cars, is characterized by irregularly shaped terraces, supported by weathering steel tree-like structures. The weathering steels or high-strength low alloy steels have a unique interesting characteristic: they corrode under proper environmental conditions, forming a compact and tightly adherent oxide barrier that seals out the atmosphere and retards further corrosion. Dry and wet cycles create a protecting patina layer, meanwhile the constant presence of humidity and of aggressive gaseous pollutants (SO<sub>2</sub>, NO<sub>x</sub>, etc) in the atmosphere degrades the properties of the layer. The diagnostic intervention is centered in the monitoring of the weathering steel structures by means of in situ electrochemical techniques, as Electrochem

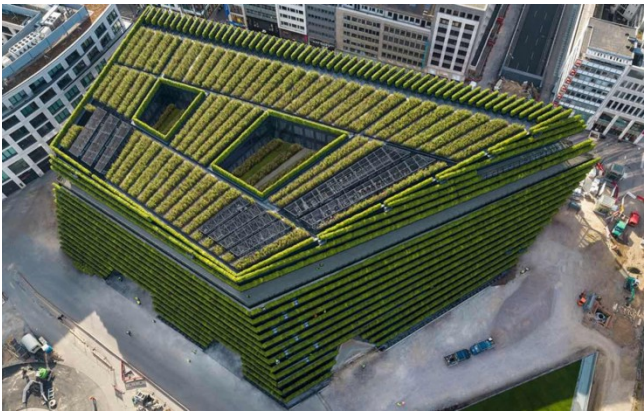
Fig. 2. Kö-Bogen II office building, in Dusseldorf, in Germany, designed by Ingenhoven architecture firm.

firm was to “restore as much green as possible to the city”. The facades are lined with hornbeam hedges resistant to harsh climatic conditions and which do not require much maintenance and care, ensured by an integrated irrigation and drainage system, Fig. 2. This expanse of greenery guarantees a high CO<sub>2</sub> absorption capacity, a fundamental aspect in any city, and favors the reduction of temperatures in summer, often raised by the strong presence of concrete and other waterproof materials.

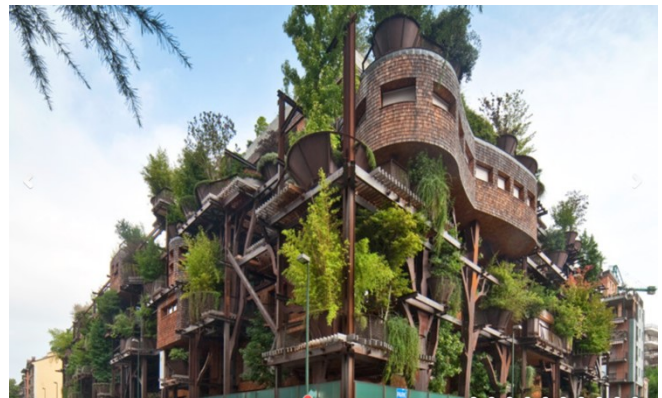
Fig. 4. The building "25 VERDE" in Turin, in Italy, designed by Luciano Pia architecture studio.

In Turin, the architect Luciano Pia designed and realized in 2012, the “25 VERDE”, a residential complex of 63 apartments conceived as a habitable forest in which almost 200 trees cut down the fine dust caused by cars, protect from noise, create an ideal microclimate inside the building by mitigating the changes in temperature in summer and winter and blend with the architecture becoming an integral part of it, Fig. 4. Designed to be introspective and pleasant to live inside, it was made with natural materials, wisely used to create a unique and spectacular effect. The irregularly shaped terraces are supported by weathering steel tree-like structures and the wooden and glass flooring has been designed to allow light to filter from one floor to another. The entire building is clad with wooden shingles to evoke the bark of trees; lush gardens cover the roofs with greenery and a large courtyard hosts a wood-garden on the ground floor. The well-being that living in a “green” environment generates in this case is tangible: considerable mitigation of external temperatures, over 5 tons/year of CO<sub>2</sub> absorbed for the same amount of oxygen produced and finally almost 1.5 kg/year of fine dust reduced. One of the objectives now achieved was to obtain maximum energy efficiency. Numerous integrated solutions have been adopted: “external coat” insulation, ventilated walls,

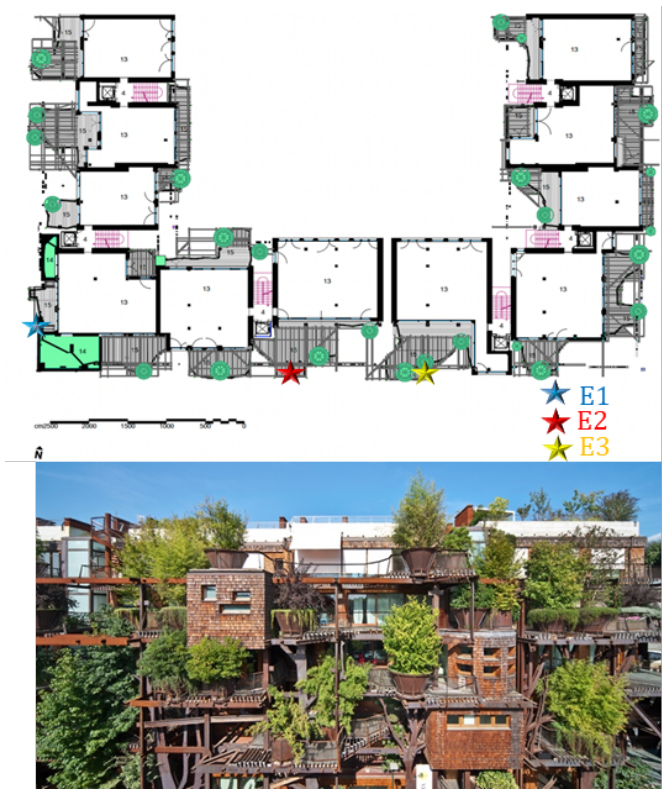
Fig. 6. The map of the second floor of 25 VERDE (top) and picture of the façade (bottom).

In the case of 25 VERDE, our diagnostic intervention, Fig. 5 and Fig. 6, was centered in the monitoring of the weathering steel structures by means of in situ electrochemical techniques, as Electrochemical Impedance Spectroscopy (EIS) [17] [18]. The ultimate goal is to understand and assess the effect of the exposure conditions to the atmospheric corrosion of the weathering steel in these modern heritage buildings and structures [11] [19]. The paper presents the electrochemical results collected during an in situ monitoring campaign started in 2016 and still running.

Thanks to the visual inspection, the primary step of every building inspection, the monitoring points were identified, as shown on the maps of ground floor and of the second level of the building, Fig. 5 and Fig. 6. Particular attention has been paid to the appearance of the structural and non-structural components of the building, observing the presence
