# A tool for monitoring rockfall protection works and plan the maintenance: the case of the autonomous region of Valle d'Aosta

Rockfall net fences and drapery meshes constitute two of the most adopted protective structural works against rockfall hazard. During their life, they are subject to ageing, corrosion, and impact loads, with a consequent loss of efficiency or even effectiveness. Due to the variability of the environment and, more in general, to external conditions, a definition of a service life, although not unique but different product by product, is not achievable.

The paper presents the methodology, in its enhanced version, some examples are proposed, considering a survey campaign performed in Valle d'Aosta (Italy) as representative. The results of its application are reported and discussed.

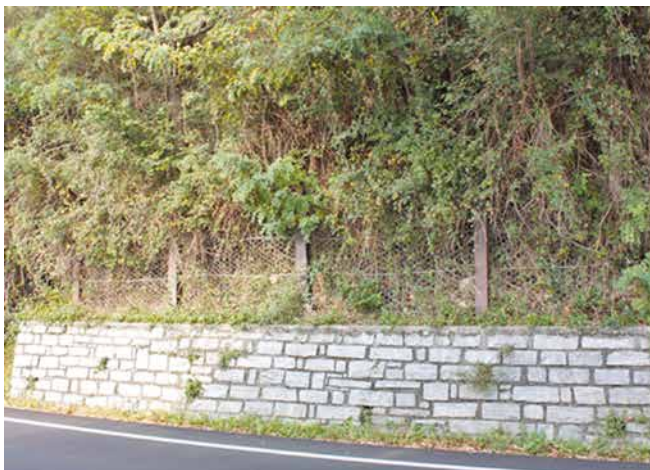
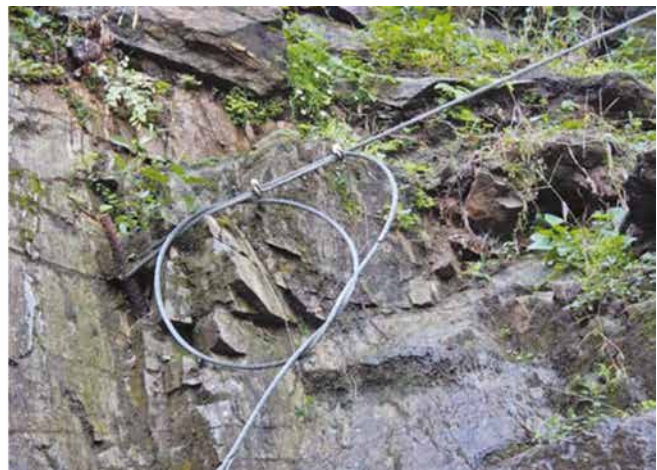
Fig. 1 – Installation errors, and unsuitable or not certified technologies.

Neglecting the design aspect, several damages frequently observed relate with installation errors, and suitable or unsuitable certified technologies (Fig. 1). Focusing directly on degradation and ageing incorrect/absent maintenance procedures, among the problems, the ones related to vegetation, directly interacting with the works or otherwise influencing their performances, are the most common. Corrosion has been frequently observed in several components, even in the anchors, where disrupted. Accumulation of debris, due also to impacts with energy much smaller than the design one, as well as impacts of element differing from rock blocks, i.e. trees after some severe or unexpected

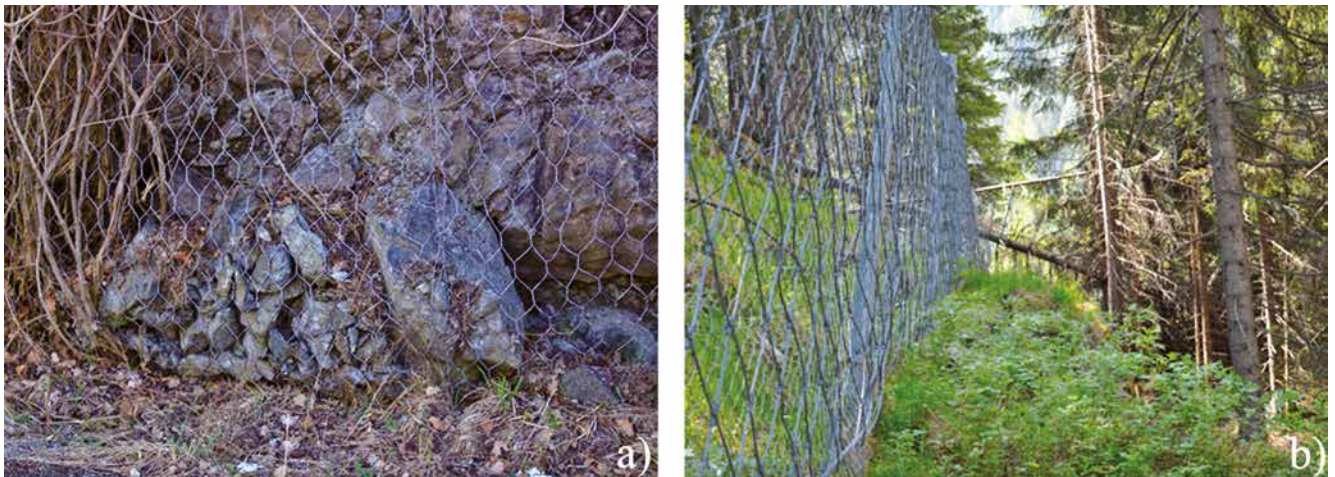
Fig. 2 – Accumulation of debris, due also to impacts with energy smaller than the design one (a), and impacts of element differing from rock blocks, i.e. trees after some severe or unexpected climatic events (b).

climatic events, represent recurring situations highlighted during inspections (Fig. 2).

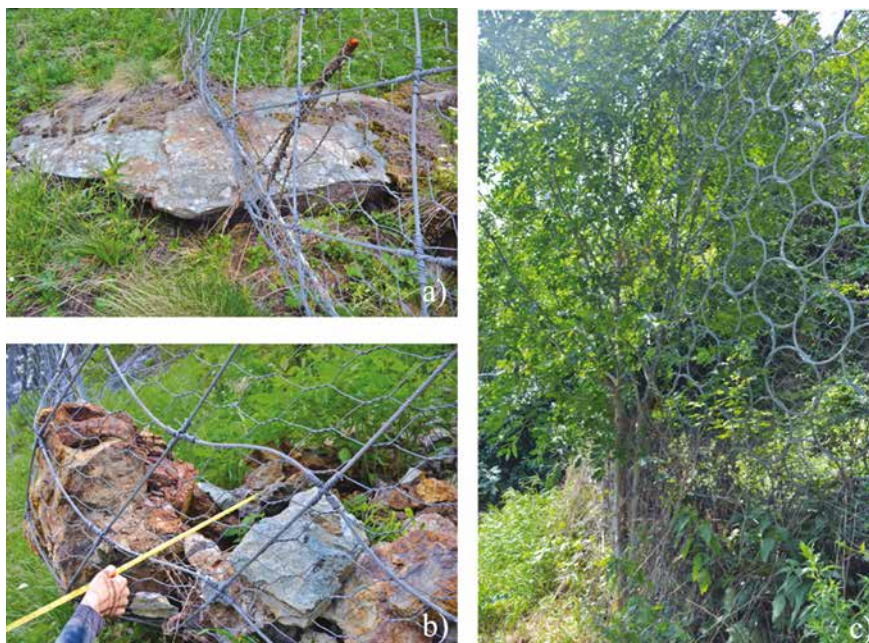
Fig. 4 – Frequent observed damages: voids at the foot of the barrier (a), debris/blocks/notches in the net (b), and elements limiting the deformation capacity of the barrier (c).

Analysing in detail those net fences that display a high need of interventions, the presence of significant void at the foot of the barrier reveals to be the major issue, together with the presence of elements limiting the deformation capacity of the barrier (Figg. 4 and

5). Both these aspects are highlighted in the 62% of the samples (and in many cases they are observed together), while in 31% the presence of debris/blocks/notches in the net is shown. Considering also  $P_{tot}$  values, this indicator is lower or equal 15% in all the cases, revealing that in the great majority the indicator  $A$  mostly affects the results. This implies that, even though high priority levels of maintenance are required, the maintenance procedures to adopt would involve only a single aspect/damage, i.e. closing the net at the bottom, removing blocks or trees

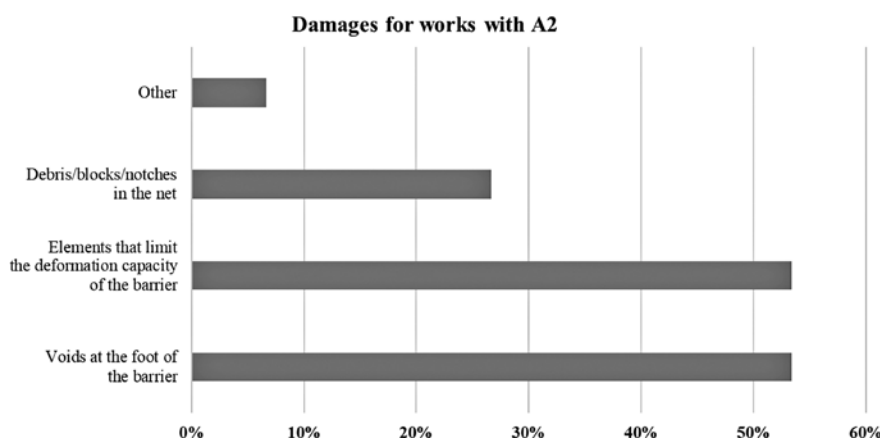
Fig. 5 – Histogram of the observed damages, which lead to a state of functionality equal to A2.

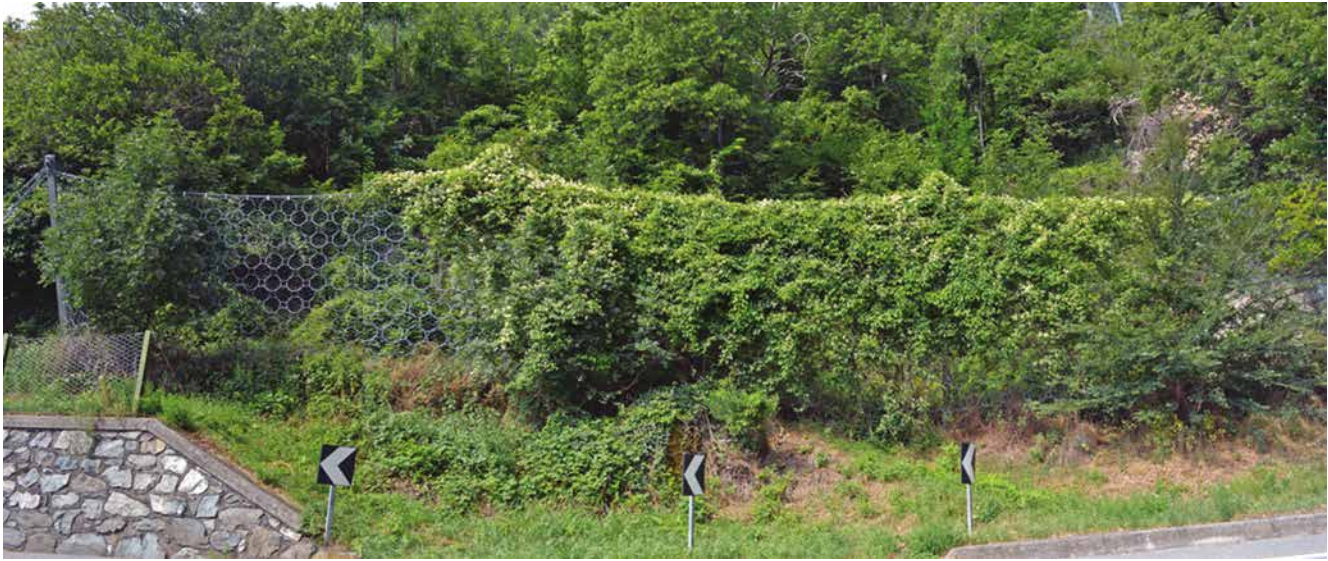
Fig. 6 – Presence of dense vegetation.
