A tool for monitoring rockfall protection works and plan the maintenance: the case of the autonomous region of Valle d'Aosta

The paper presents the methodology, in its enhanced version, some examples are proposed, considering a survey campaign performed in Valle d'Aosta (Italy) as representative. The results of its application are reported and discussed.

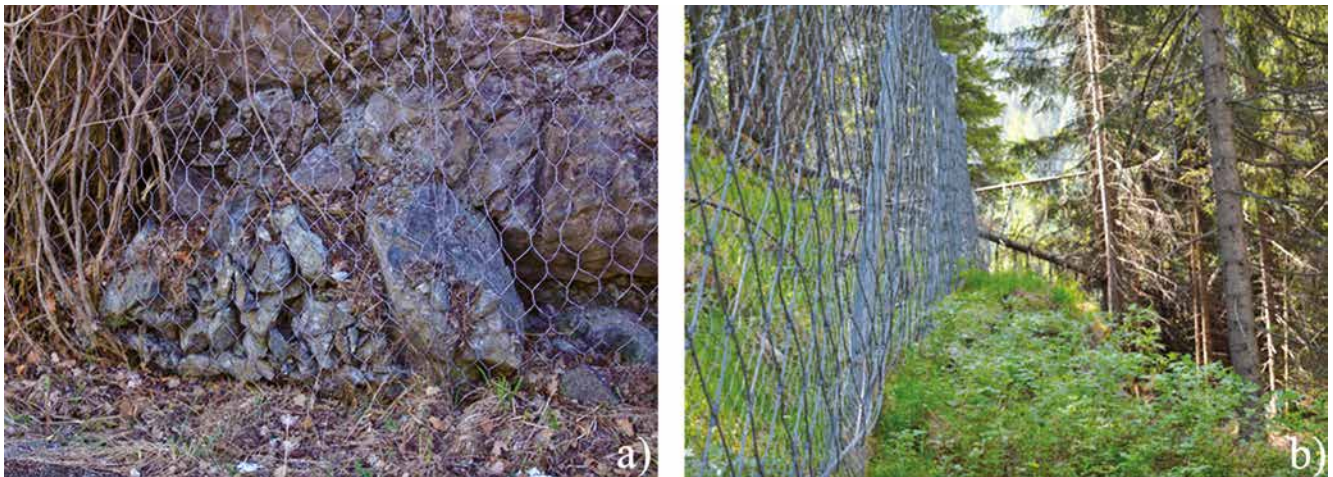
Fig. 2 – Accumulation of debris, due also to impacts with energy smaller than the design one (a), and impacts of element differing from rock blocks, i.e. trees after some severe or unexpected climatic events (b).

climatic events, represent recurring situations highlighted during inspections (Fig. 2).
