Rock mass characterization by UAV and close-range photogrammetry: A multiscale approach applied along the vallone dell'elva road (Italy)

# Rock Mass Characterization by UAV and Close-Range Photogrammetry: A Multiscale Approach Applied along the Vallone dell'Elva Road (Italy)

This study describes a multiscale approach to the study of the possible conditions of detachment for the Elva valley road (Northern Italy), in which both non-contact techniques and traditional support techniques are applied. The images acquired using UAVs and the terrestrial photogrammetric technique are used to obtain 3D point clouds, and high-resolution georeferenced DSMs are analysed to extract orientation and persistence data for the discontinuities at different scales. As described below, a multiscale approach was applied, obtaining DSMs at three different scales: a large-scale DSM of the entire road was produced, medium-scale models of the slope portions were obtained to identify the orientation of the discontinuities, and a small-scale DSM (equal to the scale of a single discontinuity) was used to obtain higher resolution point clouds in order to measure the roughness of the discontinuities. This paper

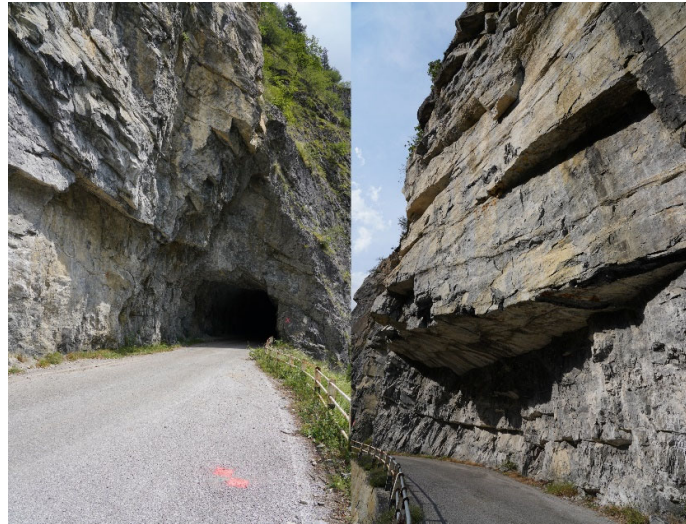
**Figure 1.** Photographs of the rock walls under study.

The road stretches for about 9 km of carriageway with overhanging rock walls and twelve tunnels excavated into the bare rock (Figure 1). Due to the numerous instability phenomena that have occurred since its construction (Table 1) along the entire road and after a large planar sliding in 2015, the road has been closed to traffic.

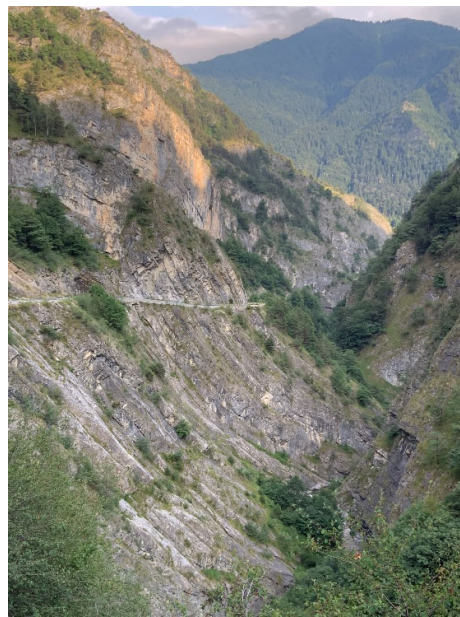
**Figure 2.** View of the hetometric fold: photo taken along the road looking south, and the road is visible on the right side of the slope.

The Elva Road is located in an area strongly tectonized with hectometric folds clearly visible in the panorama of Mount Bittone and delimited by a fault oriented toward N–S and passing through the right side of the valley itself (Figure 2). It is characterized (Figure 3 geological map extract) by dolomite rocks and light grey or black dolomitic limestones, in banks of considerable thickness, and interlayers of cinerites. Their formation took place in the Carnic and Noric Alps (Upper Triassic). These limestone–dolomitic carbonate rocks, cut from the road, are highly verticalized, with a high-angle westward immersion. This sedimentary rock is characterized by three systems, a highly persistent bedding plane and at least two more conjugated set joints, contained between, and perpendicular to, two continuous bedding planes. The orientation of the planes varies due to the presence of folds and faults, and for this reason different kinematic conditions are identified to also be linked to the variation of the orientation of the slopes along the road. The summit portion of the Valley near the town of Elva is instead set in the calcschists and micascists, with significant areas covered with soil that are the site of a deep gravitational slope deformation.

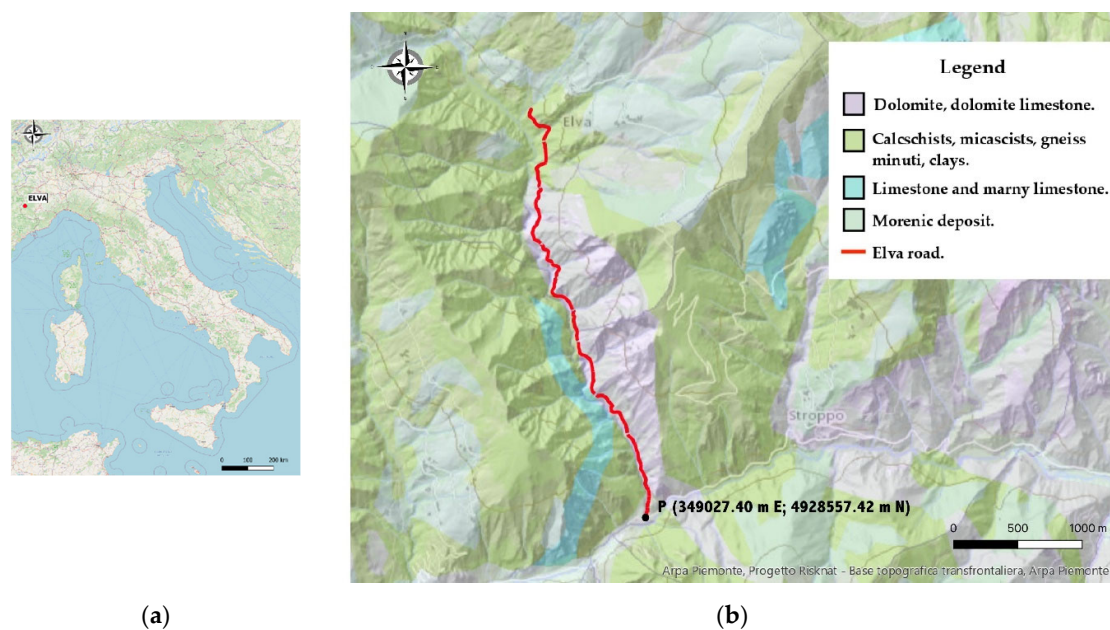
**Figure 3.** (a) Map of Italy with indication of the position of Elva (coordinates of ELVA UTM zone 32T 347,654.28 m E; 4,934,405.34 m N); (b) geological map extract of the Vallone dell'Elva [30]; coordinates of point P (UTM zone 32T, 349,027.40 m E, 4,938,557.42 m N).

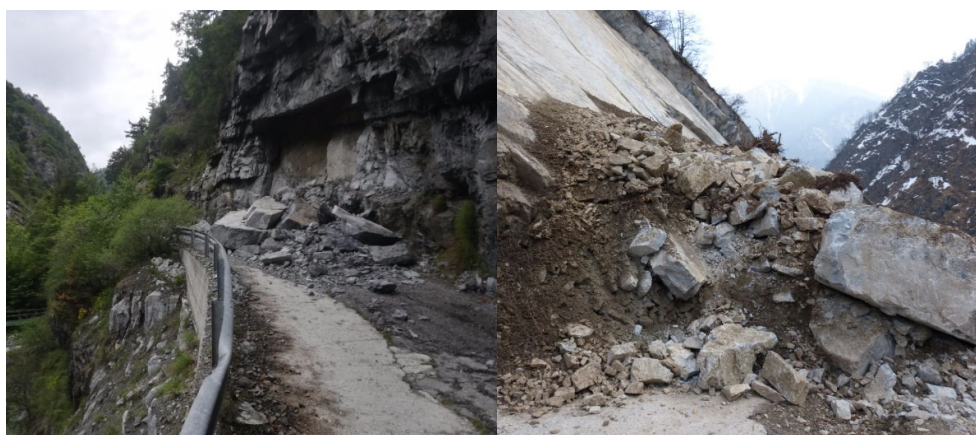
**Figure 4.** Instabilities of 2 June 2018 (about  $250 \text{ m}^3$ ) and 25 February 2015 (more than  $2000 \text{ m}^3$ ).

From the information collected, it is possible to distinguish widespread instability phenomena involving single blocks with volume variables between a few  $\text{cm}^3$  to about  $1 \text{ m}^3$  occurring along the entire road with a high temporal frequency. In addition, localized instability phenomena, with higher intensity in terms of unstable rock mass volume (variable between a few  $\text{m}^3$  to  $2500 \text{ m}^3$ ) was recorded by the public agency (Table 1), which led, in some cases, to the interruption of the traffic along the road (Figure 4).

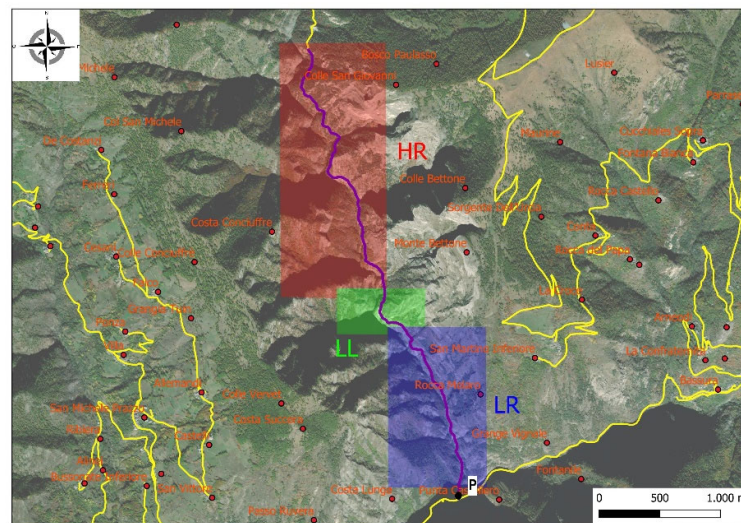
**Figure 5.** Representative surveys domains: High Road (HR), Large Landslide (LL), Low Road (LR), coordinates of point P (UTM zone 32T, 349,027.40 m E, 4,938,557.42 m N).

In order to cover all nine kilometres of the road, the survey was subdivided into three different domains, namely “High part of Road (HR)”, “Low part of Road (LR)” and “Large Landslide (LL)”, respectively, as shown in Figure 5.

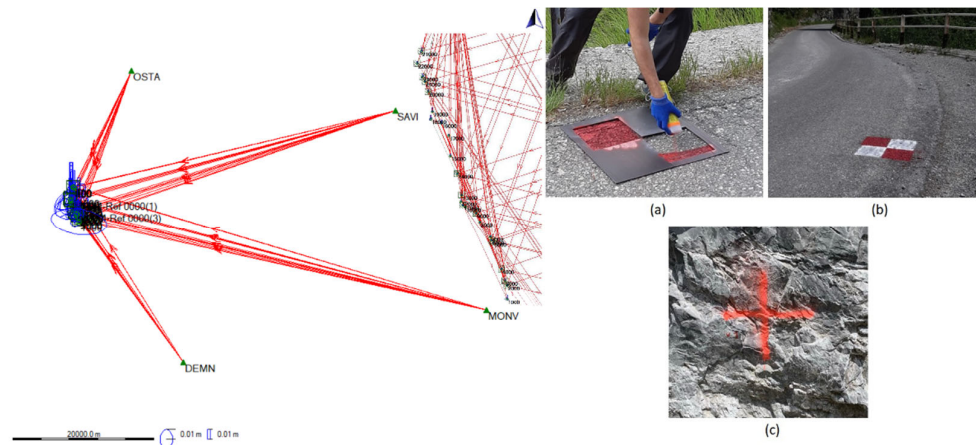
**Figure 6.** CORS constellations in Elva area and an example of the markers materialized along the road paving and rock outcropping: (a) colouring of highly visible markers (30 × 30 cm) along the street, using a specially made template; (b) a horizontal marker; (c) a vertical marker.

In order to georeferenced every digital model processed, a topographical network was designed. About 200 points were measured by GNSS or total station techniques, guaranteeing a high accuracy and precision ( $\sigma_{\max} = 3$  mm in vertical or horizontal directions): (i) 22 horizontal markers materialised along the road paving, where the coordinates were estimated considering a multibase solution (through the Leica Geo Office® software v.8.4) with the Ostana and Demonte permanent stations of the CORSs (Continuous Operating Reference Stations) network by the Piedmont district; (ii) 54 vertical markers and 120 natural targets along the rock outcropping (about 1 marker every 50 m) were acquired using total station instrument. In Figure 6, an example of the topographic marker acquisition surveys is shown.

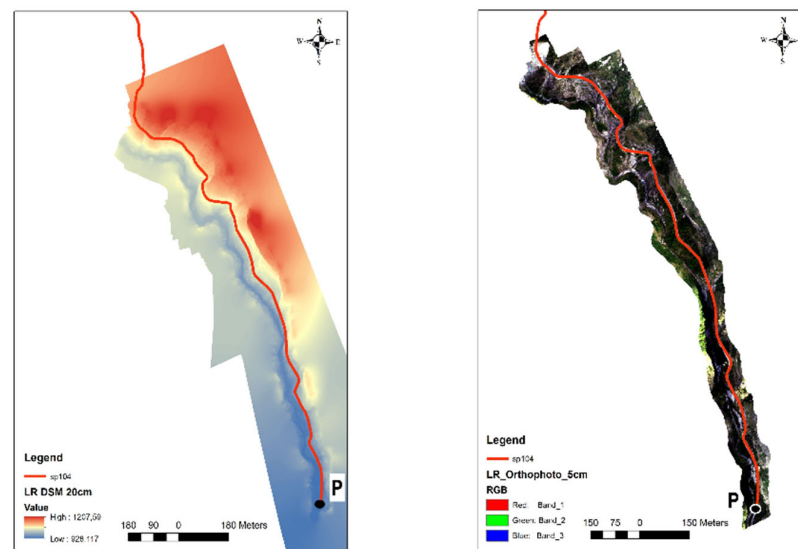
**Figure 7.** LR example of DSM and orthophoto; coordinates of point P (UTM zone 32T, 349,027.40 m E, 4,938,557.42 m N).

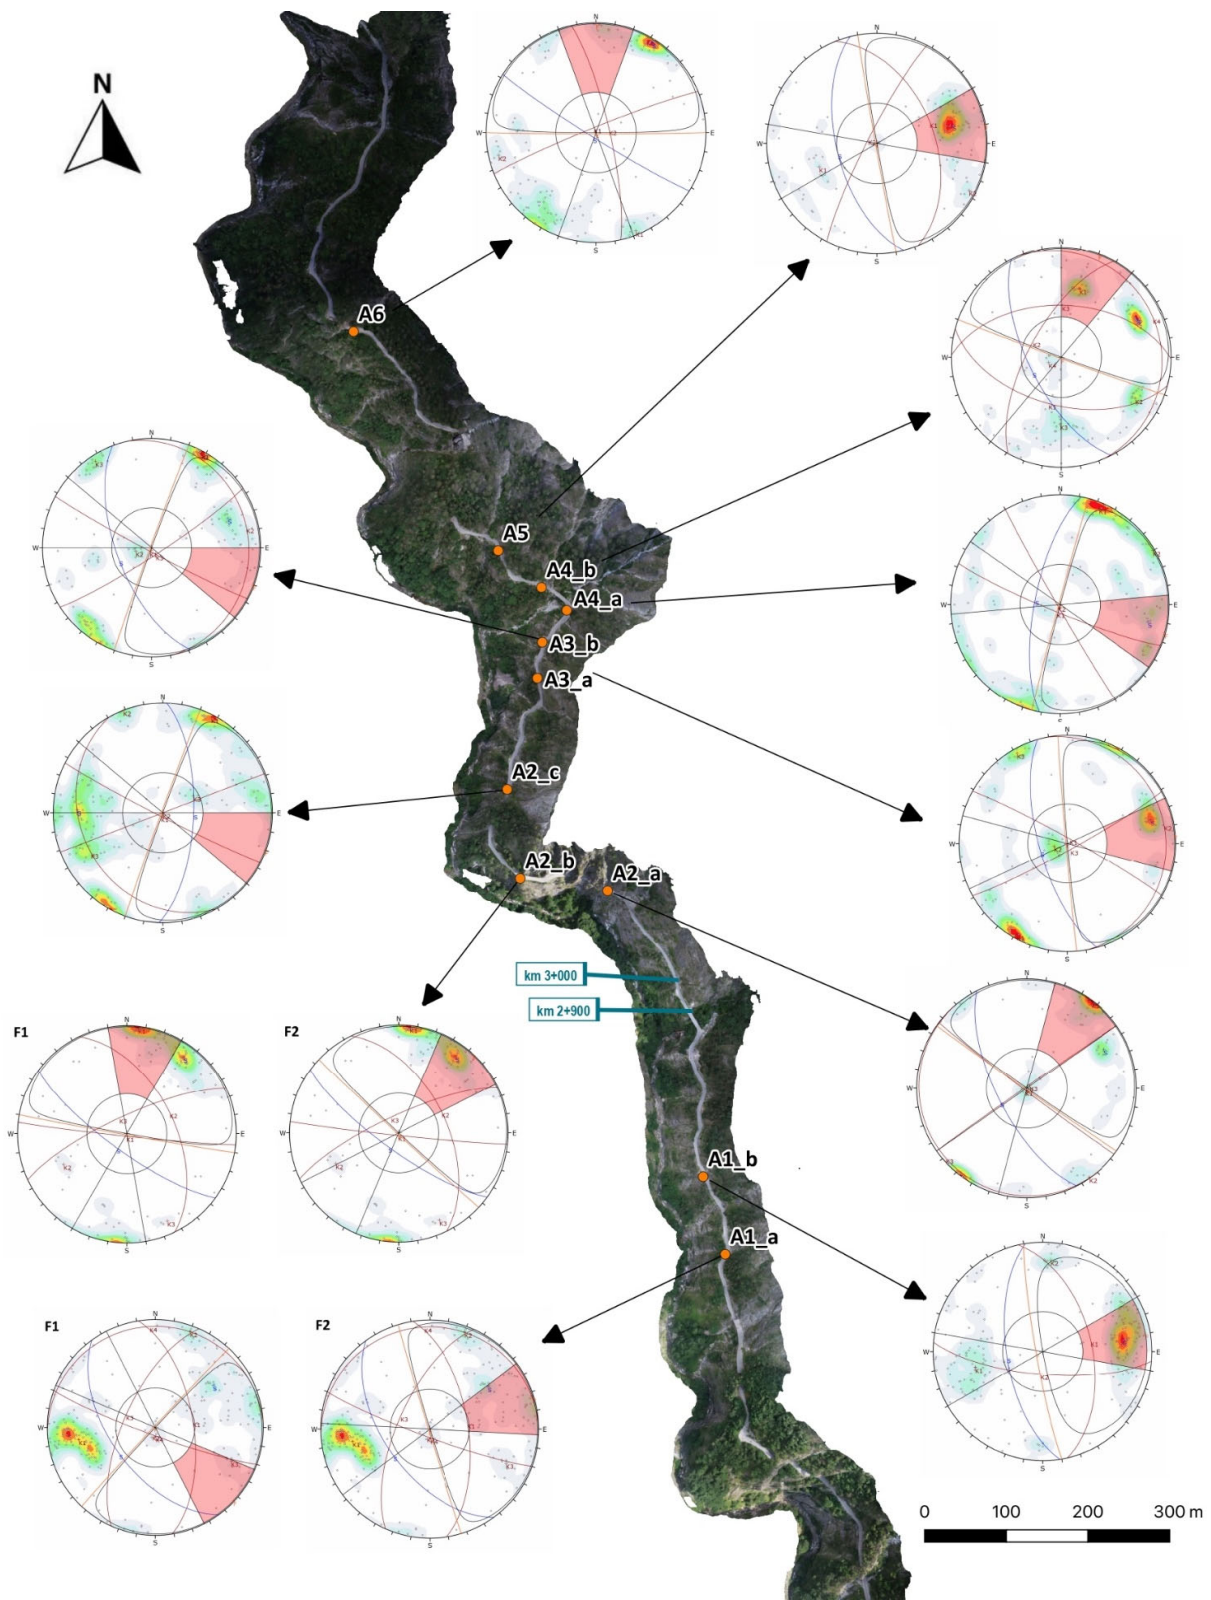
Figure 8. Orthophotos and results of kinematic analysis: High Road.

Twenty rock mass outcroppings located along the road were subject to geo-mechanical survey with both quick traditional and no-contact techniques: 11 along the HR, 9 along the LR and 1 at the LL. A detailed DSM was built in correspondence to each of the sites. Figures 8 and 9 at the end of this paper show the orthophotos in order to better visualize the position of all sectors.

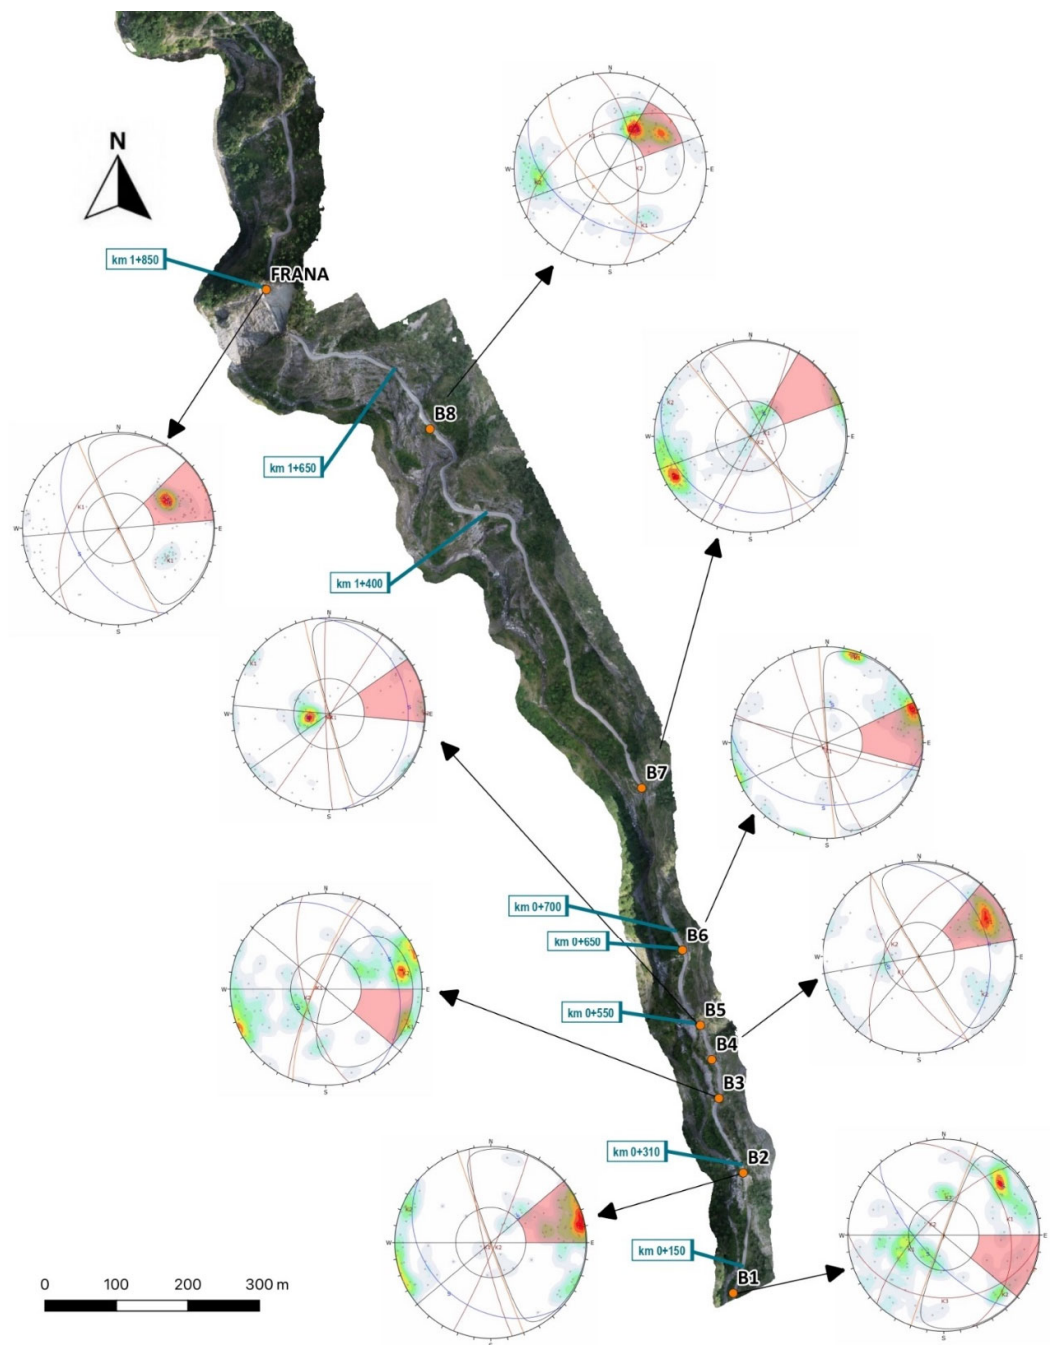
Figure 9. Orthophotos and results of kinematic analysis: Low Road and Large Landslide.

Analysing the spacing data, it can be noted that in the lower part of the road, at least in the first sector (sector B1, Figure 9), the average spacing of the bedding plane is between 80 and 115 cm, forming thick rock banks. This thickness decreases in the northern part of the low road, reaching an average spacing between 20 and 50 cm.

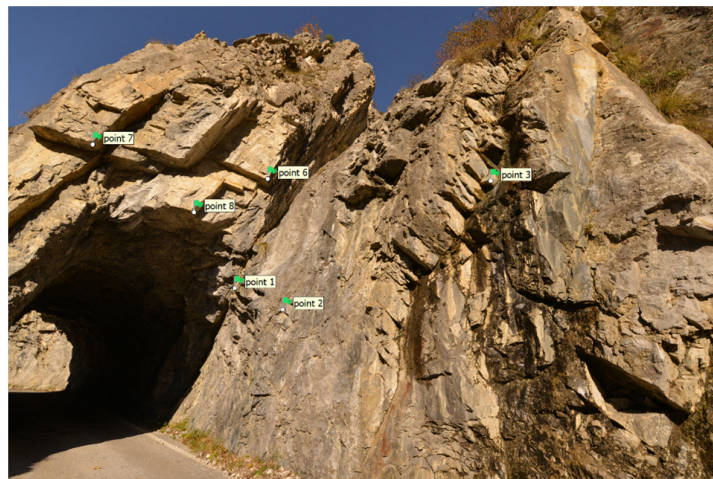
Figure 10. Examples of natural markers used for georeferencing the specific DSMs.

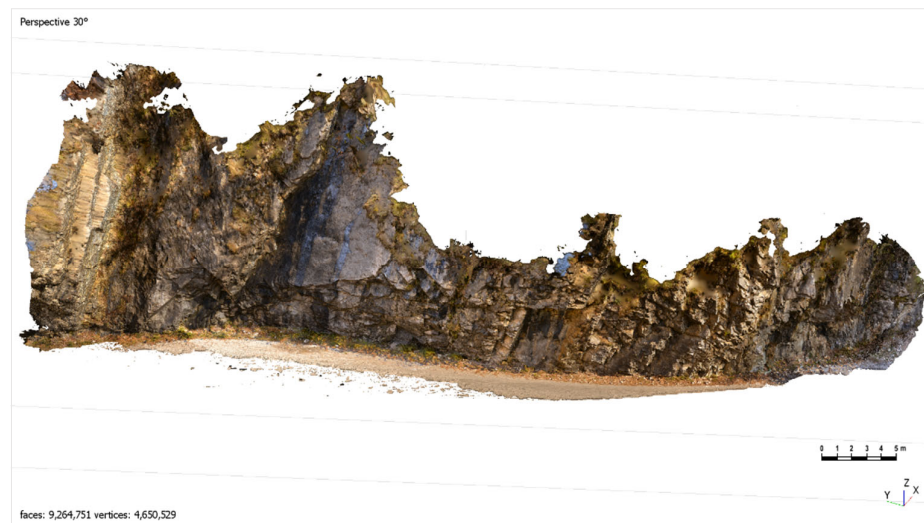
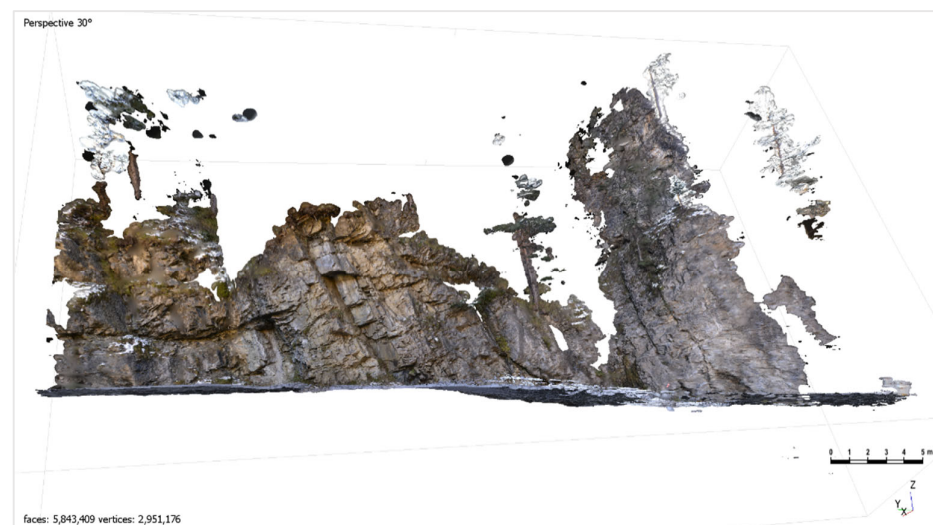
Figure 11. Three-dimensional mesh for sectors: (a) A1\_b and (b) A3\_b (Figure 8).

With the general survey, it was not possible to obtain a sufficient number of points, and with this aim, 20 detailed DSMs were built reproducing a portion of the rock slope with limited dimensions: about 30–40 m long and 15 m high; most of the surveyed rock masses did not include any GCPs or CPs, as reported in Table 3; for this reason, each DSM was georeferenced by recognizing and defining several natural points (e.g., markers in Figure 10) on the digital images and by obtaining their coordinates directly from the general DSM of the entire road. As an example, the results for two characteristic sectors considered are shown in Figure 11.

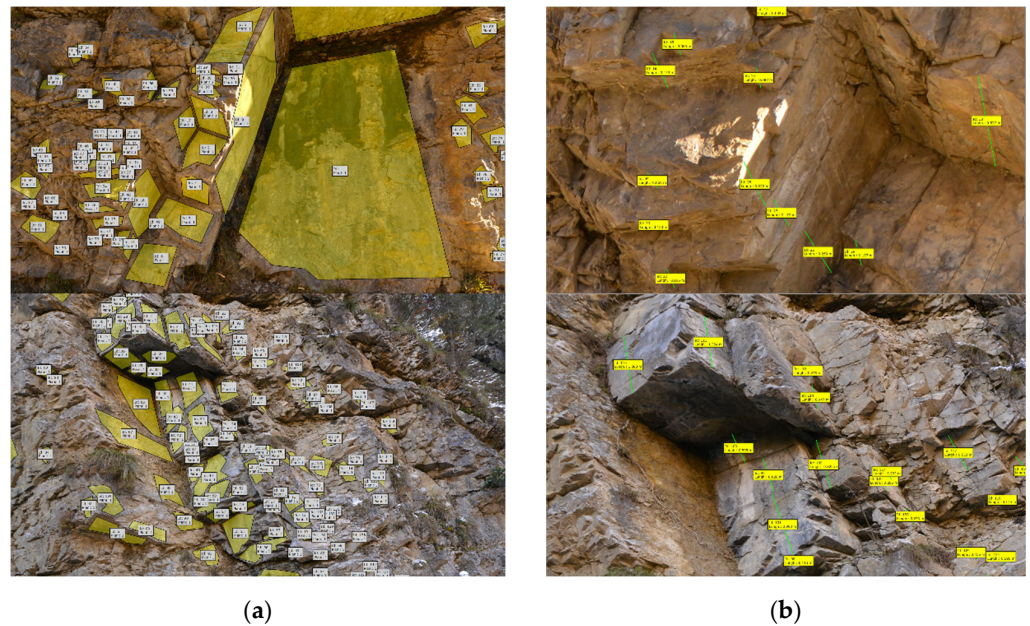
**Figure 12.** Discontinuity data collected by Rockscan software in portions of A1\_b (above) and A3\_b (below) sectors: (a) discontinuity planes and (b) spacing.

The DSMs, the oriented digital images and the calibration parameters of the camera were used in the Rockscan software [34], specifically developed for measuring the orientation and spacing of the plane (Figure 12).

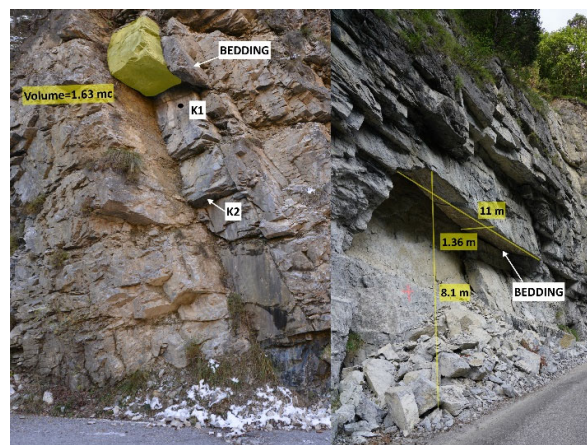
**Figure 13.** An example of distance measurements of unstable block and depletion.

Furthermore, it was possible to carry out spacing measurements between the joints belonging to the same discontinuity system. The possibility of making distance measurements is equally useful in situations where it is necessary to identify the dimensions of unstable blocks or depletions (Figure 13).

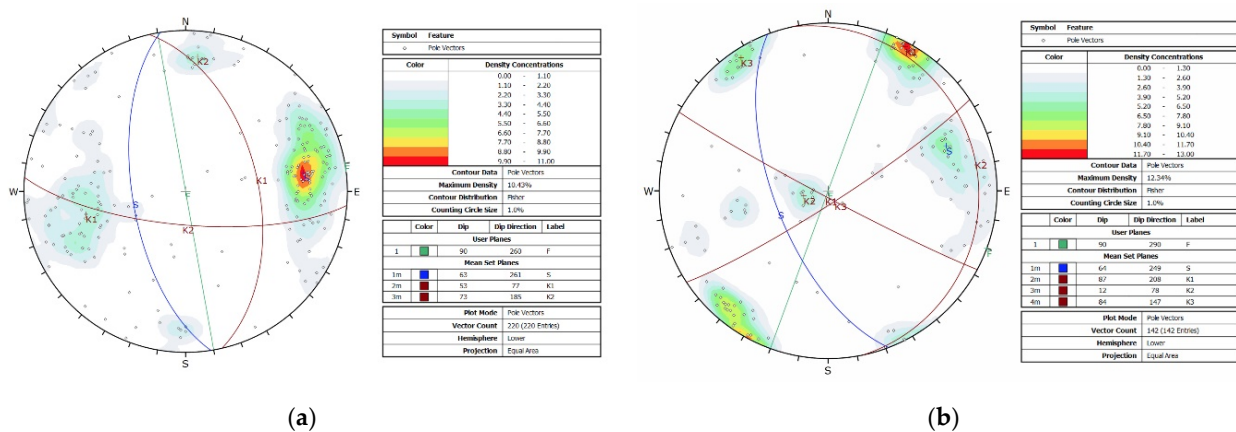
Figure 14. Stereogram for sectors (a) A1\_b and (b) A3\_b.

The identification of the discontinuity plans and the following kinematic analysis were carried out for each of the 20 sectors considered. In Figure 14, stereograms for sectors A1\_b and A3\_b are reported, while Table 6 indicates, for each sector, the number of planes detected and the mean orientation data of the discontinuity systems identified. In each sector, three main systems were identified in accordance with the geological evidence: a bedding planes (BP), the most persistent, and two conjugated systems (K1 and K2) perpendicular to the bedding plane with a limited persistence close to BP spacing. In some sectors, where the rock is more fractured, two other systems, K3 and K4, were identified.

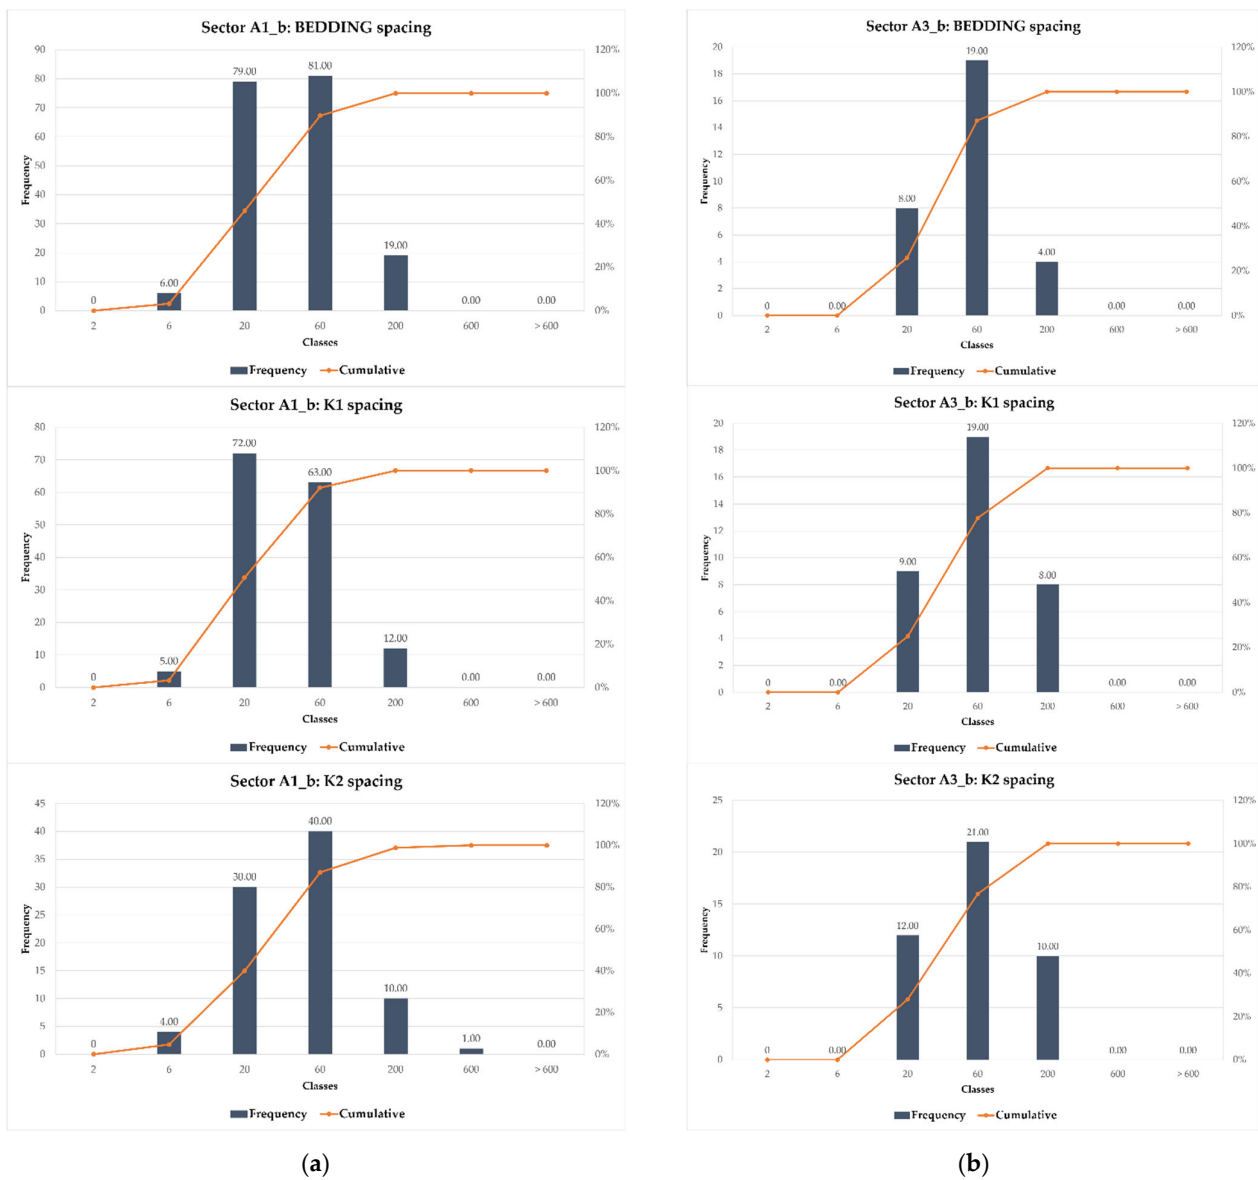
Figure 15. Frequency diagrams of the spacing data for sectors (a) A1\_b and (b) A3\_b.

Spacing data were analysed, system by system, through a frequency distribution analysis (Table 6), organizing the data into classes, as indicated in the ISRM [2]: less than 2 cm; from 2 to 6 cm; from 6 to 20 cm; from 20 to 60 cm; from 60 to 200 cm; from 200 to 600 cm and greater than 600 cm. Figure 15 reports the spacing frequency distribution and the cumulative frequency curve obtained for the sectors A1\_b and A3\_b, used as examples.

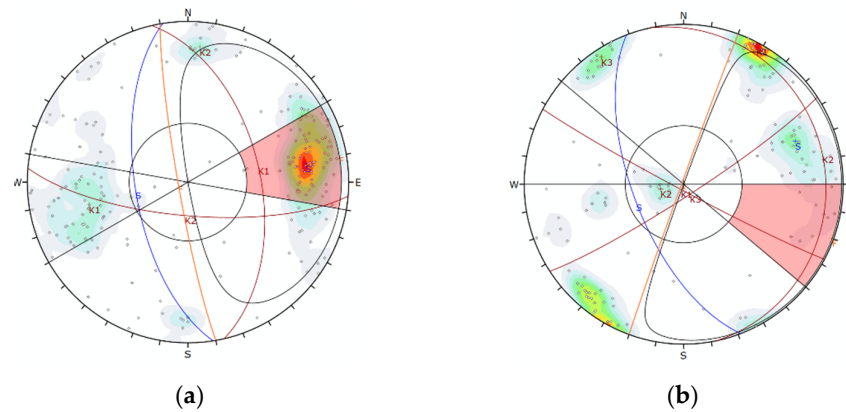
**Figure 16.** Markland test with Dips 7.0 for sectors (a) A1\_b and (b) A3\_b.

In each sector, the potential kinematic mechanisms were identified. As previously indicated, the analyses were performed by Dips7.0 [35], identifying the kinematic mechanisms that can occur, on the base of the planes and the slope orientation through the application of the Markland test [43]. Figure 16 shows the Markland test carried out for the A1\_b and A3\_b sectors; in Table 7 and in Figures 16 and 17, the results obtained in each sector are summarized. The prevailing kinematic mechanism is that of planar sliding but, in some cases, the discontinuity systems can form blocks, which can become unstable due to rockfall or toppling.

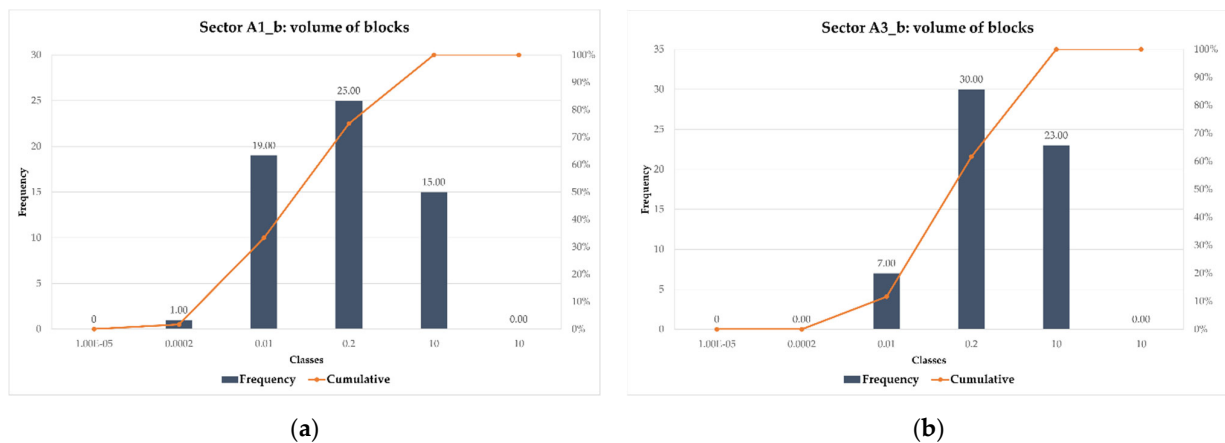
Figure 17. Frequency diagrams of volume distributions for sectors (a) A1\_b and (b) A3\_b.

A frequency distribution of the block volumes was obtained by the Palmstrøm [44] equation, considering only the presence of the three principal discontinuity systems (BP, K1 and K2) and a combination of their spacing statistical parameters: maximum, minimum, average and modal values. In each sector, 60 volume values were evaluated, and the frequency distribution and the cumulative distribution obtained in the A1\_b and A3\_b sectors are shown in Figure 17. The volume of the blocks defined as such is highly variable and ranges from 10 cm<sup>3</sup> to 40 m<sup>3</sup>. In this case, the classes considered for the frequency analysis are: less than 10 cm<sup>3</sup>; from 10 to 200 cm<sup>3</sup>; from 0.2 to 10 dm<sup>3</sup>; from 10 to 200 dm<sup>3</sup>; from 0.2 to 10 m<sup>3</sup> and greater than 10 m<sup>3</sup>. Table 8 summarizes the results in terms of volume values.

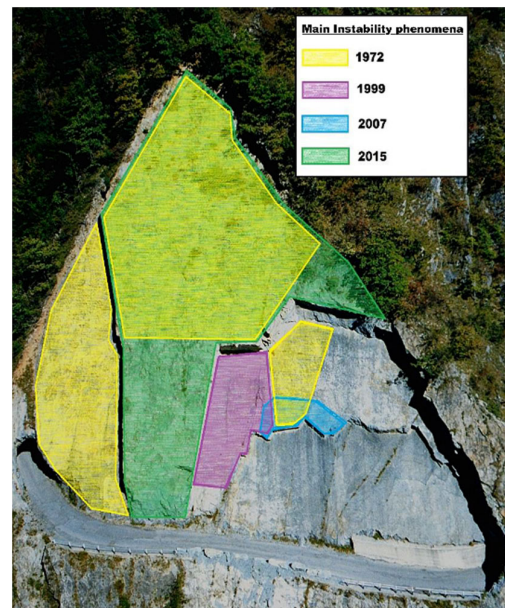
**Figure 18.** Chronology of the collapses in the LL sector (photo 2002).

The geometry of the road, connected with the natural stratification of the rock face, gives a dip slope morphology with the presence of disharmonious folds. Since the construction of the road and its widening, this site has exhibited phenomena of planar sliding that have progressively mobilized slabs or portions of slabs released at the foot precisely from the re-profiling of the slope made to allow the construction of the roadway. The natural slope, which was initially characterized by a morphological surface similar to the current lateral slopes that delimit the area of instability, has undergone progressive collapses of considerable magnitude that have resulted in its current morphology (Figure 18).
