Rock mass characterization by UAV and close-range photogrammetry: A multiscale approach applied along the vallone dell'elva road (Italy)

# Rock Mass Characterization by UAV and Close-Range Photogrammetry: A Multiscale Approach Applied along the Vallone dell'Elva Road (Italy)

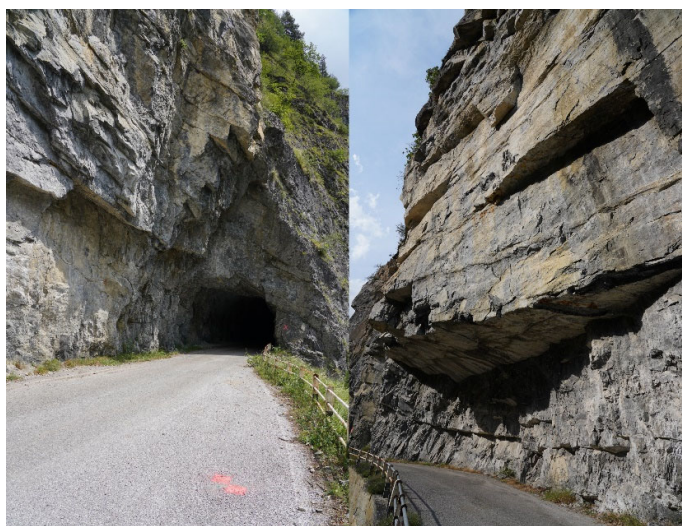
**Figure 1.** Photographs of the rock walls under study.

The road stretches for about 9 km of carriageway with overhanging rock walls and twelve tunnels excavated into the bare rock (Figure 1). Due to the numerous instability phenomena that have occurred since its construction (Table 1) along the entire road and after a large planar sliding in 2015, the road has been closed to traffic.

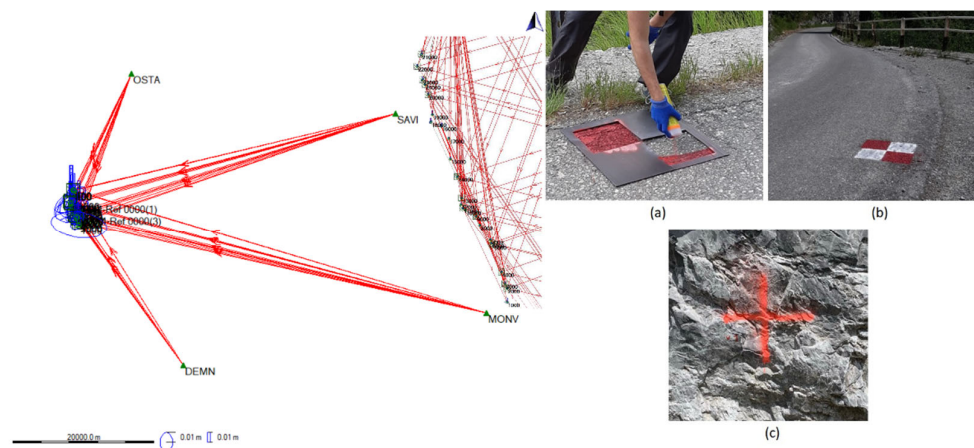
**Figure 6.** CORS constellations in Elva area and an example of the markers materialized along the road paving and rock outcropping: (a) colouring of highly visible markers (30 × 30 cm) along the street, using a specially made template; (b) a horizontal marker; (c) a vertical marker.

In order to georeferenced every digital model processed, a topographical network was designed. About 200 points were measured by GNSS or total station techniques, guaranteeing a high accuracy and precision ( $\sigma_{\max} = 3$  mm in vertical or horizontal directions): (i) 22 horizontal markers materialised along the road paving, where the coordinates were estimated considering a multibase solution (through the Leica Geo Office® software v.8.4) with the Ostana and Demonte permanent stations of the CORSs (Continuous Operating Reference Stations) network by the Piedmont district; (ii) 54 vertical markers and 120 natural targets along the rock outcropping (about 1 marker every 50 m) were acquired using total station instrument. In Figure 6, an example of the topographic marker acquisition surveys is shown.

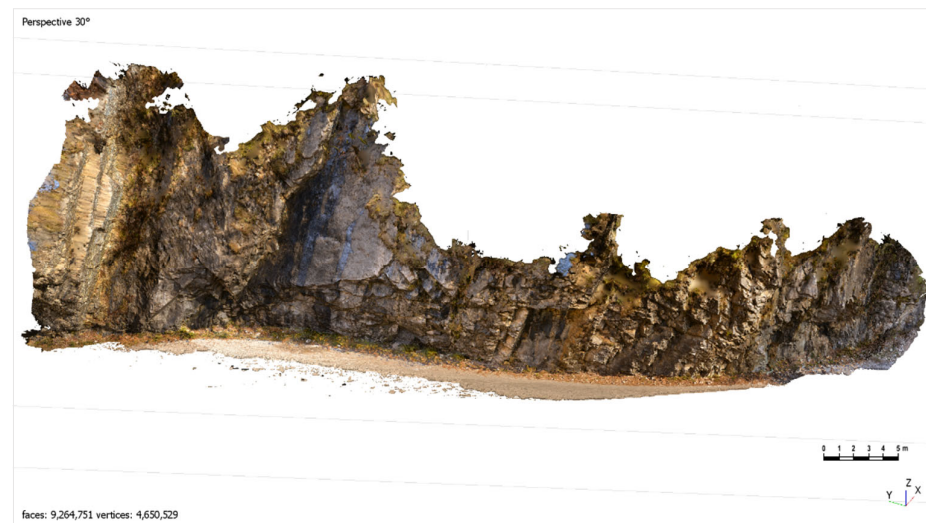
Figure 11. Three-dimensional mesh for sectors: (a) A1\_b and (b) A3\_b (Figure 8).

With the general survey, it was not possible to obtain a sufficient number of points, and with this aim, 20 detailed DSMs were built reproducing a portion of the rock slope with limited dimensions: about 30–40 m long and 15 m high; most of the surveyed rock masses did not include any GCPs or CPs, as reported in Table 3; for this reason, each DSM was georeferenced by recognizing and defining several natural points (e.g., markers in Figure 10) on the digital images and by obtaining their coordinates directly from the general DSM of the entire road. As an example, the results for two characteristic sectors considered are shown in Figure 11.

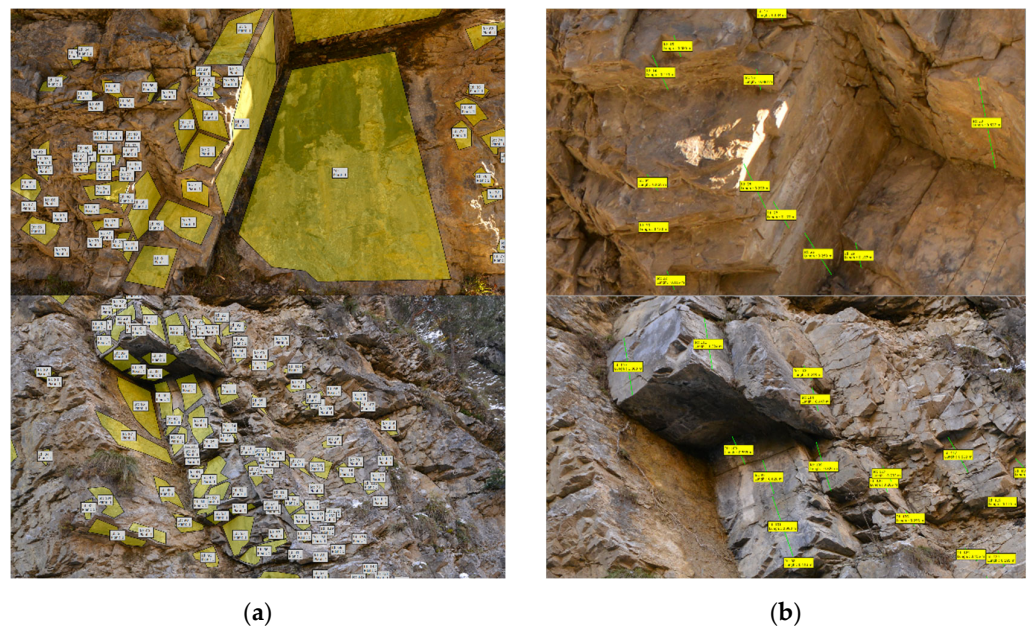
**Figure 12.** Discontinuity data collected by Rockscan software in portions of A1\_b (above) and A3\_b (below) sectors: (a) discontinuity planes and (b) spacing.

The DSMs, the oriented digital images and the calibration parameters of the camera were used in the Rockscan software [34], specifically developed for measuring the orientation and spacing of the plane (Figure 12).

This program calculates the orientation and position of the discontinuity surfaces, with an interface that, through the image of the wall itself, allows the visual recognition and selection of discontinuity planes. The selection of the regions of interest (ROIs) on the photograph corresponds to the selection of the relative portion of DSM and, therefore, to a certain number of oriented points, belonging to the surface of the selected wall.

Through the RANdom SAMple Consensus (RANSAC) [41] procedure of geometric segmentation of the DSM, it is possible to determine the plane or planes that better approximate the geometry and to define the orientation, in terms of dip and dip direction, as well as the coordinates of the barycentre of the plane or planes identified.

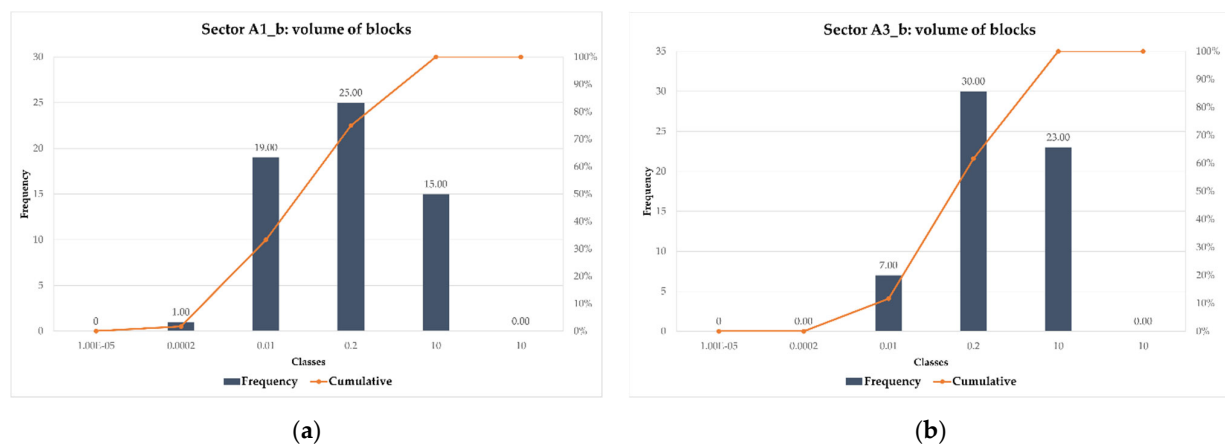
Figure 17. Frequency diagrams of volume distributions for sectors (a) A1\_b and (b) A3\_b.

A frequency distribution of the block volumes was obtained by the Palmstrøm [44] equation, considering only the presence of the three principal discontinuity systems (BP, K1 and K2) and a combination of their spacing statistical parameters: maximum, minimum, average and modal values. In each sector, 60 volume values were evaluated, and the frequency distribution and the cumulative distribution obtained in the A1\_b and A3\_b sectors are shown in Figure 17. The volume of the blocks defined as such is highly variable and ranges from 10 cm<sup>3</sup> to 40 m<sup>3</sup>. In this case, the classes considered for the frequency analysis are: less than 10 cm<sup>3</sup>; from 10 to 200 cm<sup>3</sup>; from 0.2 to 10 dm<sup>3</sup>; from 10 to 200 dm<sup>3</sup>; from 0.2 to 10 m<sup>3</sup> and greater than 10 m<sup>3</sup>. Table 8 summarizes the results in terms of volume values.
