Land Planning and Extreme Snow Events: The Case of Buthier Avalanche in Aosta Valley - IT

The article reports the example of the indispensable update of hazard mapping used to reduce the snow avalanche danger with urban constraints in Cogne – Aosta Valley, in north-eastern of Italian Alps.

On 15th December 2008, an event induced by extreme weather and snow conditions occurred exceeding the known limits of the avalanche basin: the paper shows how the Avalanche Warning Service of Aosta Valley had to investigate in order to estimate the return period of the event and to update hazard maps. Due to the lack of information, the study was carried out coupling the historical and dendrochronological investigations of the woods embodied in avalanche basin and destroyed by the event.

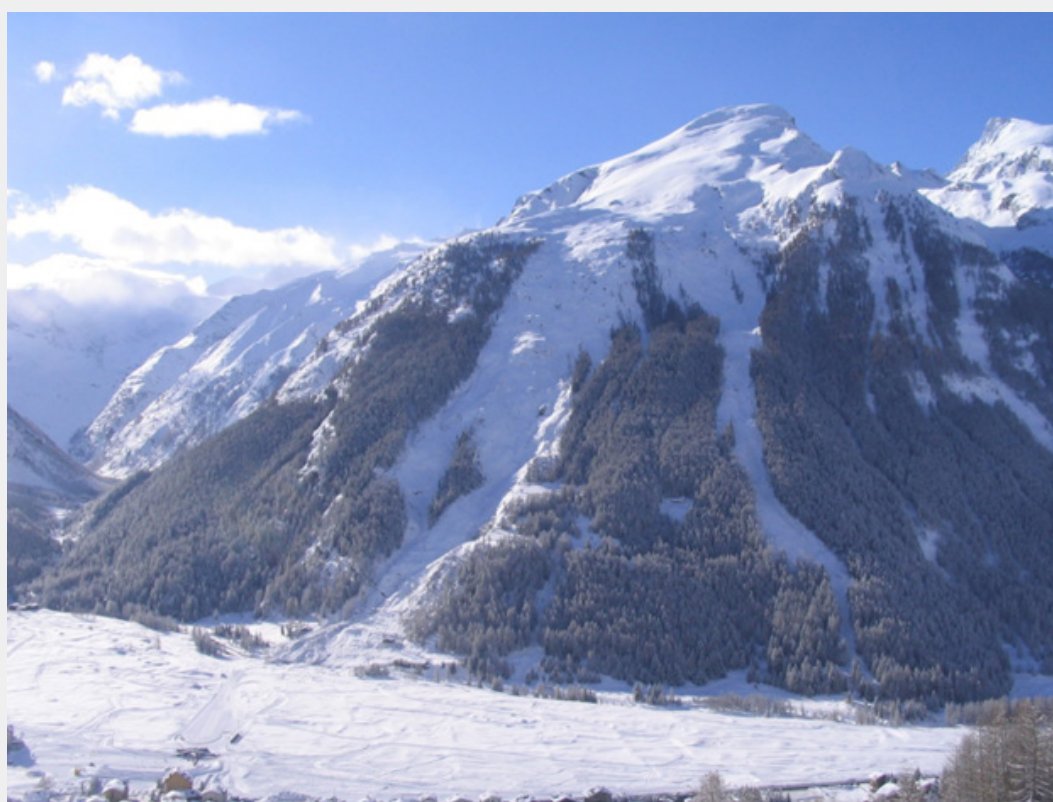
**Figure 2:** Aerial view of the Buthier avalanche released on December 15th, 2008. At the same time, the closer Pointe de l'Ouille avalanche released too (to the right in the picture): it also causes extensive damage to the forest (photo: forestry station of Aymavilles – Aosta Valley).

smell of resin filling the countryside. The cause of the sound was revealed only when the fog was cleared, uncovering the Mont Herban with a large wound of the forest at its northeastern side (Figure 2).

The avalanche released just below the Mont-Herban peak - east/north-east face, at 2970m a.s.l. and 35° of inclination - and flowed on the grassy slopes up to 2300m meeting the edge of the coniferous forest. From here, the mixed avalanche continued breaking down and uprooting many pines and coniferous trees. The presence of two watersheds in the forest affected the avalanche partially limiting the lateral expansion. The snow flow was splitted allowing trees grown between the two watersheds to remain intact: a strip of wood, as a wedge-shape with 350m length and a range of 10m-40m width was saved from the avalanche destruction. The two main avalanche streams re-joined closed to the meadows of Buthier, at about 1570m, where the inclination of the slope decreases and the avalanche velocity slowed down leaving snow deposition with most of the uprooted trees. During its descent, the avalanche passed very close to the buildings of the Buhier village at 1560m, crossed the Valnontey creek and, finally, stopped in the meadows of Sant'Orso.

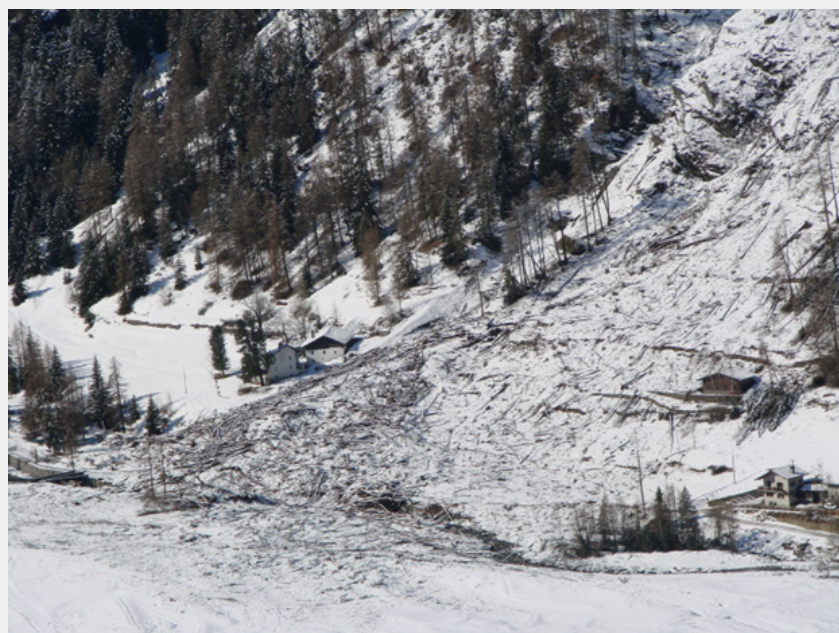
**Figure 3:** At the end of the slope, the snow flow hit two buildings in Buthier village on the south of deposition zone (on the left of picture). However, the snow flow was partially deflected by a little deflecting dam built to protect the buildings from the debris flows from the slopes of Mont-Herban. At 1554m a.s.l. (on the right of the picture), the chalet was hit by the avalanche damaging the roof, the chimney and the western side. Fortunately, the main stream of avalanche passed south of the deposition zone where most of larger size wood debris were deposited.

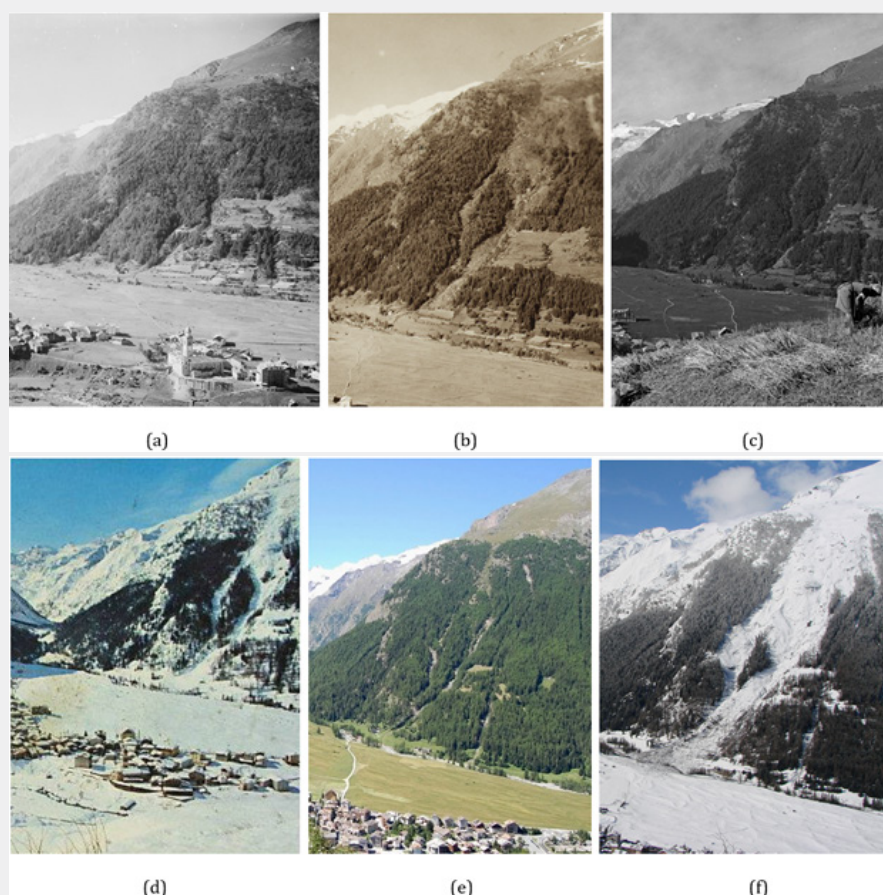
**Figure 7:** The six images to evaluate the frequency and size of the avalanche phenomenon starting from the beginning of the twentieth century analyzing the width of the forest cover.

- (a) 1915 (photo: BREL Archive - Fonds Fisanotti);
- (b) 1925-1935 (photo: BREL Archive - Fonds Domaine);
- (c) 1963 (photo: BREL Archive - Fonds Willien);
- (d) 1970-1975 (photo: private collection A. Roveyaz);
- (e) 2008 (photo: E. Borney) and
- (f) 2009 (photo: E. Borney).

Thanks to the following six images (Figure 7), the frequency and the size of the avalanche phenomenon starting from the beginning of the twentieth century has been reconstruct by analyzing the width of the forest cover.

By observing the sequence of the six photographs, we note that central strip of forest saved from the event of December 2008 appears also in historical photos of 1925-1935 (Figure 7b) and 1970-1975 (Figure 7d), but is larger than the event of December 15th, 2008 witnessing how past events were less destructive. This is also confirmed by the observation of the lateral limits of the forest affected by the historic avalanches which appear to be less extensive than those achieved by the last 2008 event. Focusing on the images where the forest is damaged (Figure 7b, 7d & 7f)

and on the left edge of the intact forest, it is easy to conclude that the event of December 15th, 2008 was clearly larger than the previous ones. In order to verify this conjecture, during the spring, an extensive dendrometric survey [11-13] was carried by using the Pressler auger, sampling various plants survived in the small core of larch (LC51E) and in staked ones at in the damaged forest (Figure 8). The samples were suitably processed to make the growth rings more visible and thus facilitate age counting on each plant.

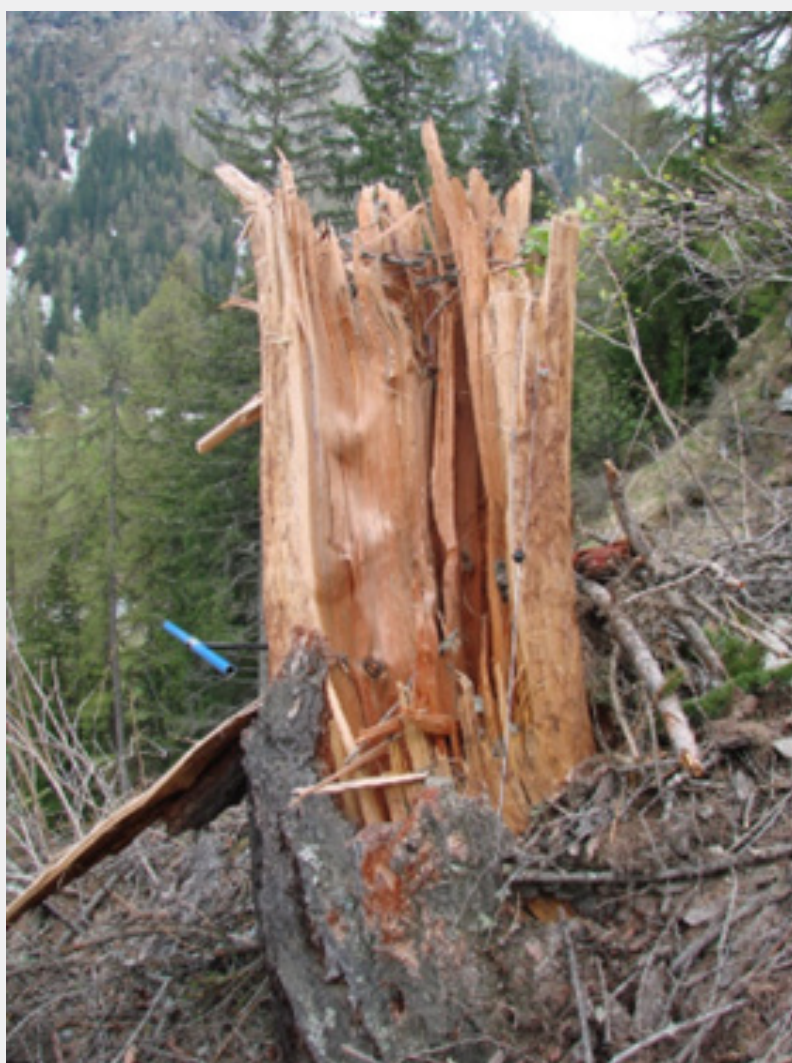
**Figure 8:** The larch (*Larix decidua* Miller) crushed by the avalanche on December 15th, 2008 (sample n. 5). It was located closed to the Buthier village. The age of the plant is about 140 years old.
