Large-Scale Experimental Static Testing on 50-Year-Old Prestressed Concrete Bridge Girders

2.1. Corso Grosseto Viaduct

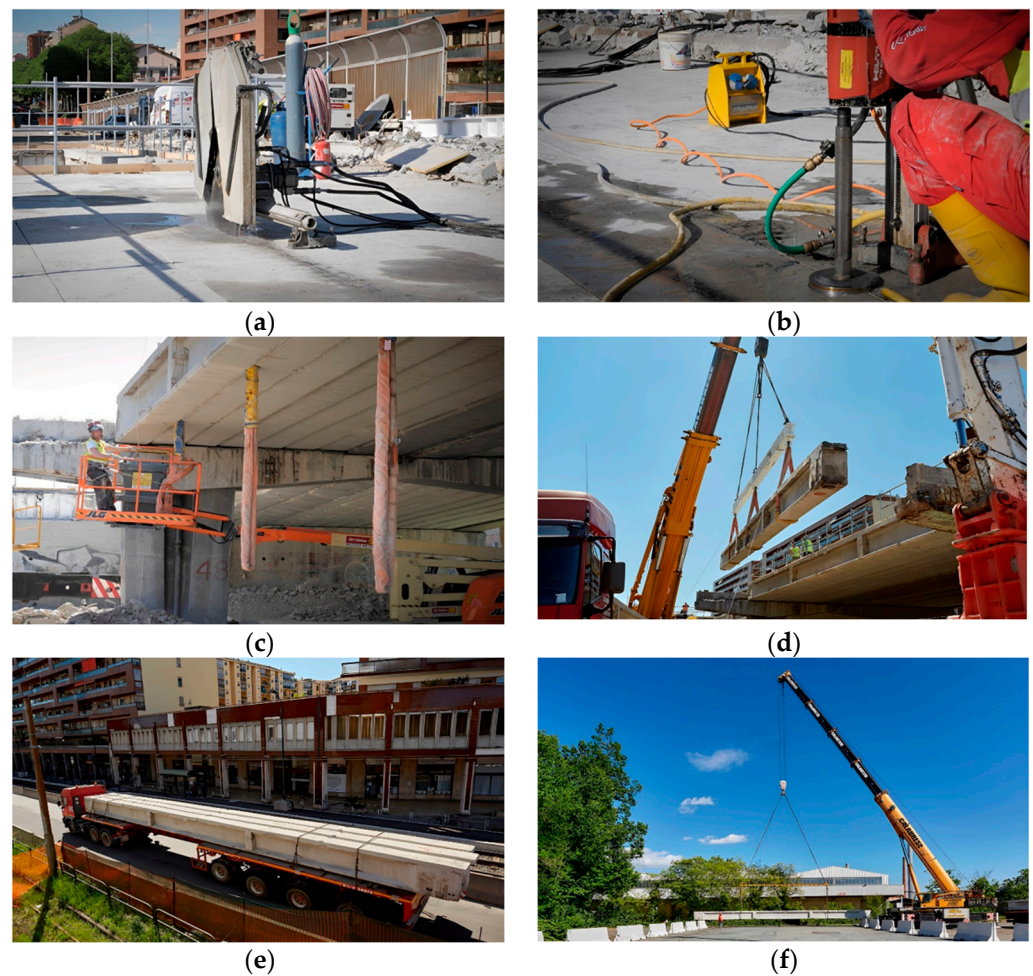
Figure 4. Deconstruction phases: (a) cutting; (b) drilling; (c) sling ropes; (d) lifting; (e) moving; (f) testing site setup.

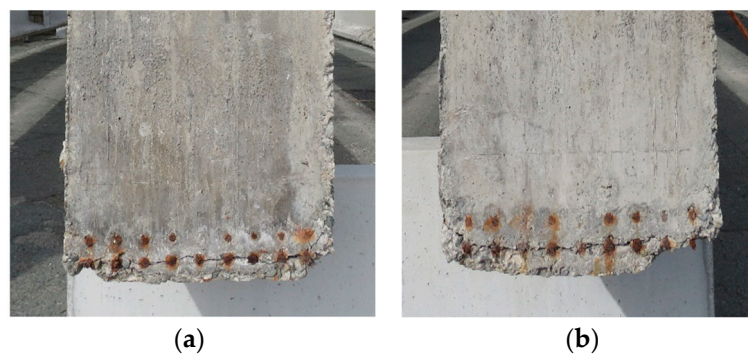
The B3-P47/46 and B4-P47/46 girders showed 5 mm wide horizontal cracks at the edges caused by corrosion activity that transversally crossed the strands (Figure 6). The visual inspections revealed no other corrosion-induced damages. The presence of such kind of damage can be ascribed to the presence of structural joints.

Figure 6. Cracks on the end of the (a) B3-P47/46 and (b) B4-P47/46 beams.
