Conservation of Earthen Bricks in Architecture: An Experimental Campaign to Test Treatments on Vernacular Built Heritage

Conservation of Earthen Bricks in Architecture: An Experimental Campaign to Test Different Treatments on Vernacular Built Heritage

Keywords: earthen architecture; earthen bricks; conservation issues; protective products; test methods

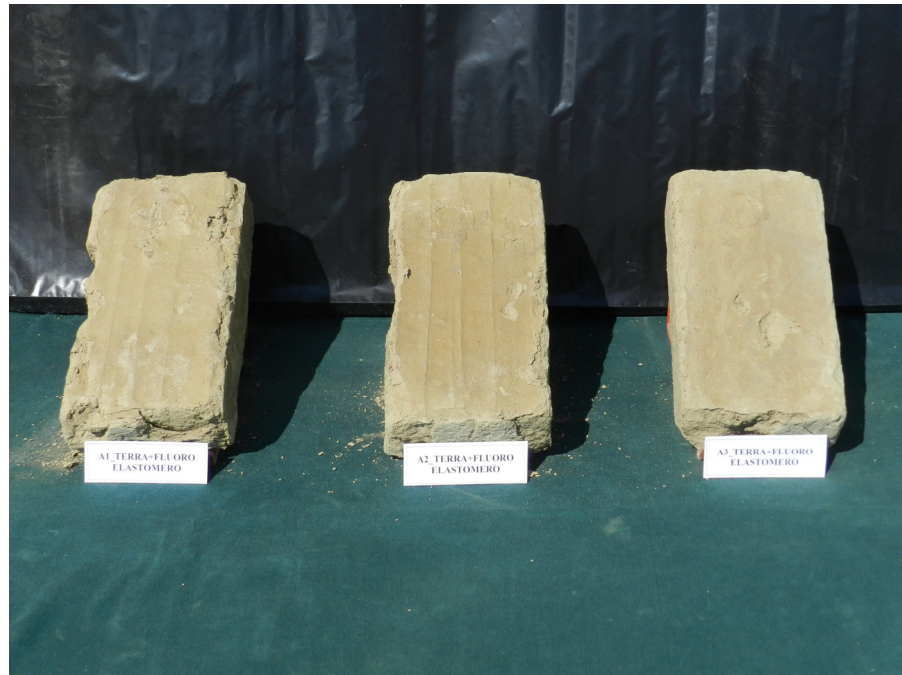
Figure 5. Earthen bricks: Specimens made with local earth (from Alessandria, Italy) and treated with a fluoroe elastomer (Tecnoflon N215).

The dimensions of the earthen bricks used for the experimentation were $26 \times 13 \times 6$ cm. Not fissured bricks with relatively regular surfaces were chosen. They were previously cleaned with a chisel stonemason and a brush, removing all traces of plaster, mortar, and any vegetal residues (Figures 5 and 6).

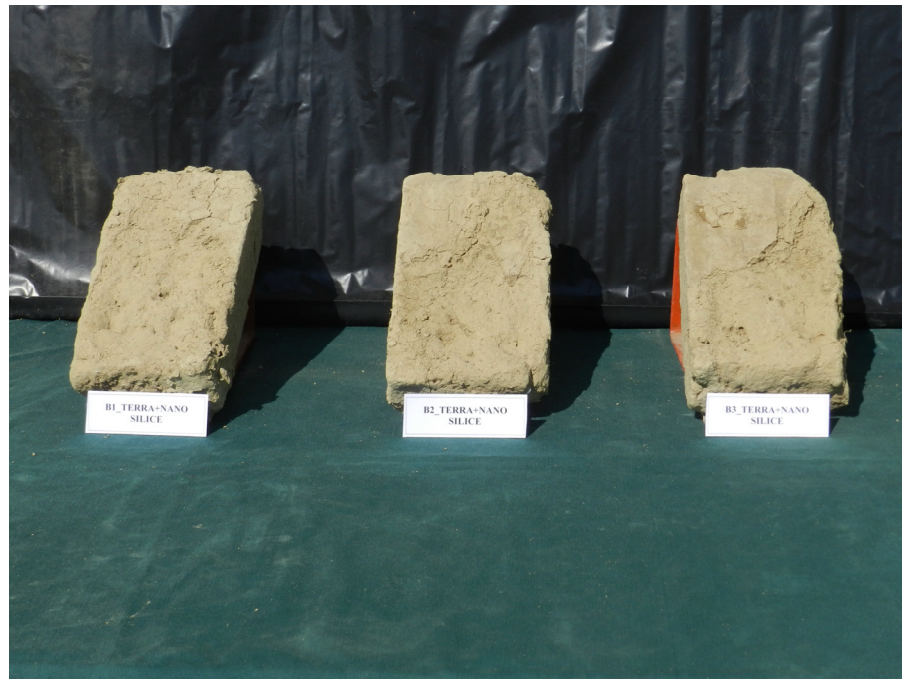
Figure 6. Earthen bricks: Specimens made with local earth (from Alessandria, Italy) and treated with nano-silica (Nano Estel).

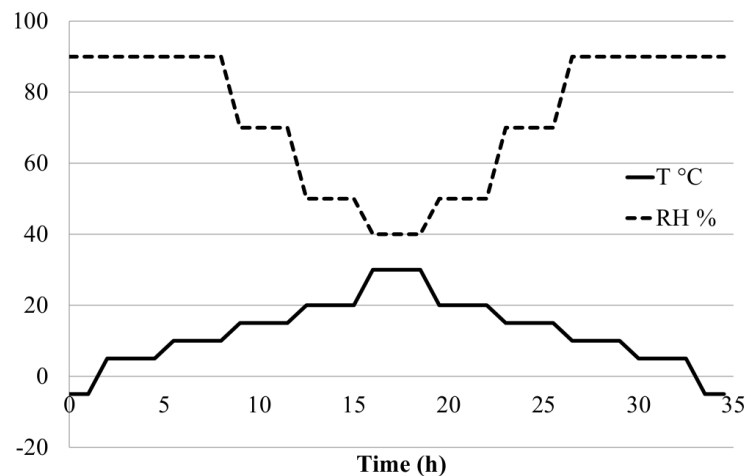
Figure 7. Diagram representative of the TH cycle (credit: Rescic).

The not treated and treated earthen bricks were exposed to artificial ageing in an Angelantoni Challenge 500 Climatic Chamber. The thermo-hygrometric conditions were simulated experimentally based on the cycle represented in Figure 7. This cycle was carried out by reprocessing original data recorded by “Rete di Monitoraggio Meteorografica” of ARPA Piedmont in the Alessandria Lobbi weather station over ten years. The data were averaged, and one-year behaviour was converted to an RH cycle of 35 h ranging from $-5\text{ }^{\circ}\text{C}$ to $30\text{ }^{\circ}\text{C}$ and from 40 to 90% RH. The cycle was repeated 50 times. Colorimetric change, weight, and contact angle measurements were performed before and after accelerated ageing.

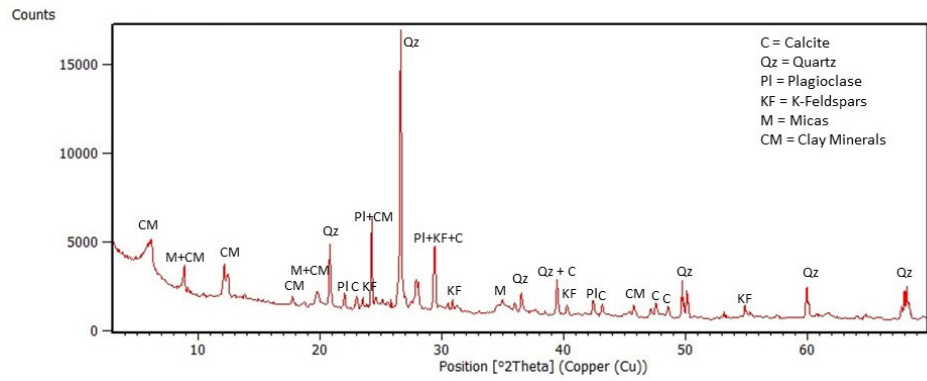
Figure 8. XRD diagram of the main mineralogical composition of the earthen not treated brick (credit: Rescic).

The grain size distribution of the earthen material (sand 24%, silt 45%, clay 31%) taken from the farmhouse under demolition was obtained through sieving. The main mineralogical composition of the earthen bricks, performed by X-ray diffraction, is as follows: quartz, feldspars, calcite, micas, and clay minerals (Figure 8).

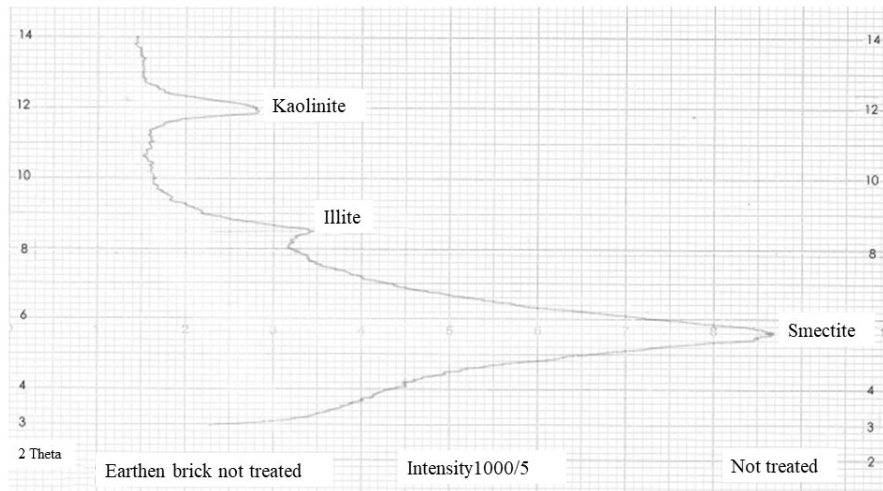
Figure 9. XRD diagram of the clay mineral fraction: Not treated sample.

The semi-quantitative composition of the clay fraction was as follows: kaolinite 35%, illite 20%, and smectite 45% (Figures 9–11).

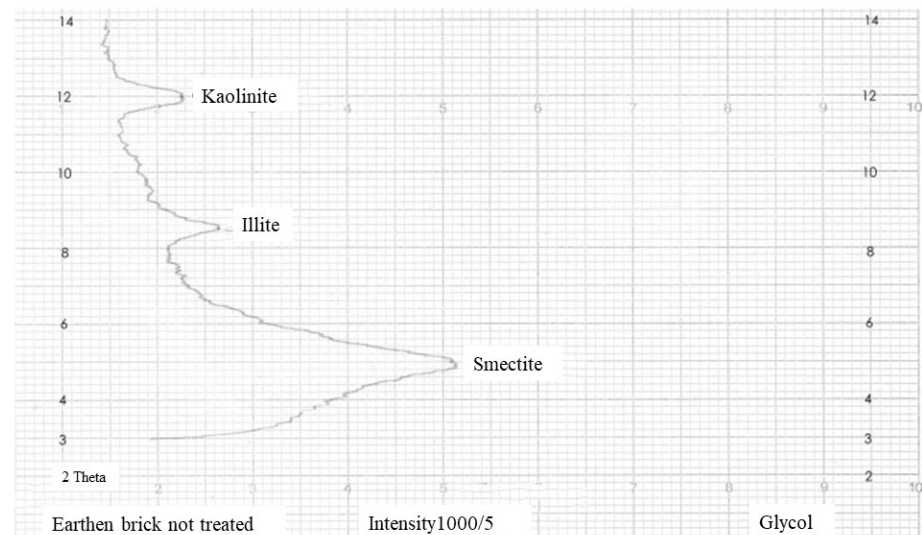
Figure 10. XRD diagram of the clay mineral fraction: glycol sample

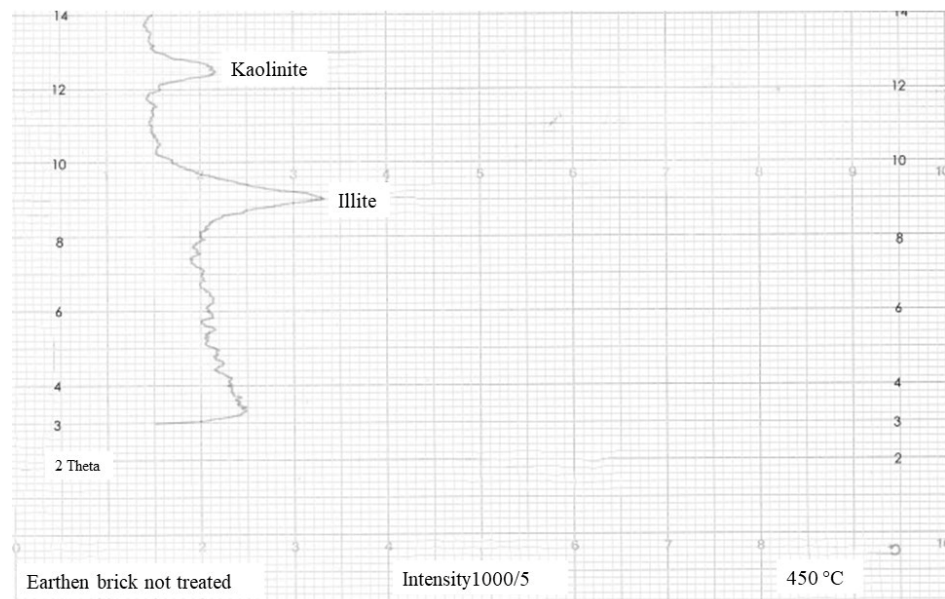
Figure 11. XRD diagram of the clay mineral fraction: sample at 450 °C

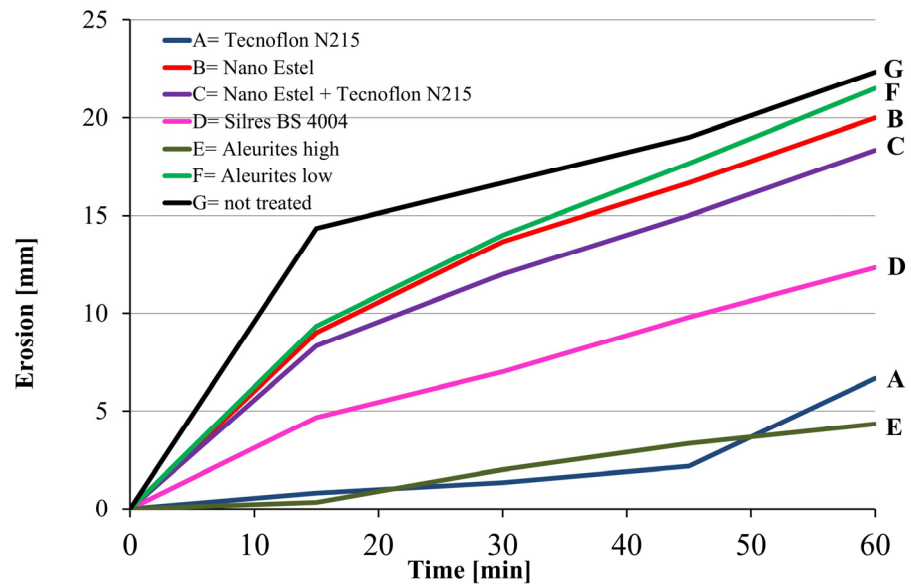
**Figure 14.** Spray erosion test diagram (credit: Mattone).

The results of the spray erosion tests are shown in Figure 14.

The results of the spray erosion test allow for the following considerations:

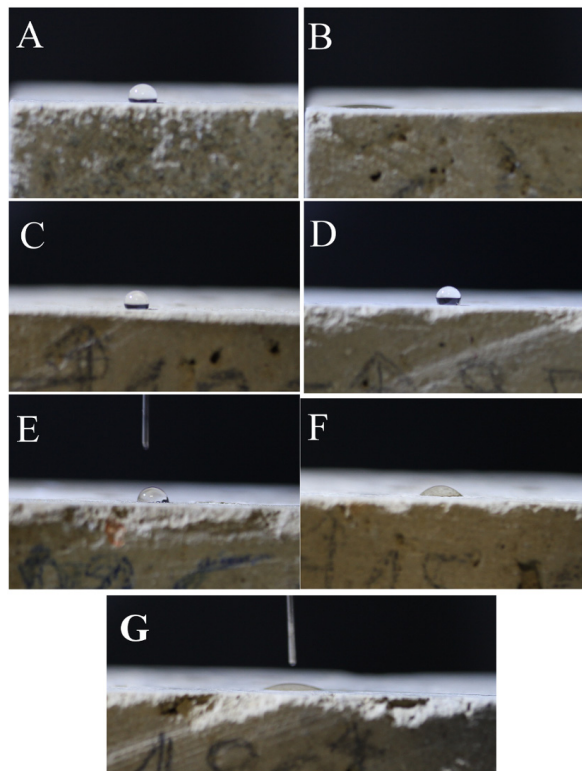
Figure 16. Contact angle of the earthen brick samples treated (A–F) and not treated (G). (A = Tecnoflon N215; B = Nano Estel; C = Nano Estel + Tecnoflon N215; D = Silres BS 4004; E = Aleurites high; F = Aleurites low; G = not treated) (credit: Rescic).

The conservative treatment products that performed best in this test were Tecnoflon N215(A), Nano Estel + Tecnoflon N215 (C), and Silres BS 4004 (D), namely, the products with well-known hydrophobic properties.

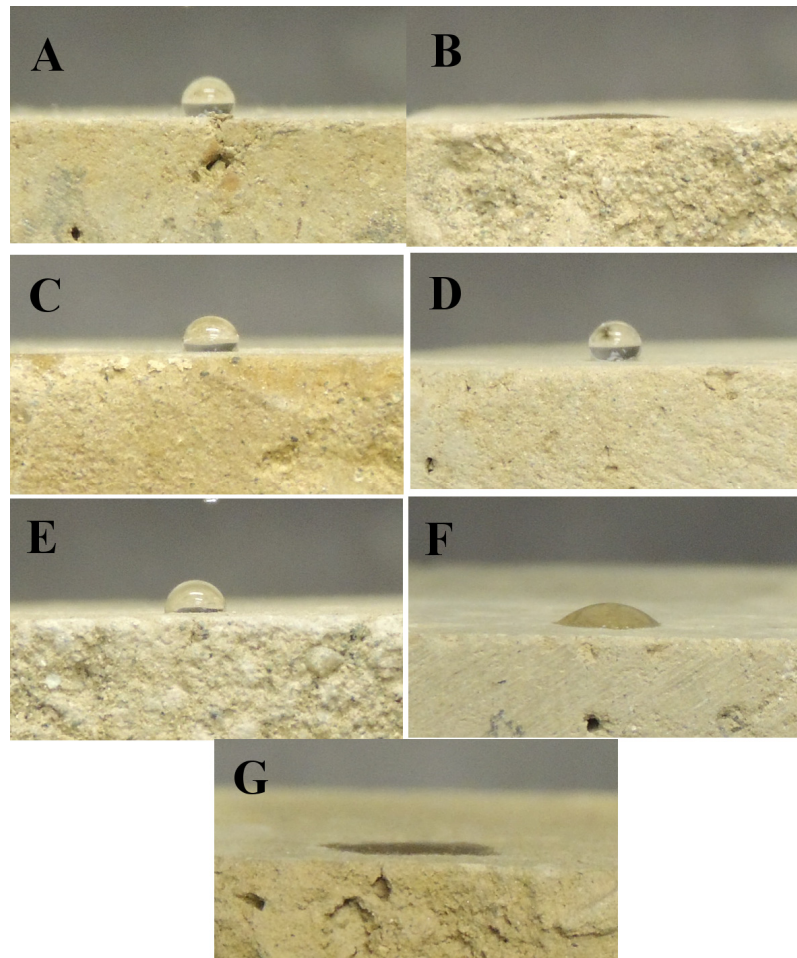
**Figure 19.** After ageing, contact angle of the earthen brick samples treated (A–F) and not treated (G). (A = Tecnoflon N215; B = Nano Estel; C = Nano Estel + Tecnoflon N215; D = Silres BS 4004; E = Aleurites high; F = Aleurites low; G = not treated) (credit: Rescic).

The untreated earthen brick appeared to be the only one with a slight worsening in its natural capacity of hydrophobicity, with a contact angle reduction and an increased absorption rate. The contact angle and the corresponding water absorption rate for all other treatments remained practically unchanged.
