# LEARNING FROM TRADITION: A CASE STUDY OF THE DIAGNOSIS, DENDROCHRONOLOGICAL DATING, AND INTERVENTION ON A 16TH-CENTURY TIMBER ROOF STRUCTURE IN THE WESTERN ITALIAN ALPS

Tanja Marzi, Clara Bertolini-Cestari, Olivia Pignatelli

e-ISSN 2421-4574  
Vol. 8, Special Issue part 2 - (2022)

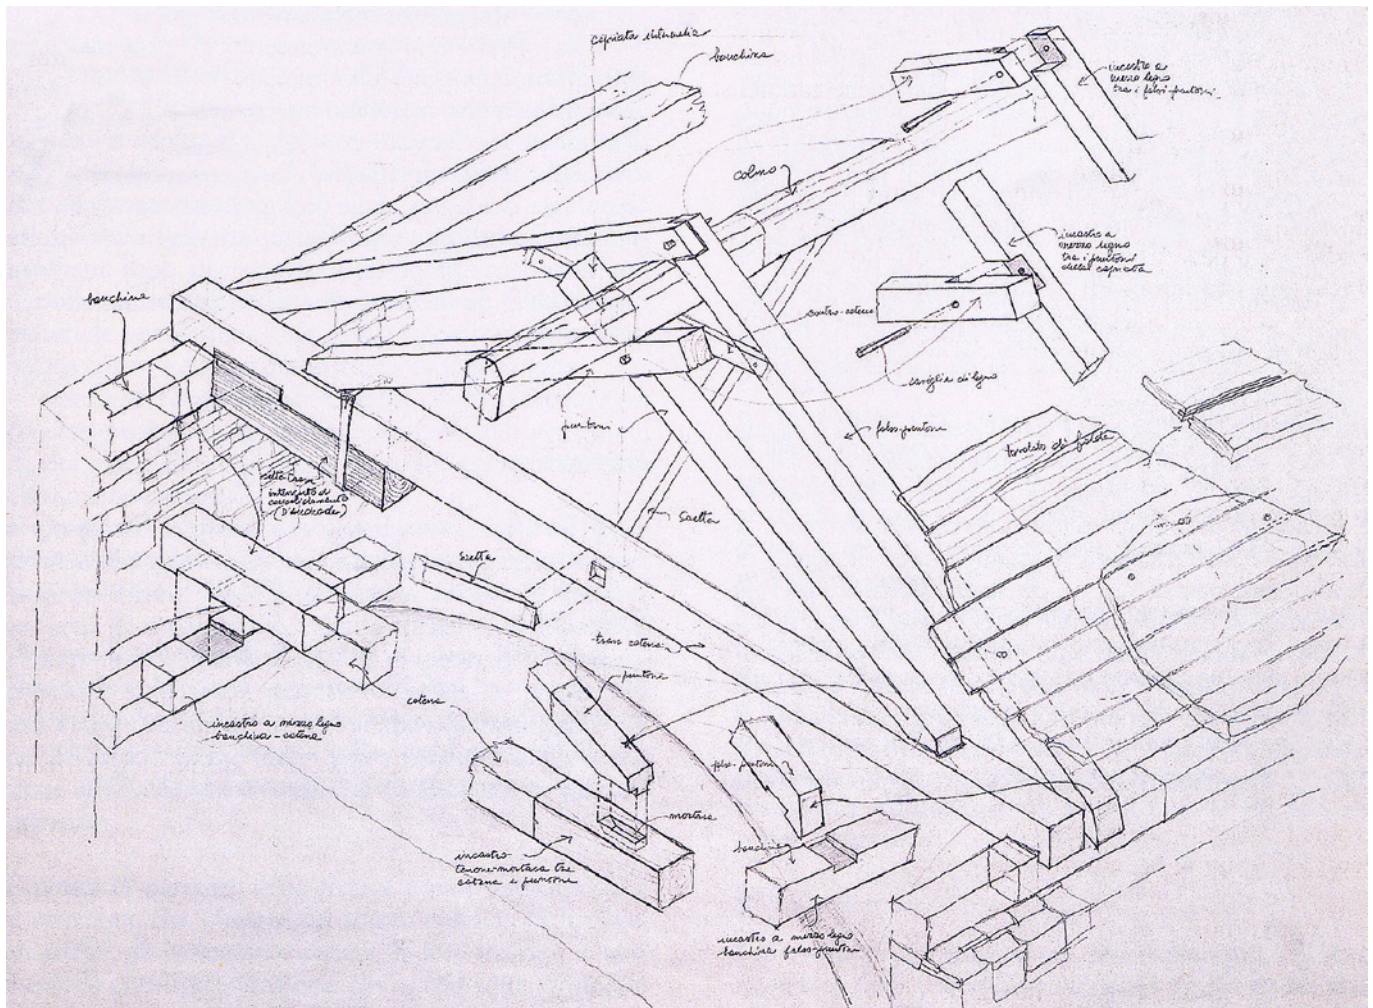
Fig. 5. Church of San Giovanni Battista in Salbertrand. Construction survey of the timber roof structure and the typical wooden joints. (Image source: drawings courtesy by C. Bertolini-Cestari).

The pitched roof of the central nave – the object of the present study – has two slopes with a sloping angle of  $29^\circ$ . It is composed of three small timber trusses of about 8 meters of span on which a large ridge of 20 meters (with a diameter of about 50 cm) supports 13 false rafters on each side of the slope displayed at close distance (Fig. 5).

The specificity of the trusses is the position of the connection between the tie-beam and the rafters, which is set back from the joint between the tie-beam and the longitudinal masonry walls of the central nave. This condition leads to part of the element being subject not only to tension but also to bending. With this arrangement, the ridge assumes a fundamental role in preserving and conserving all the different elements constituting the roof, particularly the inclined elements defined as false rafters. However, the roof structure, which appears poorly braced in the longitudinal direction, is connected on the slopes with two horizontal beams resting on the masonry walls.

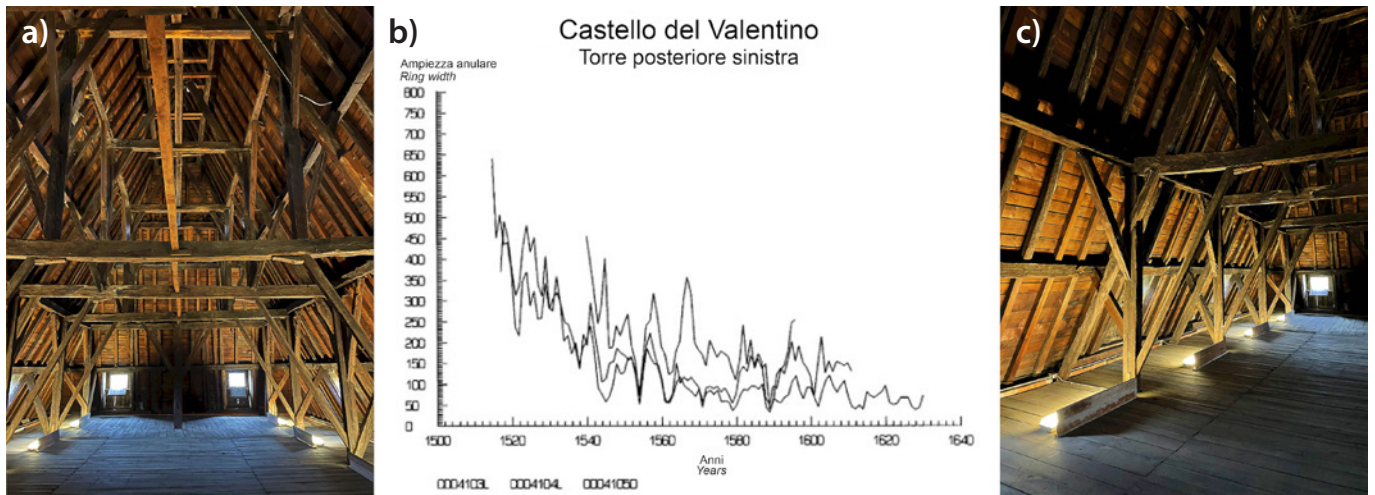
Fig. 7. Valentino Castle, Turin: (a, c) view of the roof structures of the north-east tower (photos T. Marzi, 2022). (b) Dendrochronological curve of the three trusses of the back tower: the years, corresponding to the succession of the rings measured, are shown on abscissae, while the corresponding ring width is shown on the axis of ordinates.

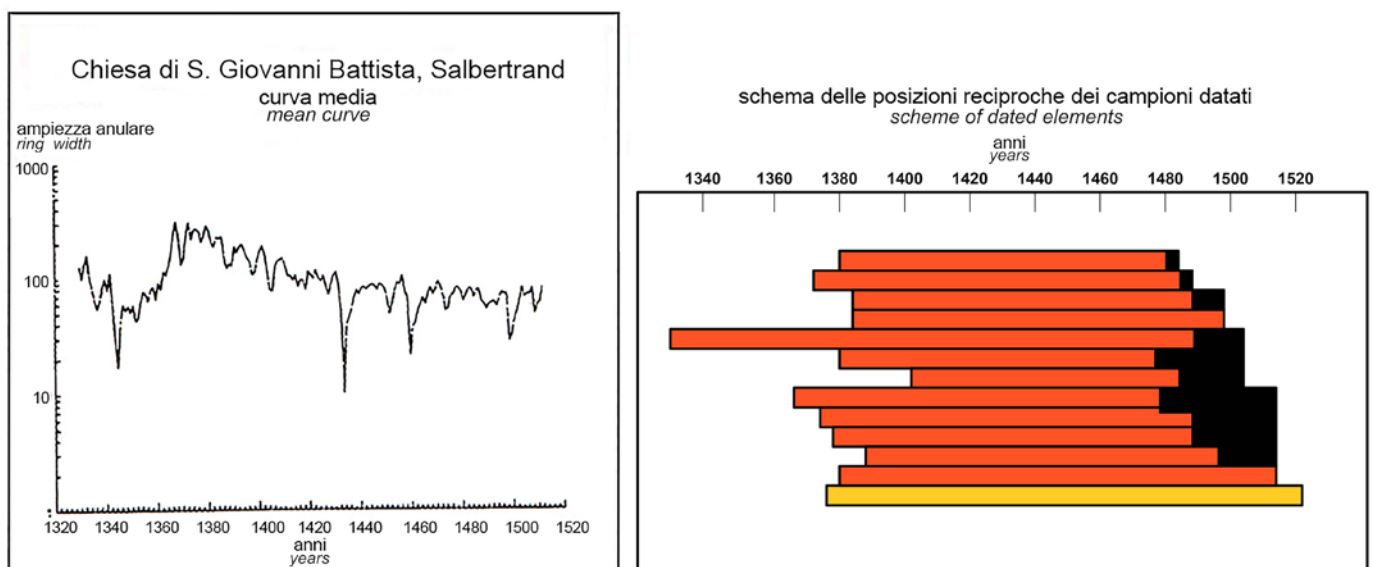
In the church of San Giovanni Battista in Salbertrand, the dendrochronological investigation was carried out on 13 elements of the timber roof structure of the church (truss beams, struts, false rafters, and planks of the roof), including a single plank attributable to the 19th-century restoration carried out by Alfredo D'Andrade, and on the ridge beam of the roof of the porch. The beams, not so accurately squared, allowed the conservation of at least part of the sapwood in most of the elements sampled, and in some cases, even the last ring under the bark seems to be present, allowing a precise dating (Fig. 8).

Fig. 8. Church of Salbertrand. Dendrochronological mean curve. Bar diagram of the dated elements: in black, the part of the existing sap; in red, different samples from the timber roof structure of the church; in yellow, the sample from the ridge beam of the porch roof.

The mean curve built for the roof covers the period between AD 1330 and AD 1512, overlapping only for a short time with that of the Valentino Castle (AD 1447-AD 1637).

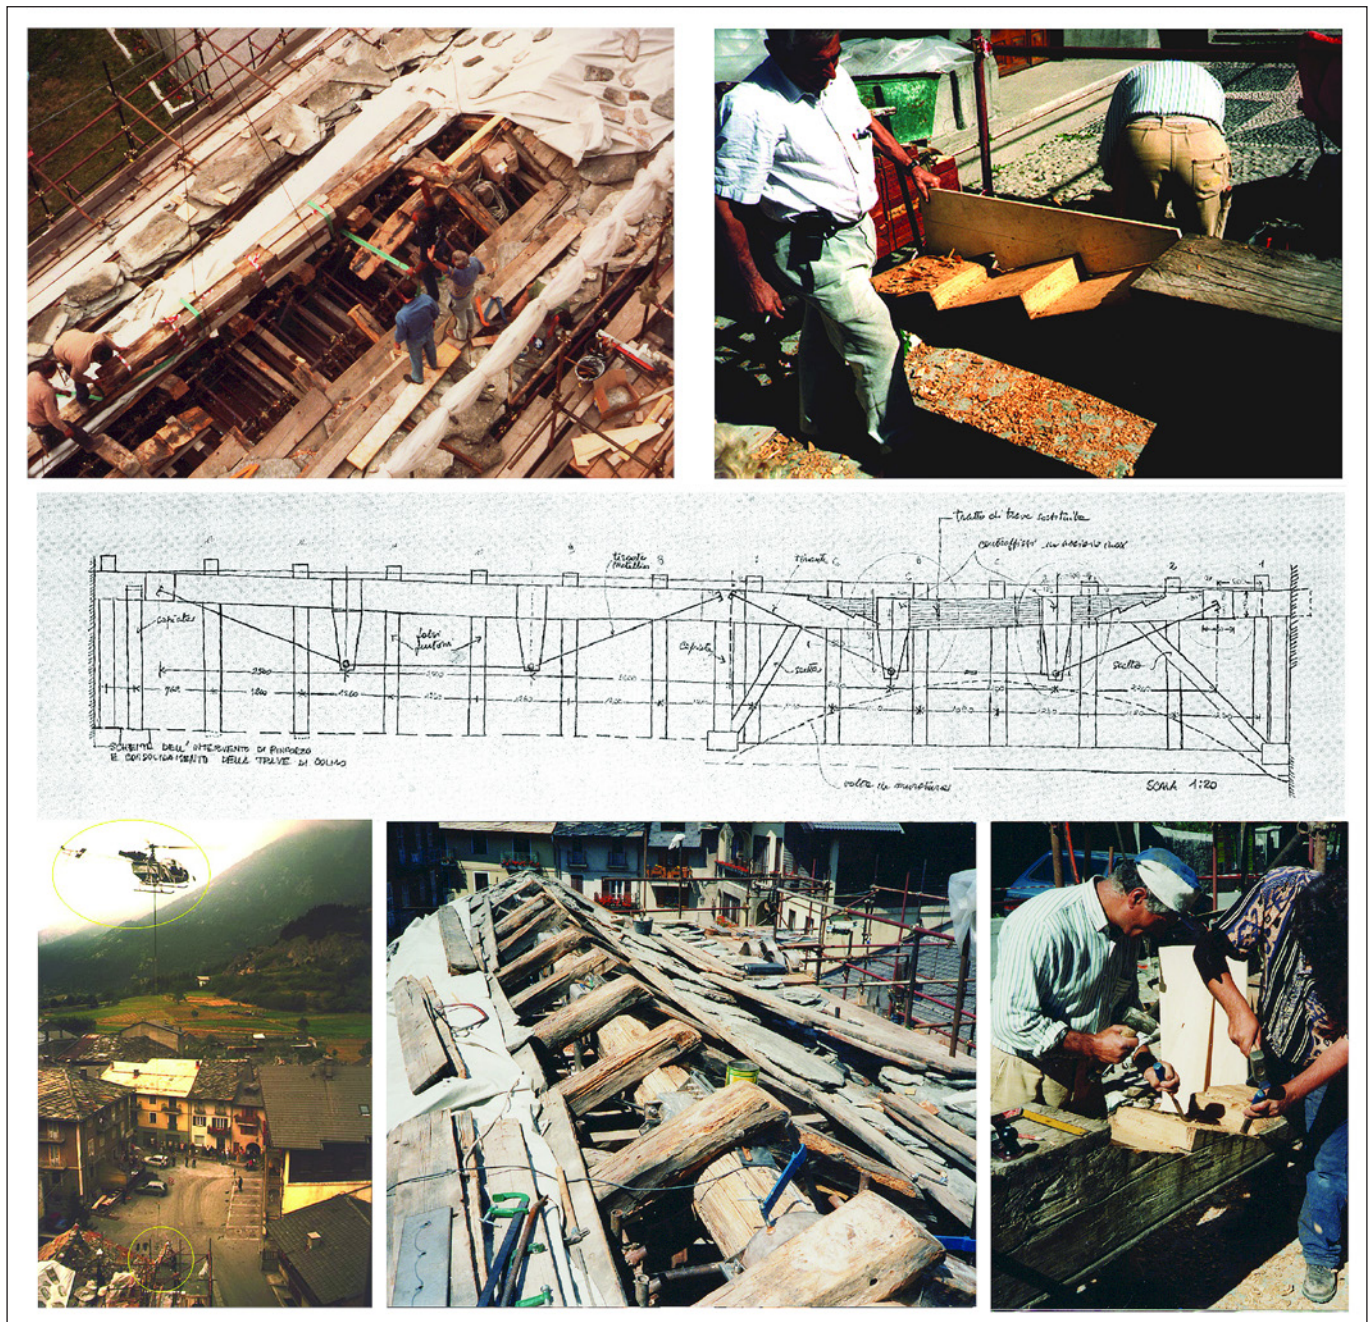
Fig. 10. Phases of the interventions carried out in 2000 with the integration of timber elements, the realization of the double “dart of Jupiter” joint, the transportation of the larch beam on the construction site, some details of the steel elements of the reinforced beam, and the scheme of the reinforcement intervention with Polonceau system. (Image source: drawings and photos courtesy of C. Bertolini-Cestari).

- removal of the damaged section (length 4 m) and positioning of a sound wooden element (an old beam from a demolition of a wooden floor was used for this). For this phase, provisional support of the two parts of the ridge beam with tubular trellis resting on the perimeter walls was necessary so as not to overload the underlying stone vaults. The connections between the ridge beam and the new element were made on-site with “head” connections, also known as the double “dart of Jupiter” joints, tightened by three bolted stainless-steel collars. In this regard, it should be noted that the use of external stirrups (or through screws), required during installation, presents little guarantee of duration over time. A synthetic structural adhesive was therefore used to provide further unity in the parts where the two surfaces of the connections line up (Figs. 9 and 10);
