The timber roof structure of Chapel XVI at Sacro Monte of Orta: an example of conservative strengthening work

THE TIMBER ROOF STRUCTURE OF CHAPEL XVI AT SACRO MONTE OF ORTA: AN EXAMPLE OF CONSERVATIVE STRENGTHENING WORK

Marco Zerbinatti, Alessandro Grazzini, Sara Fasana, Giovanni Vercelli

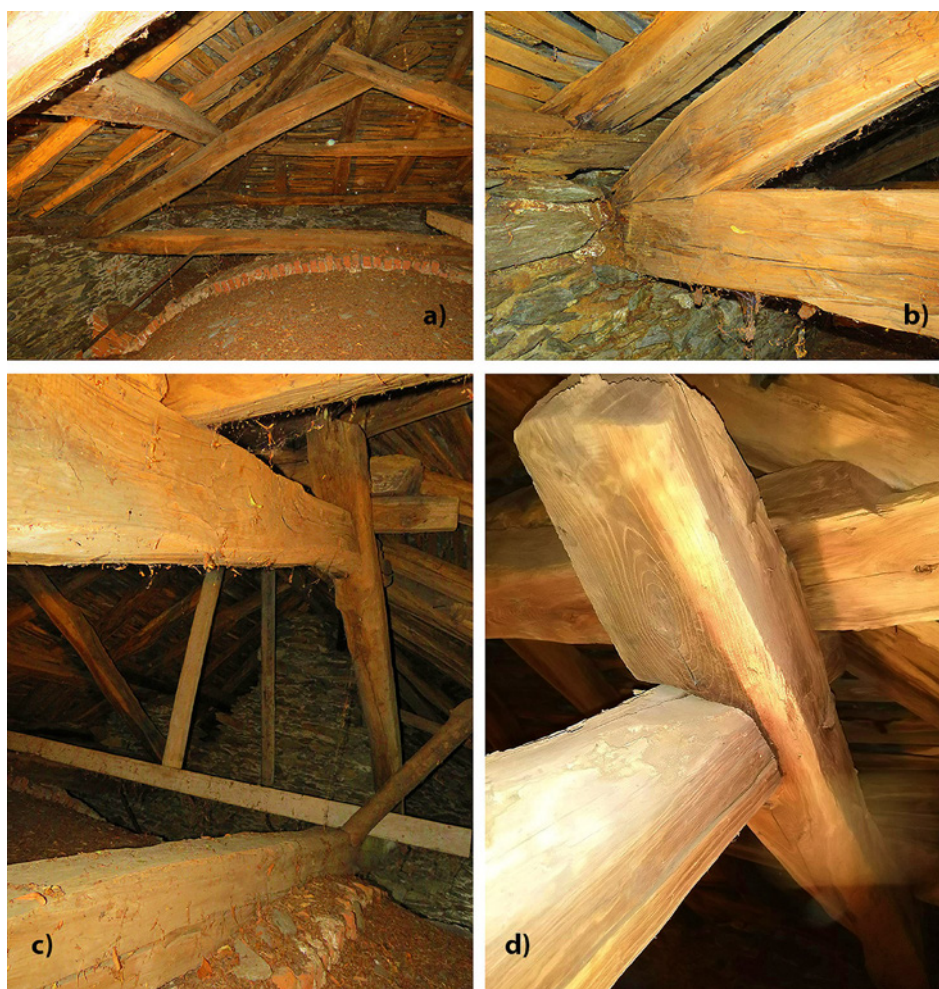
Fig. 5. (a) North truss; (b) detail of the tie beam-rafters connection, in evident degradation inside the masonry support; (c) tie beam rests on the extrados of the vaults; (d) detail of a half-lap coupling connection.

Both trusses are made up of timber tie beams, section 20 cm x 20 cm, resting on the East and West walls and timber rafters of a similar section (Fig. 5a). The connections of the rafters on the tie beams are arranged as common practice, with the support surface oriented according to the bisector of the angle of incidence (Fig. 5b). It should be noted that the tie beams of the trusses have metal elements inserted into the masonry walls and connected to anchoring brackets on the external sides, thus

forming a metallic tie of the ribs of the masonry vault (Fig. 5a). Both tie beams rest on the extrados of the vaults and are slightly curved (deformation just under 10 cm), with the supports at lower altitudes than the center lines (Fig. 5c). The top of the rafters has a *half-lap* coupling connection, therefore without the presence of the classic connection by the king post, with both rafters continuing in the complete section beyond the coupling area (Fig. 5d). The North truss has the supporting section of the tie beam totally degraded, corresponding on the East side (Fig. 5b), with a partial impairment of the coupling surface of the corresponding rafter. The South truss has conditions of partial degradation of the tie beam in the middle section and at the East final part. The East rafter presents conditions of partial deterioration in the top portion. The trusses support a quay beam on the fork generated by the crossing of the rafters (Fig. 5d). This beam is made up of the overlap of two beams in order to reach the correct support level for the cantonal beams and the

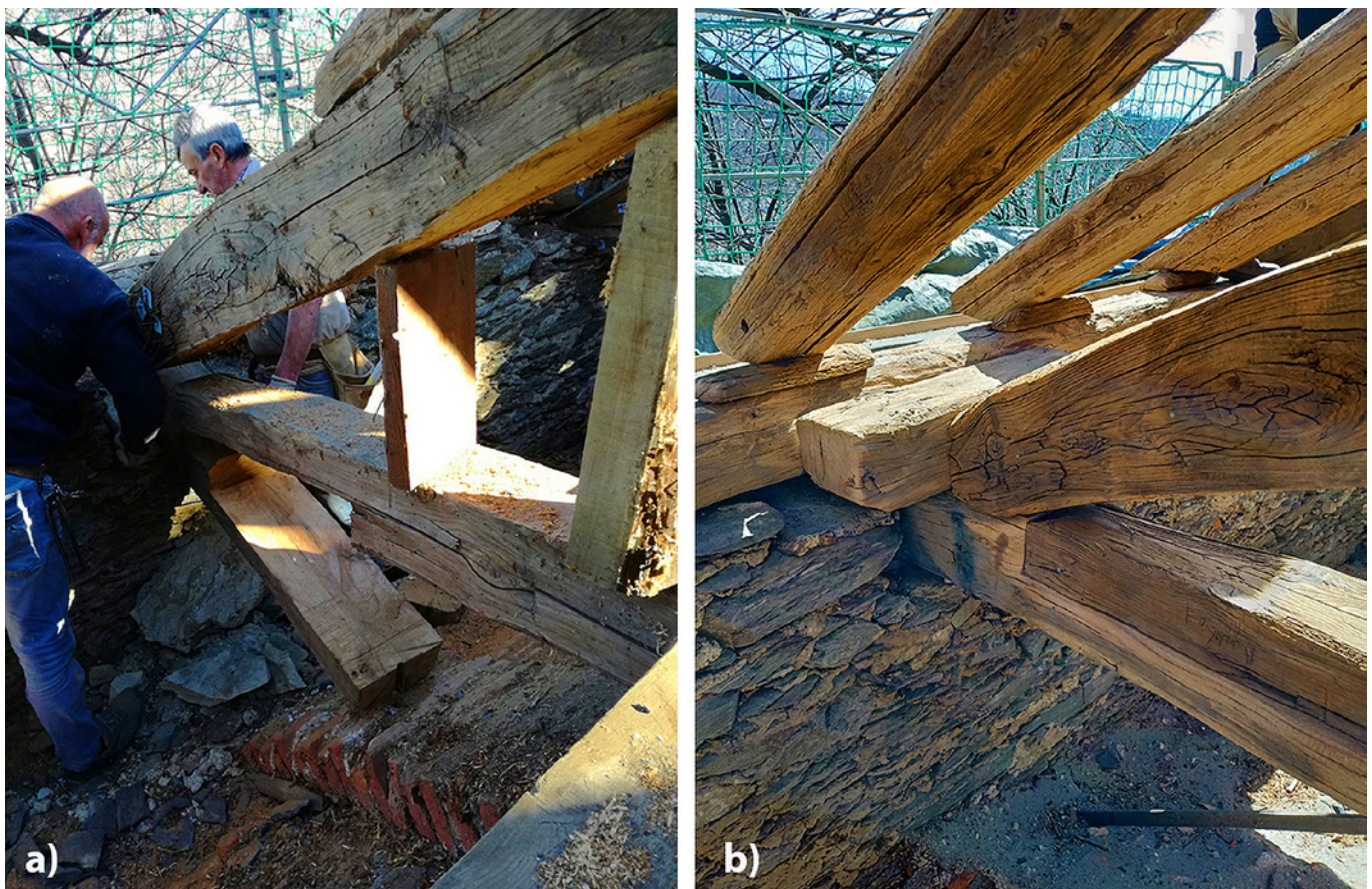
Fig. 9. (a) Positioning of the timber prosthesis; (b) the timber-timber prosthesis performed.

Also, it has been planned to replace all quay beams on the North, East, and South slopes and the angular elements, preserving the quay beam incorporated in the West masonry while still ensuring the connection with the new elements of the other layers. The replacement of the quay beams took place by the slight lifting of the minor rafters acting in such a way as not to unbalance the entire structure, prop it up and fan it to ensure the stability of the whole. Moreover was planned to replace the ridge beam and add two cross beams parallel to the same beam, creating a frame/scheme with a more precise structural concept. The supporting knot of the South truss, compromised by the material degradation, was reinforced with a conservative solution by means of timber-wood prosthesis inserted in contrast with clamping screws, without resorting to epoxy resin prosthesis of undoubted/unproven compatibility (Fig.

9). The main connection was made with screws passing from the extrados rafter to the intrados of the tie beam and between the integrative transverse element and the tie beam.
