3D slope stability analysis of a limestone quarry expansion in Northern Italy

3D slope stability analysis of a limestone quarry expansion in Northern Italy / Martinelli, D.; Pasqualone, G.; Cardu, M.; Linares Gonzalez, M.. - In: IOP CONFERENCE SERIES. EARTH AND ENVIRONMENTAL SCIENCE. - ISSN 1755-1307. - 1124:(2023), p. 012131. (Eurock 2022 Symposium: Rock and Fracture Mechanics in Rock Engineering and Mining Helsinki 2022) [10.1088/1755-1315/1124/1/012131].

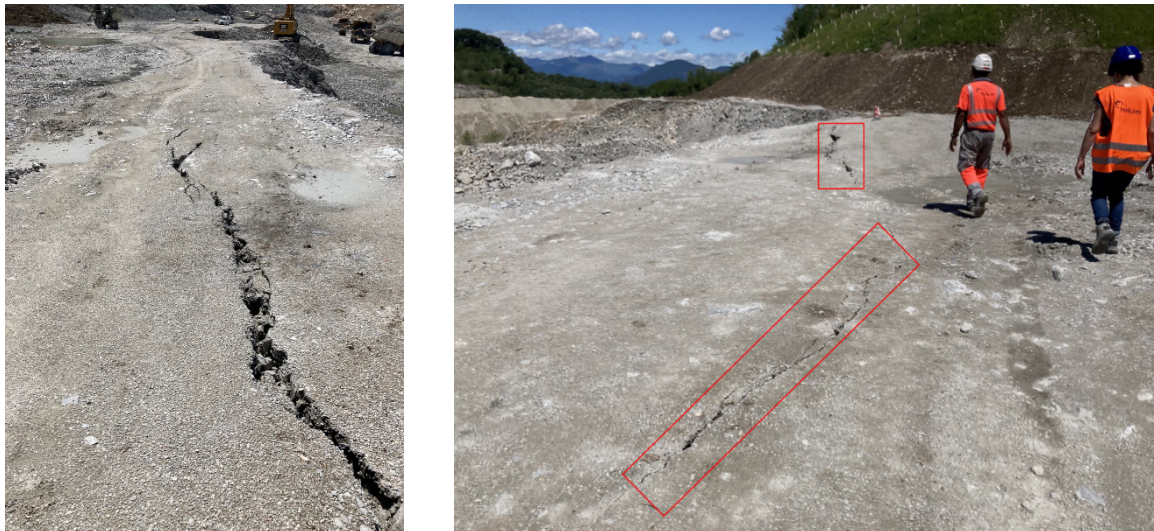
Figure 2. Example of tension cracks formed at the edge of the bench after blasting.

Similar minor instability phenomena still occur with some regularity, in spite of the increase of the water pressure during the whole excavation of the East area of the quarry: in particular, after blasting, tension cracks develop close to the bench edge, potentially creating unstable volumes which can easily slide (Fig. 2).
