Integrated 3D Mapping and Diagnosis for the Structural Assessment of Architectural Heritage: Morano's Parabolic Arch

This paper illustrates an integrated approach to 3D mapping and structural diagnosis by means of non-destructive testing for the preservation of a historical industrial monument: the parabolic arch of Morano sul Po. This paper reports the results of the non-destructive test campaign carried out on the structure and focuses on the procedures for structuring an integrated approach, which served as the basis to provide guidelines for its conservation.

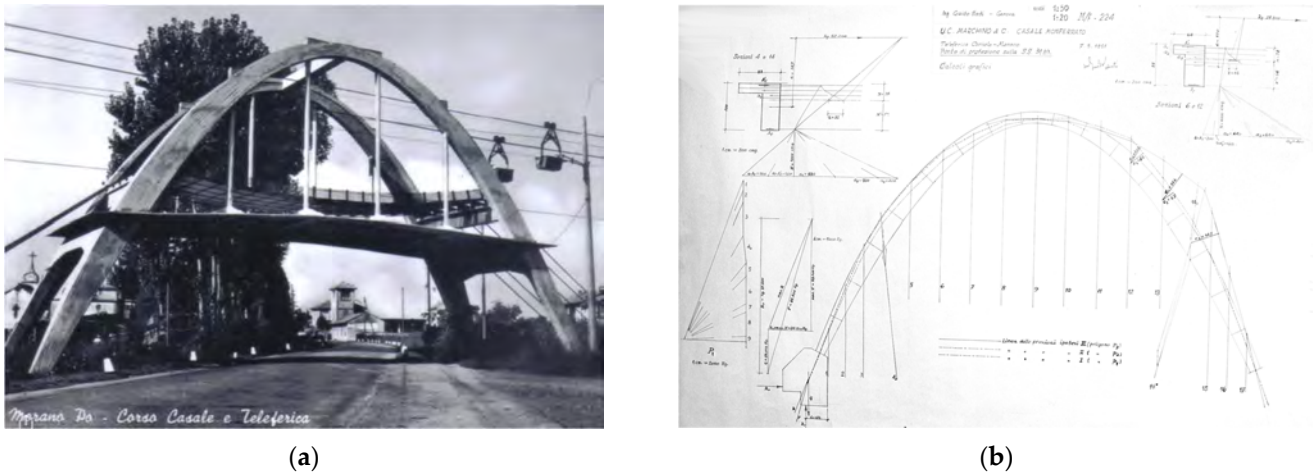
Figure 2. (a) Historical postcard showing the original configuration of the arch, where the shielding roofs were present; (b) original drawing with the graphic tracing of the thrust line of the arch.

Fortunately, some of the structural drawings of the arch are still available. Figure 2b shows an excerpt of such design drawings, from which is possible to recognize the graphical procedure for the determination of the thrust line of the arch, which was made with three distinct loading configurations. In addition, the graphical determination of the neutral axis and the stress field in some of the arch sections due to eccentric compression was obtained using the Mohr–Guidi method.

The determination of the depth of carbonation was carried out in accordance with the provisions of EN 14630:2007 [34] using a 1% phenolphthalein solution in ethyl alcohol as a reagent. In order to minimize structural disturbance, the in situ test was conducted by taking advantage of the holes drilled with the percussion drill, which had already been used for direct verification of the cover thickness and for corrosion testing to minimize the removal of the original concrete. Carbonation testing was performed at multiple locations on the columns. At all locations, the carbonation depth was detected to be within 3 mm, as shown in. Given the age of the structure, the limited carbonation depth could be attributed to previous coatings that were installed in the past, as confirmed by the historical photograph (Figure 2a).

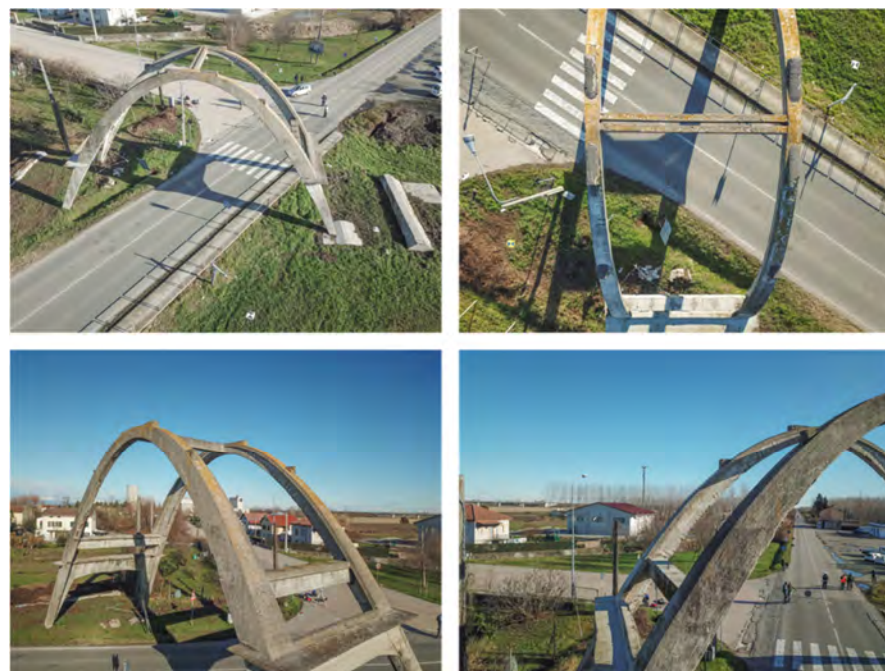
Figure 4. Digital images acquired from an aerial perspective using the micro UAV system, which enabled the acquisition of the extrados and the higher surfaces of the concrete arch.

- The photogrammetric survey was carried out by integrating the acquisitions from both a micro UAV (Figure 4) and a DSLR (digital single lens reflex) camera using all of the images (more than 600). Regarding the image-based approach, an SfM solution was adopted. This type of 3D reconstruction is widely used in the field of image-based documentation of heritage buildings since it allows for the generation of dense and accurate point clouds that are characterized by high-resolution radiometry. This feature represents a very useful tool for restorers and conservators since it enables them to consider elements related to the material consistency of a building, thus facilitating its study and diagnostic investigations. The Agisoft Metashape platform (Version 1.8.1) was employed for this operation since it is one of the most commonly adopted and user-oriented software solutions in the field of image-based documentation of heritage buildings. The subsequent pipeline was managed without criticalities (Table 1): image masking, interior orientation of the camera, relative orientation of the images and tie-points extraction, georeferencing and bundle adjustment using the acquired ground control points, accuracy evaluation using both control and check points, and dense point cloud generation (Figure 5).

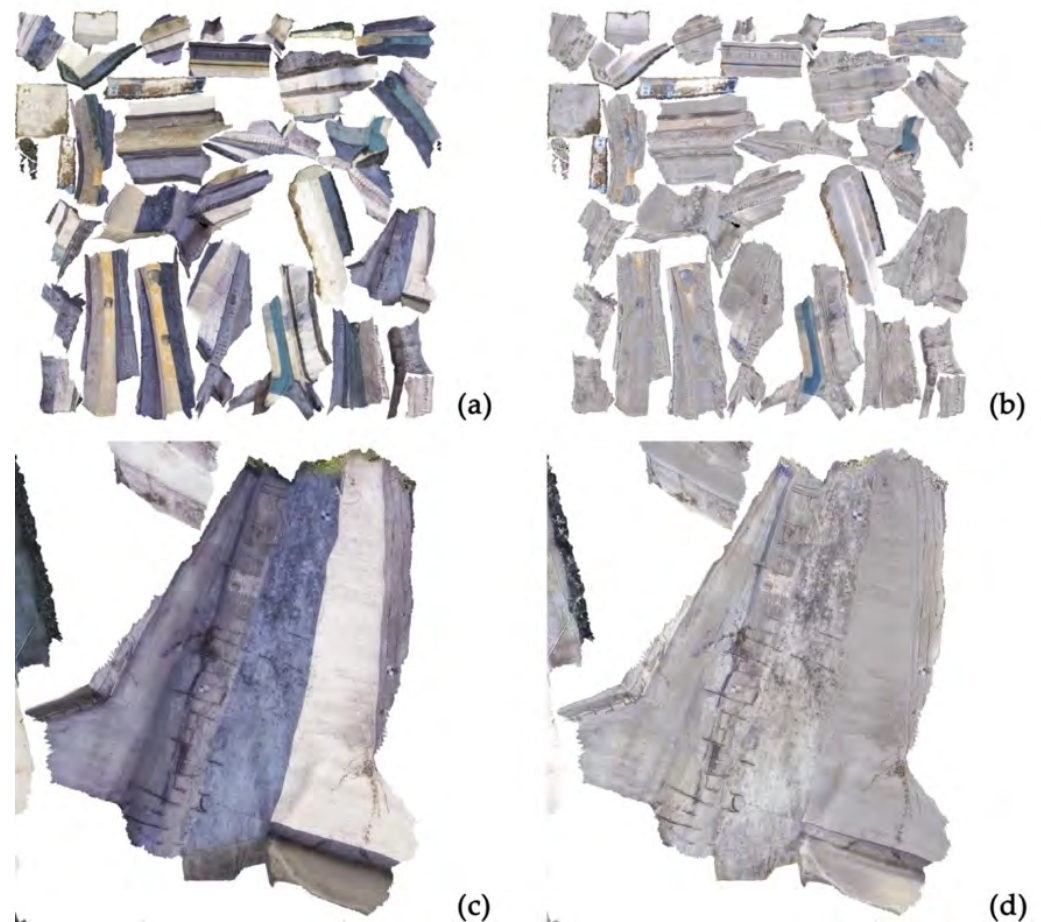
Figure 6. (a) Original UV map; (b) UV map after the editing process; (c) detail of the original UV map; (d) detail of the UV map after the editing process.

The generated UV map was processed with the aim of performing a radiometric equalization to homogenize the radiometry of composite elements of the same material but characterized by different solar exposures. This operation was carried out using the Agisoft Delightner platform, which allows for performing the equalization procedure by identifying different samples of underexposed and overexposed areas. The results of this operation can be observed in Figure 6d.

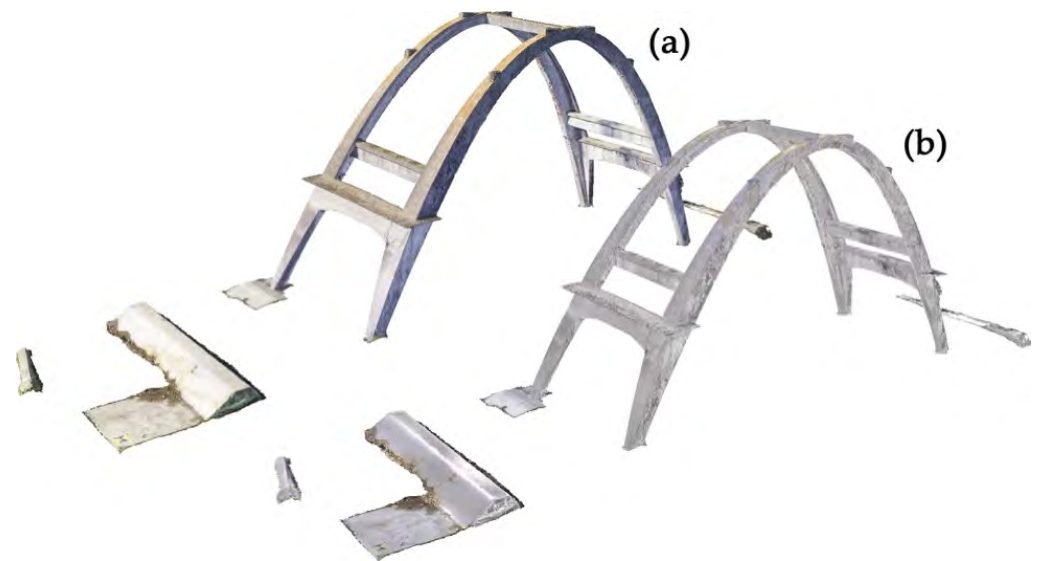
Figure 7. (a) Photogrammetric 3D mesh of the arch with the original texture; (b) reprojection of the edited texture on the original photogrammetric 3D mesh.

The edited texture was re-projected onto the computed 3D mesh (Figure 7) for the subsequent generation of the orthophotos that were used as primary data for the RGB-based reclassification for the identification of the analyzed types of decay. The reclassification of the exported raster images was carried out using the open-source software QGIS, which allowed—through the Raster Calculator tool—for grouping clusters of pixels with comparable digital number values and reclassifying them, exploiting the difference in terms of radiometry of the analyzed material (concrete) and decays (uncovered irons, efflorescence, and pollution blackening). After the reclassification processing, a degradation map was generated. In this case, the digital numbers embedded in each pixel of the classified orthophotos contained only four values: 0 for the concrete, 1 for the exposed irons, 2 for the areas affected by efflorescence, and 3 for the areas affected by the presence of pollution blackening (Figure 8).

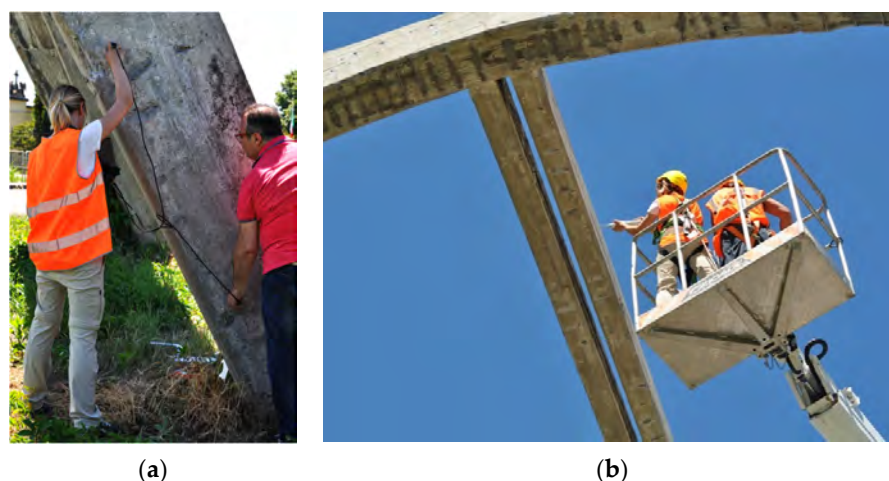
Figure 10. On-site testing of the various elements of the structure: (a) ultrasonic pulse velocity test; (b) rebound hammer test on one of the top beams connecting the arches.

Ultrasonic pulse velocity tests are well-known non-destructive tests that are used to evaluate the quality and homogeneity of concrete. Measurements were conducted in accordance with the standards [7,10]. The measurement of the propagation time of the ultrasonic pulses was carried out using two probes, namely, a transmitter and a receiver, each with a frequency of 54 kHz, and applied to the surface of the element involved in the test. Indirect, i.e., homeosurface, tests were performed by placing the probes on the same face of the structural element at varying distances (Figure 10a), and once the distance between the points under test was provided, the instrument returned the time and speed of the wave propagation.

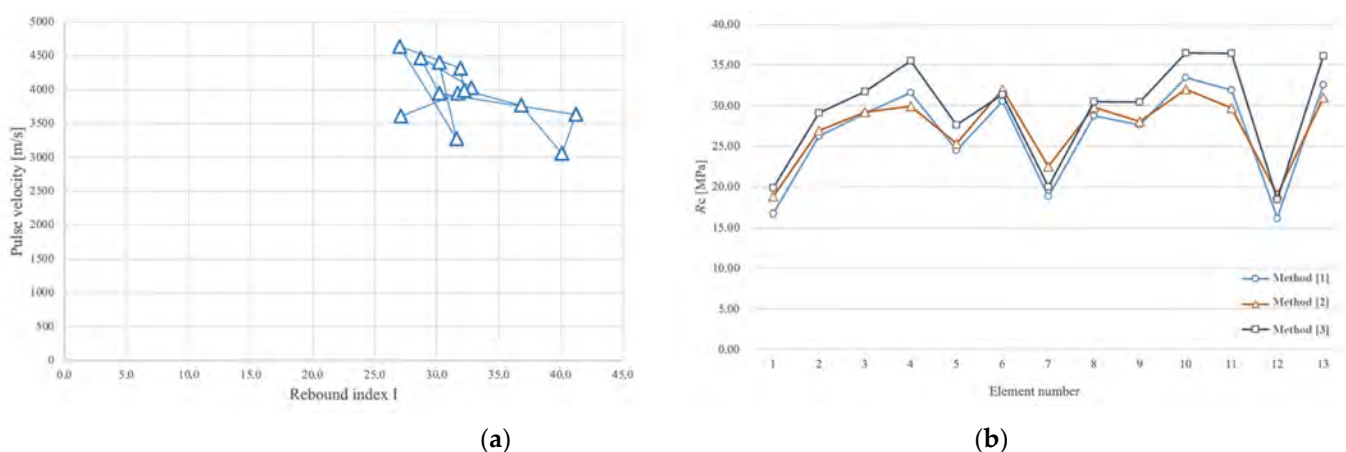
Figure 11a,b shows the results of the SONREB tests in graphical form. As can be seen, the values formed a rather definite cluster, which is generally an indication of a uniform material type.

Figure 11. (a) Diagram illustrating the values of the pulse velocities and rebound index; (b) SONREB results in terms of R_c .

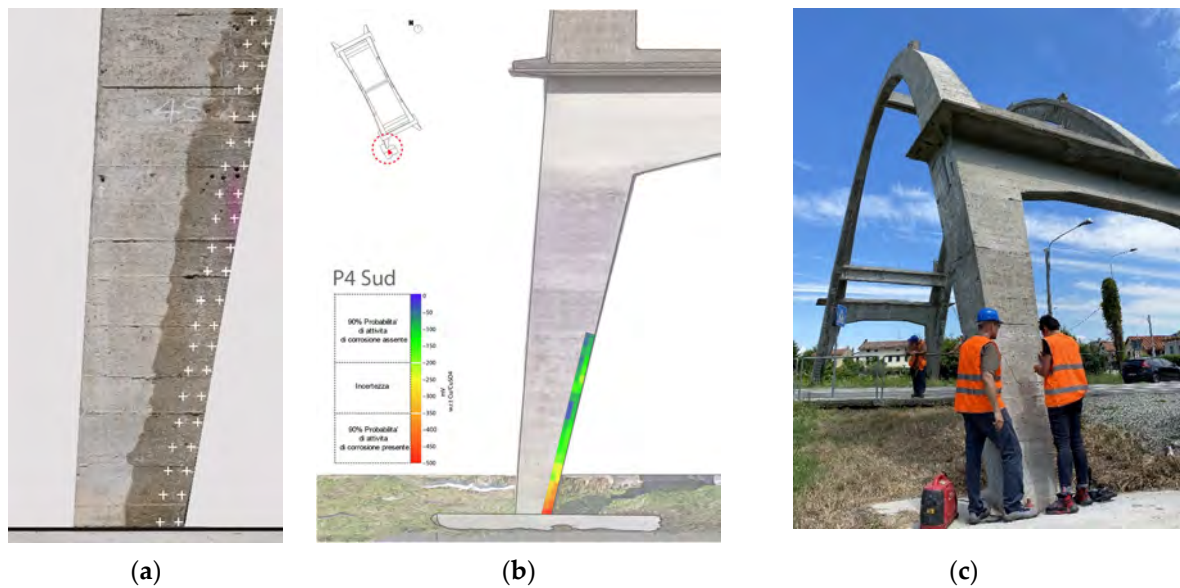
The data collected were translated into color contour maps to better illustrate the findings (Figure 12). Negligible corrosion levels were detected at the time of testing.

Figure 12. (a) Diagram illustrating the grid used to record the potential measurements (“+” indicate measuring locations); (b) an example of a half-cell potential map (the red circle specifies the arch pillar); (c) a photograph of the team during the fieldwork.

A half-cell potential survey was carried out in accordance with the ASTM C876-22b Standard Test Method for Corrosion Potentials of Uncoated Reinforcing Steel in Concrete [35]. The test was conducted by using a copper–copper sulfate reference electrode. Continuity testing was carried out before completing the corrosion testing to assess the presence of electrical continuity within the existing steel reinforcement. Due to limited continuity found between the existing steel reinforcement, testing was carried out in limited areas.

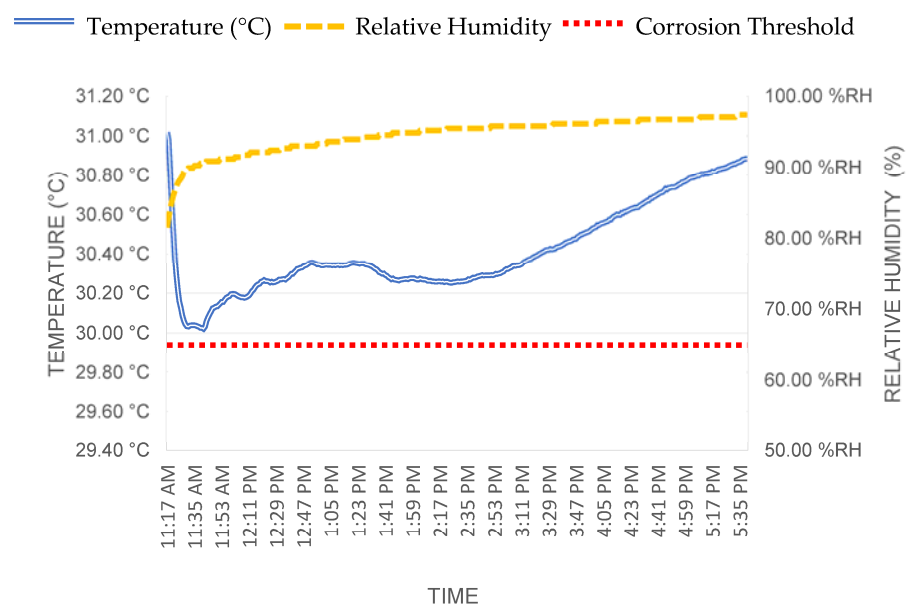
Environmental monitoring is an important factor to consider when assessing reinforced concrete structures. Several of the common deterioration mechanisms that affect reinforced concrete structures are initiated by a certain level of moisture present within the material. With corrosion, moisture is one of the two ingredients, together with oxygen, that needs to be present for the reaction to occur. Internal environmental monitoring was carried out at one location. A temporary sensor was installed inside the concrete to measure the internal temperature and humidity levels. Measurements were recorded every 20 min during the field workday (approximately 5 h). From the internal environmental monitoring, a high moisture content was detected from the data collected on site (Figure 13).

Figure 13. Graph illustrating the data collected of the internal temperature and humidity at the concrete column.

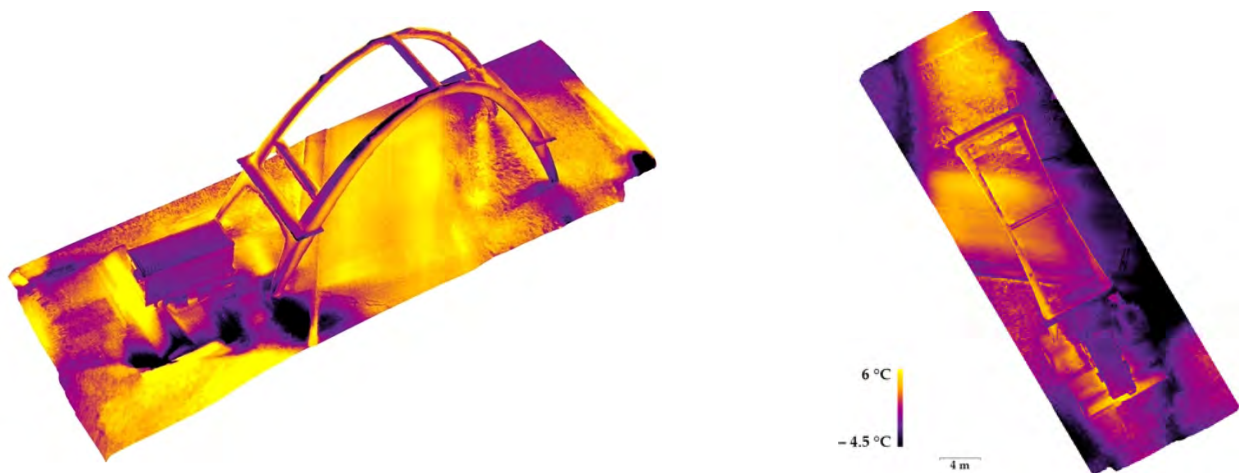
Figure 15. A 3D mesh derived from the integration between the visible data and the oriented TIR images.

- A high-resolution thermal-textured 3D mesh (Figure 15);
- Thermal orthoimagery (Figure 15).
