Integrated 3D Mapping and Diagnosis for the Structural Assessment of Architectural Heritage: Morano's Parabolic Arch

Integrated 3D Mapping and Diagnosis for the Structural Assessment of Architectural Heritage: Morano's Parabolic Arch / Ceravolo, R., Invernizzi, S., Lenticchia, E., Matteini, I., Patrucco, G., Spano', A.T.. - In: SENSORS. - ISSN 1424-8220. - ELETTRONICO. - 23:14(2023), pp. 1-22. [10.3390/s23146532]

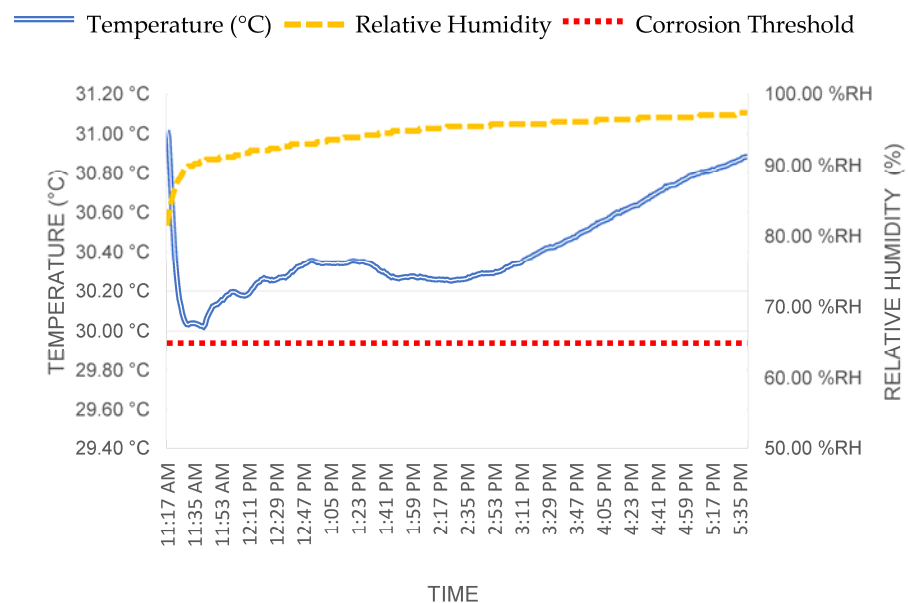
Environmental monitoring is an important factor to consider when assessing reinforced concrete structures. Several of the common deterioration mechanisms that affect reinforced concrete structures are initiated by a certain level of moisture present within the material. With corrosion, moisture is one of the two ingredients, together with oxygen, that needs to be present for the reaction to occur. Internal environmental monitoring was carried out at one location. A temporary sensor was installed inside the concrete to measure the internal temperature and humidity levels. Measurements were recorded every 20 min during the field workday (approximately 5 h). From the internal environmental monitoring, a high moisture content was detected from the data collected on site (Figure 13).

Figure 13. Graph illustrating the data collected of the internal temperature and humidity at the concrete column.
