RESTORATION OF A LANDMARK BALANCED CANTILEVER BRIDGE CONSIDERING DIFFERENT RESILIENCE AND SUSTAINABILITY STRATEGIES

Marco Domaneschi¹, Stergios A. Mitoulis², Raffaele Cucuzza¹, Valentina Villa¹ and Roberta Di Bari³, Gopika Siva²

Abstract

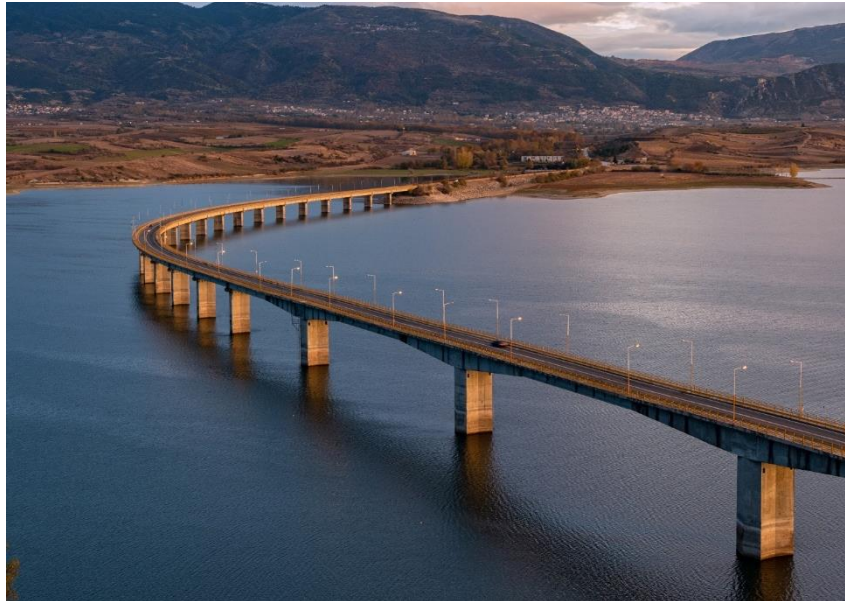
Figure 1: Bridge layout.

The Polyfytos bridge is an asset built in 1975 in the Municipality of Western Macedonia, Kozani, Greece and bridges the artificial homonymous lake of Polyfytos, with the local and the national road network relying entirely on its integrity. The balanced cantilever method was used to build a part of the bridge, specifically six cantilevers spanning from piers 22, 23 and 24 (Fig.1) accounting for a total of 260 meters (total length of the bridge is 1372 m).
