Failure and Damage of Reciprocating Lip Seals for Pneumatic Cylinders in Dry Conditions

# Failure and Damage of Reciprocating Lip Seals for Pneumatic Cylinders in Dry Conditions

Luigi Mazza \* and Edoardo Goti

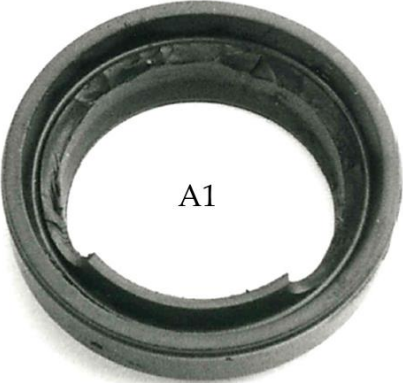
Picture	Description	Dominant Failure Mode
  <p style="text-align: center;">A1</p>	<p>Serious distributed loss of chunks of material from the sealing edge of lips (sometimes followed by tearing of the whole lip) due to operation under high mounting eccentricity.</p>	<p>Mode I</p>
  <p style="text-align: center;">A1</p>

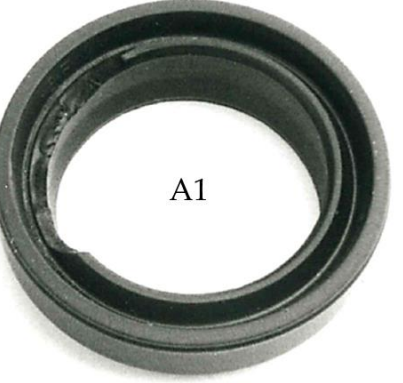
<p>A1</p>	<p>Bulk continuous tearing of the sealing edge of the lip due to partial extrusion from the seat associated with a reduced retaining action of the shoulder (due to an increase in the diameter <math>d_1</math> of the seat shoulder). Sometimes, the lip detachment occurs without complete loss of material from the contact site. Failure often indicates the region where extrusion took place during the tests, and cross-section distortion of the seal during wear cycles may also be experienced in these regions.</p>	<p>Mode II and Mode I</p>

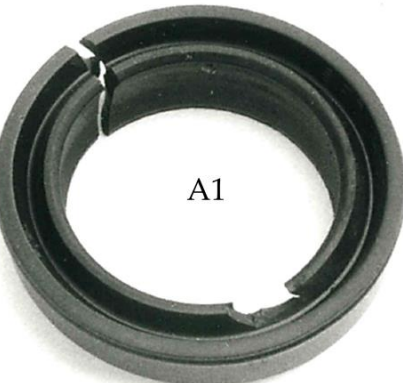
<p>A1</p>	<p>Cracking of the sealing ring produced by a radial cut due to the complete ejection of the seal from its seat.</p>	<p>Mode II</p>
